*Feasibility Study*

*Replacement of Beaver Lake Outlet*

*Prepared for  
Ramsey-Washington Metro Watershed District*

*June 2005*

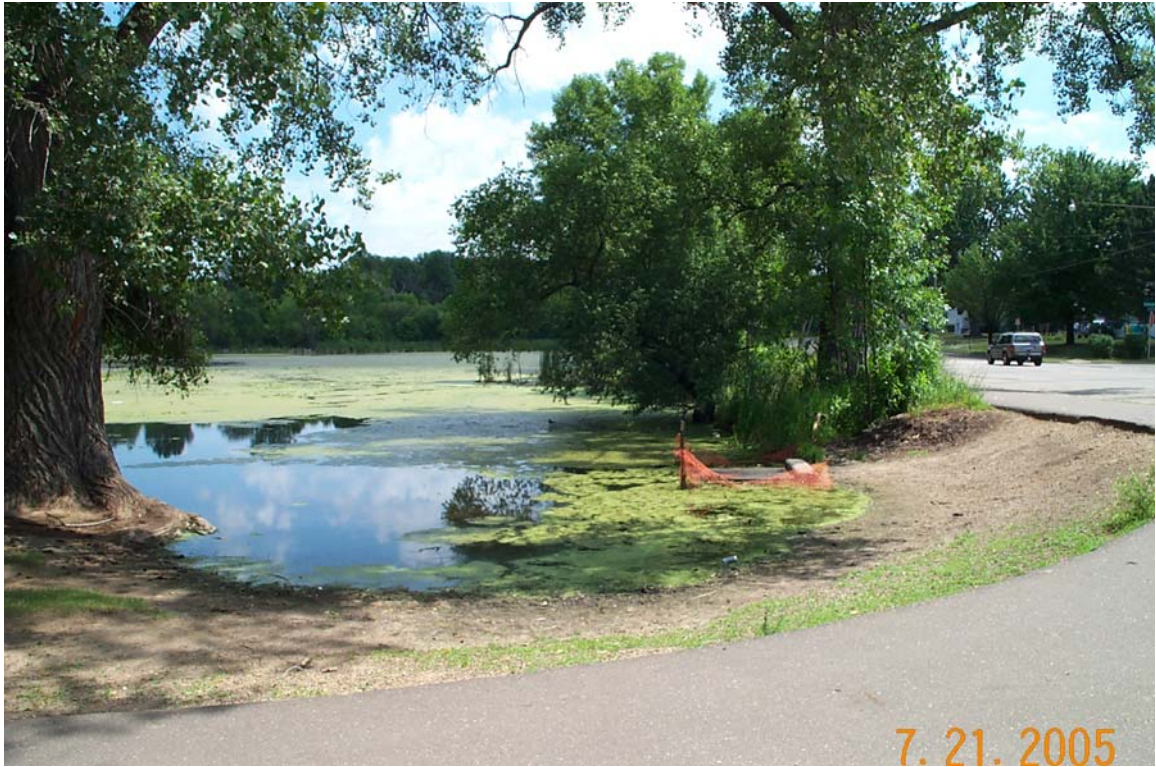
Photo 1 – Beaver Lake Outlet (View facing east)

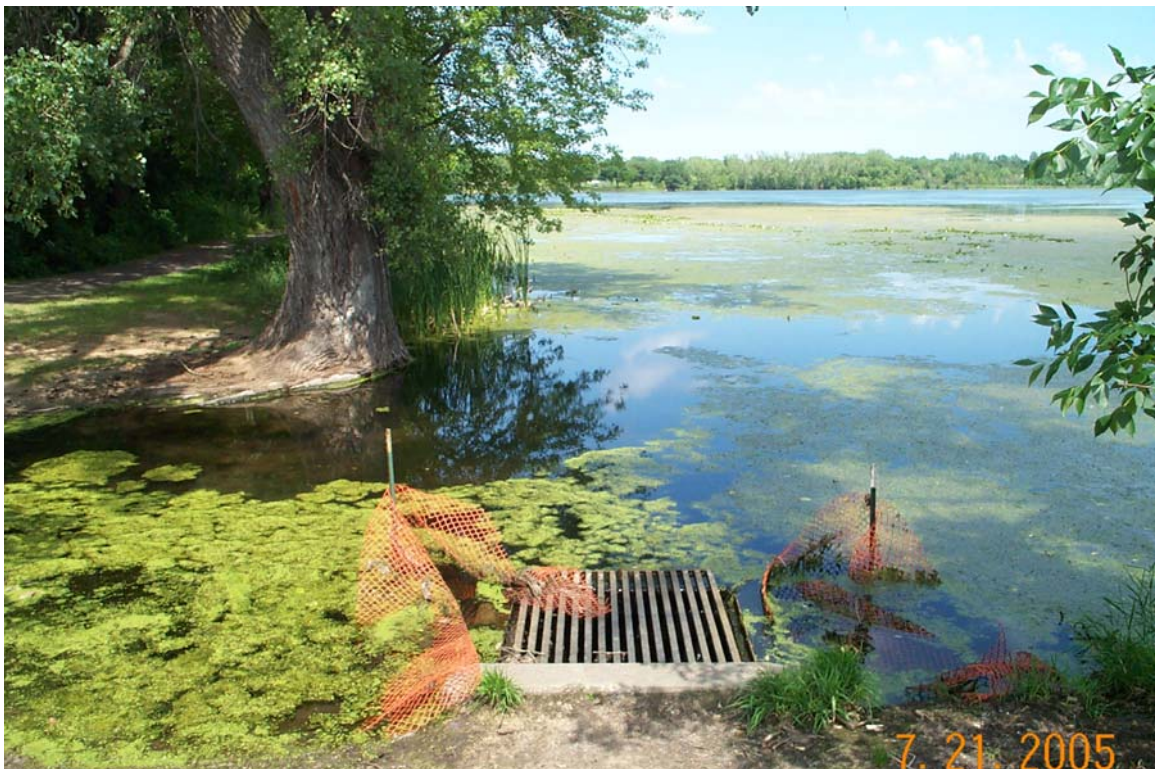
Photo 2 – Beaver Lake Outlet (View facing north)

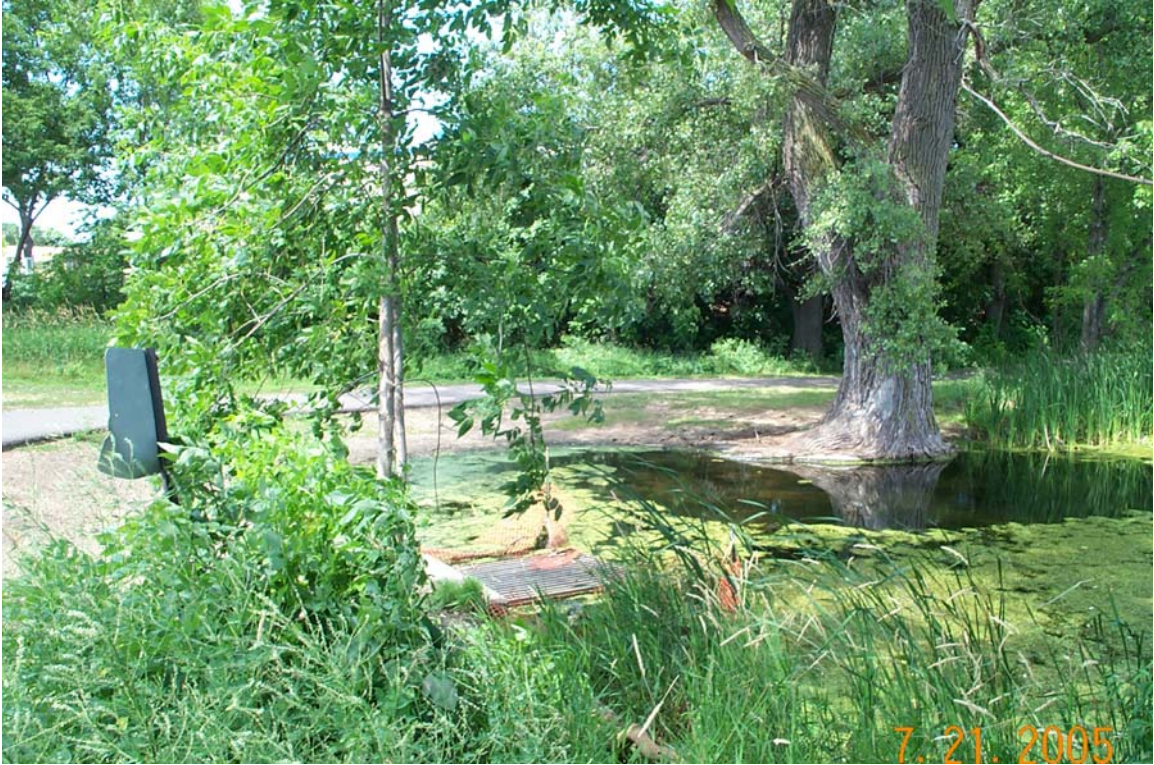
Photo 3 – Beaver Lake Outlet (View facing west)

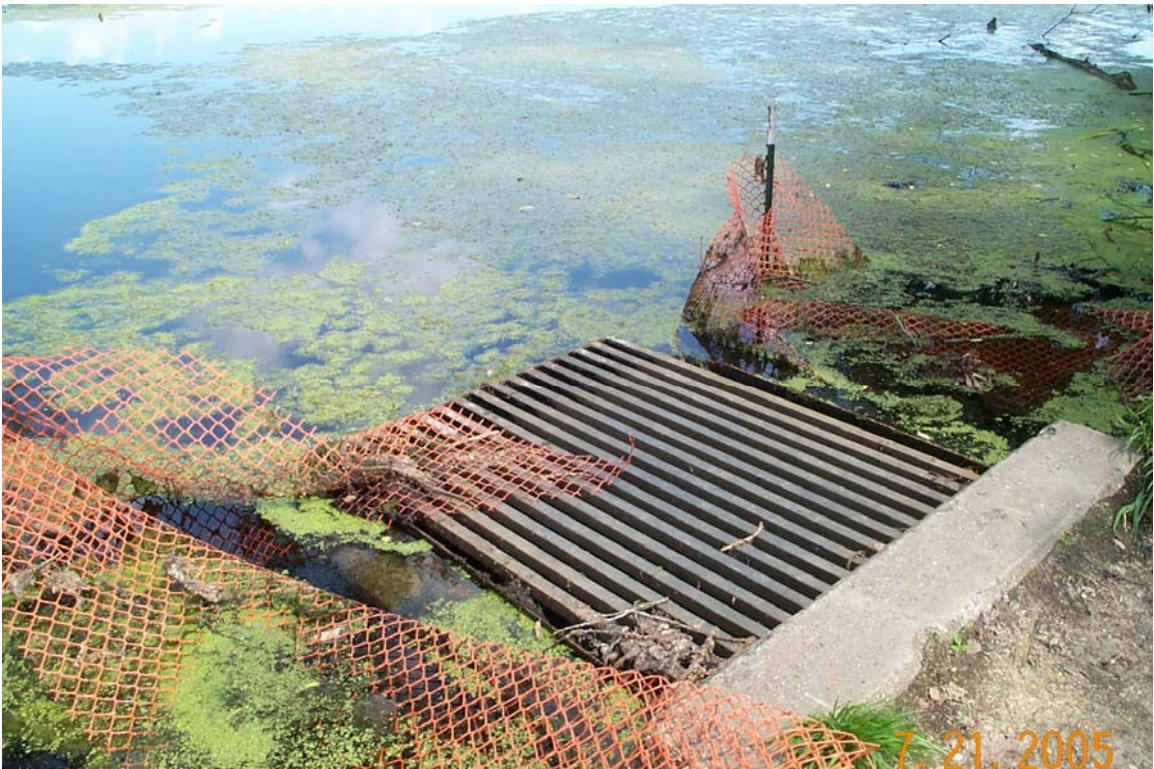
Photo 4 – Beaver Lake Outlet (close-up facing lake)

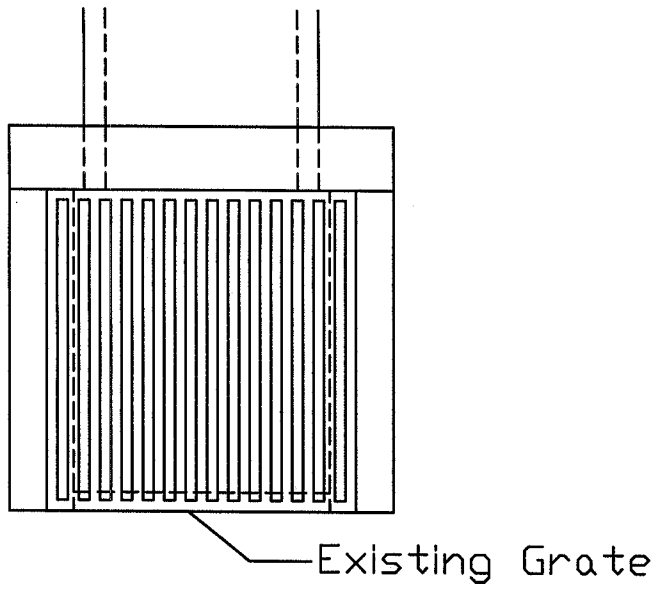
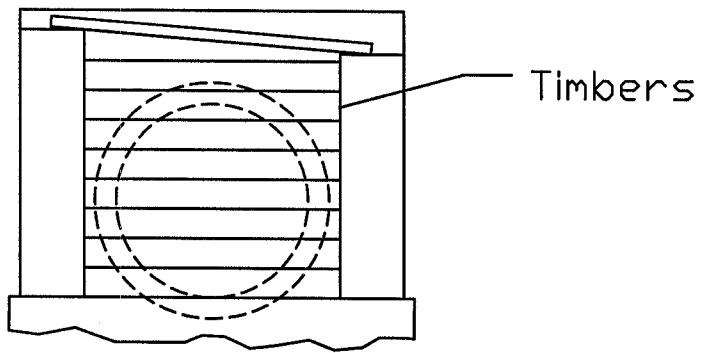
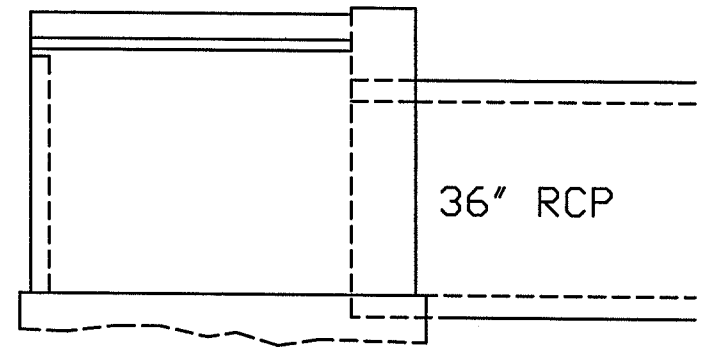
Figure 2 - Existing Structure

The existing outlet structure for Beaver Lake consists of a drop box inlet structure. The structure is 6 feet wide and extends into the lake a distance of 5 feet. The drop box structure is the inlet for a 36-inch diameter reinforced concrete pipe. A sketch of the drop box inlet structure is shown in Figure 2.

The drop box inlet structure includes a horizontal tubular steel grate which serves as a trash rack. The existing steel grate collects significant quantities of floating debris. This debris commonly results in significant restriction to the flow through the steel grate. This horizontal trash rack collects extraordinary quantities of debris which substantially restricts the flow of water through the grate.

The drop box inlet structure also includes removable stop logs. It appears that the stop logs could be removed to lower the level of the lake. The existing stop logs appear to be in fair condition.

Under existing conditions it is estimated that during high flow events, the capacity of the trash rack is restricted to approximately one-third of its' unobstructed capacity by debris accumulation. A site survey was performed in March 2005. The survey as shown in Figure 3 used the 1929 datum..
