Feasibility Report on

Mailand-McKnight Road Gully Erosion

Cities of Maplewood and St. Paul, Ramsey County

Ramsey-Washington Metro Watershed District

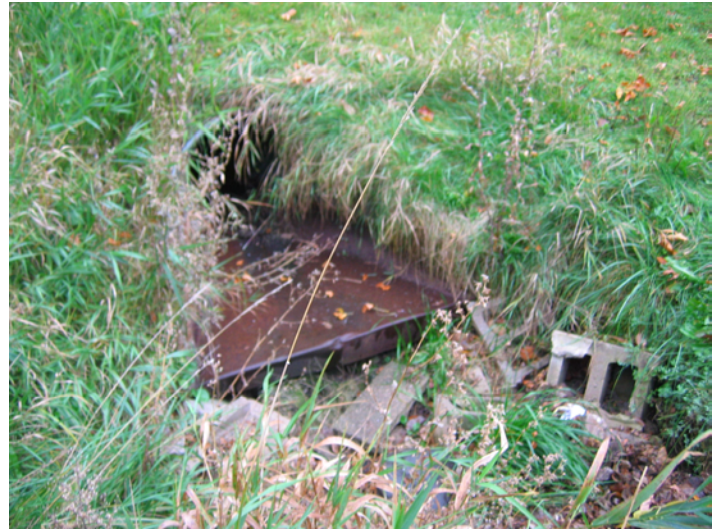
Erosion is immediately apparent at the pipe outlet, where the homeowner recently placed concrete blocks in an attempt to armor the sandy soil (Photo 1). Beginning approximately 100 feet down-channel, in a segment that veers north across the backyards of 451 and 443 McKnight, the channel cuts down to a depth of 2.5 to 4 feet near Station 2 (Figure 3). As water heads northwest, it moves through a small grassed swale running alongside a “mini-berm” that was constructed in the backyard of 2221 Mailand Road to control the flow of water across their property.

Photo 1. *Outlet on 451 McKnight Road property*

Starting at the pipe outlet, an energy dissipation structure would be installed. The structure would consist of a 60-inch diameter manhole with a 2-foot deep sump that would connect to the end of the outlet pipe. A larger (36-inch) outlet pipe placed at a 1percent slope or flatter, with a flared end section and grate or trash rack, would extend from the manhole to create the new outlet. (See Figure 4.) The drop inside the structure would serve to dissipate some of the water's energy and velocity. The structure's outlet, placed at a lower elevation than the current outlet, would reduce the initial channel slope and spread the water wider, thus reducing its erosive force. The pipe and manhole would be covered with topsoil to match the existing slope of the yard and the outlet area would be armored with fieldstone riprap.

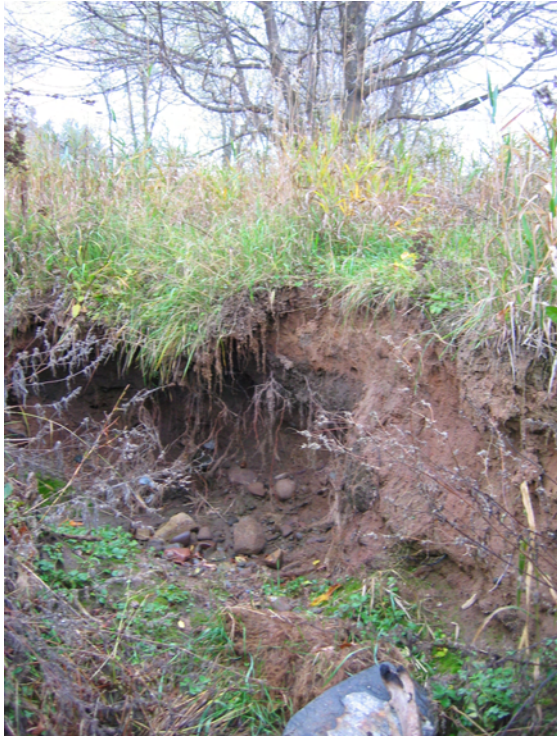
At Station 6, north of 2191 Mailand, the deepest gully erosion occurs (Photo 2). Following a sharply

curved area, the water has cut 5 feet into the sandy soils. While some weedy herbaceous vegetation is growing in portions of the eroded area, the channel is largely characterized by bare soil, open to further erosion. The surrounding area is dominated by aggressive vegetation, including non-native reed canary grass and smooth brome and native Canada goldenrod.

Photo 2. The deepest gully erosion (Station 6)

Hydrologic modeling shows that peak flow rates occur through the pipe and channel during short-duration, high-intensity rainfall events, i.e. "gully washers." The model predicts that 20 cubic feet per second (cfs) would discharge from the outlet pipe (Station 1) during a 10-year design storm (2.1 inches of rainfall in 1 hour). The resulting velocity would be approximately 4 feet per second between Stations 1 and 2. Further down the channel at Station 6, the flow rate would increase to approximately 30 cfs as contributions from the surrounding watershed boost the flows. At a flow rate of 30 cfs, the velocity of the water through the channel at Station 6 is approximately 6 feet per second.

At Station 5 and 6, where the erosion is the most severe, a rock drop structure designed by a professional engineer should be installed. The structure would consist of strategically placed boulders and riprap that would allow water to drop 4 to 5 vertical feet without causing erosion. The final product would resemble a section of rapids on a river, though it would not remain wet at all times. (See Photo 3, which shows a constructed rock drop structure in Battle Creek Park, St. Paul and

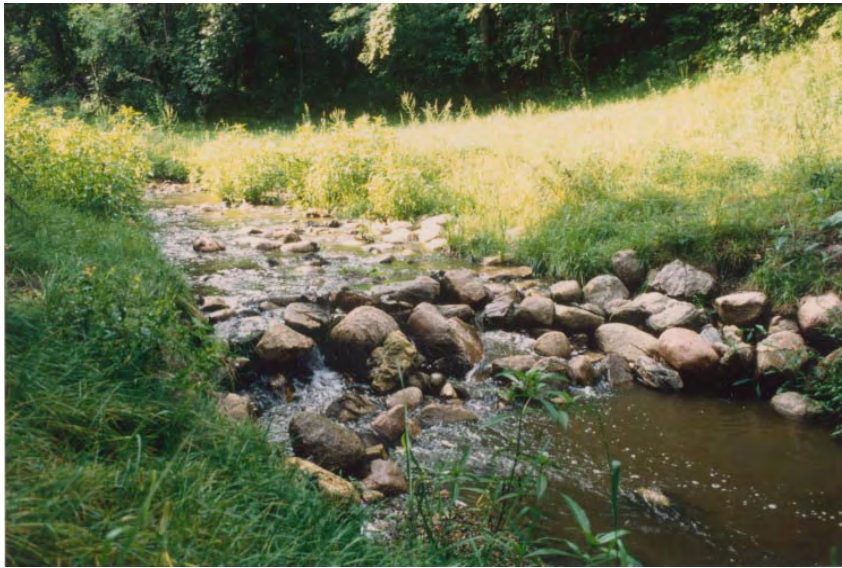
Photo 3. *Rock drop structure at Battle Creek Park.*

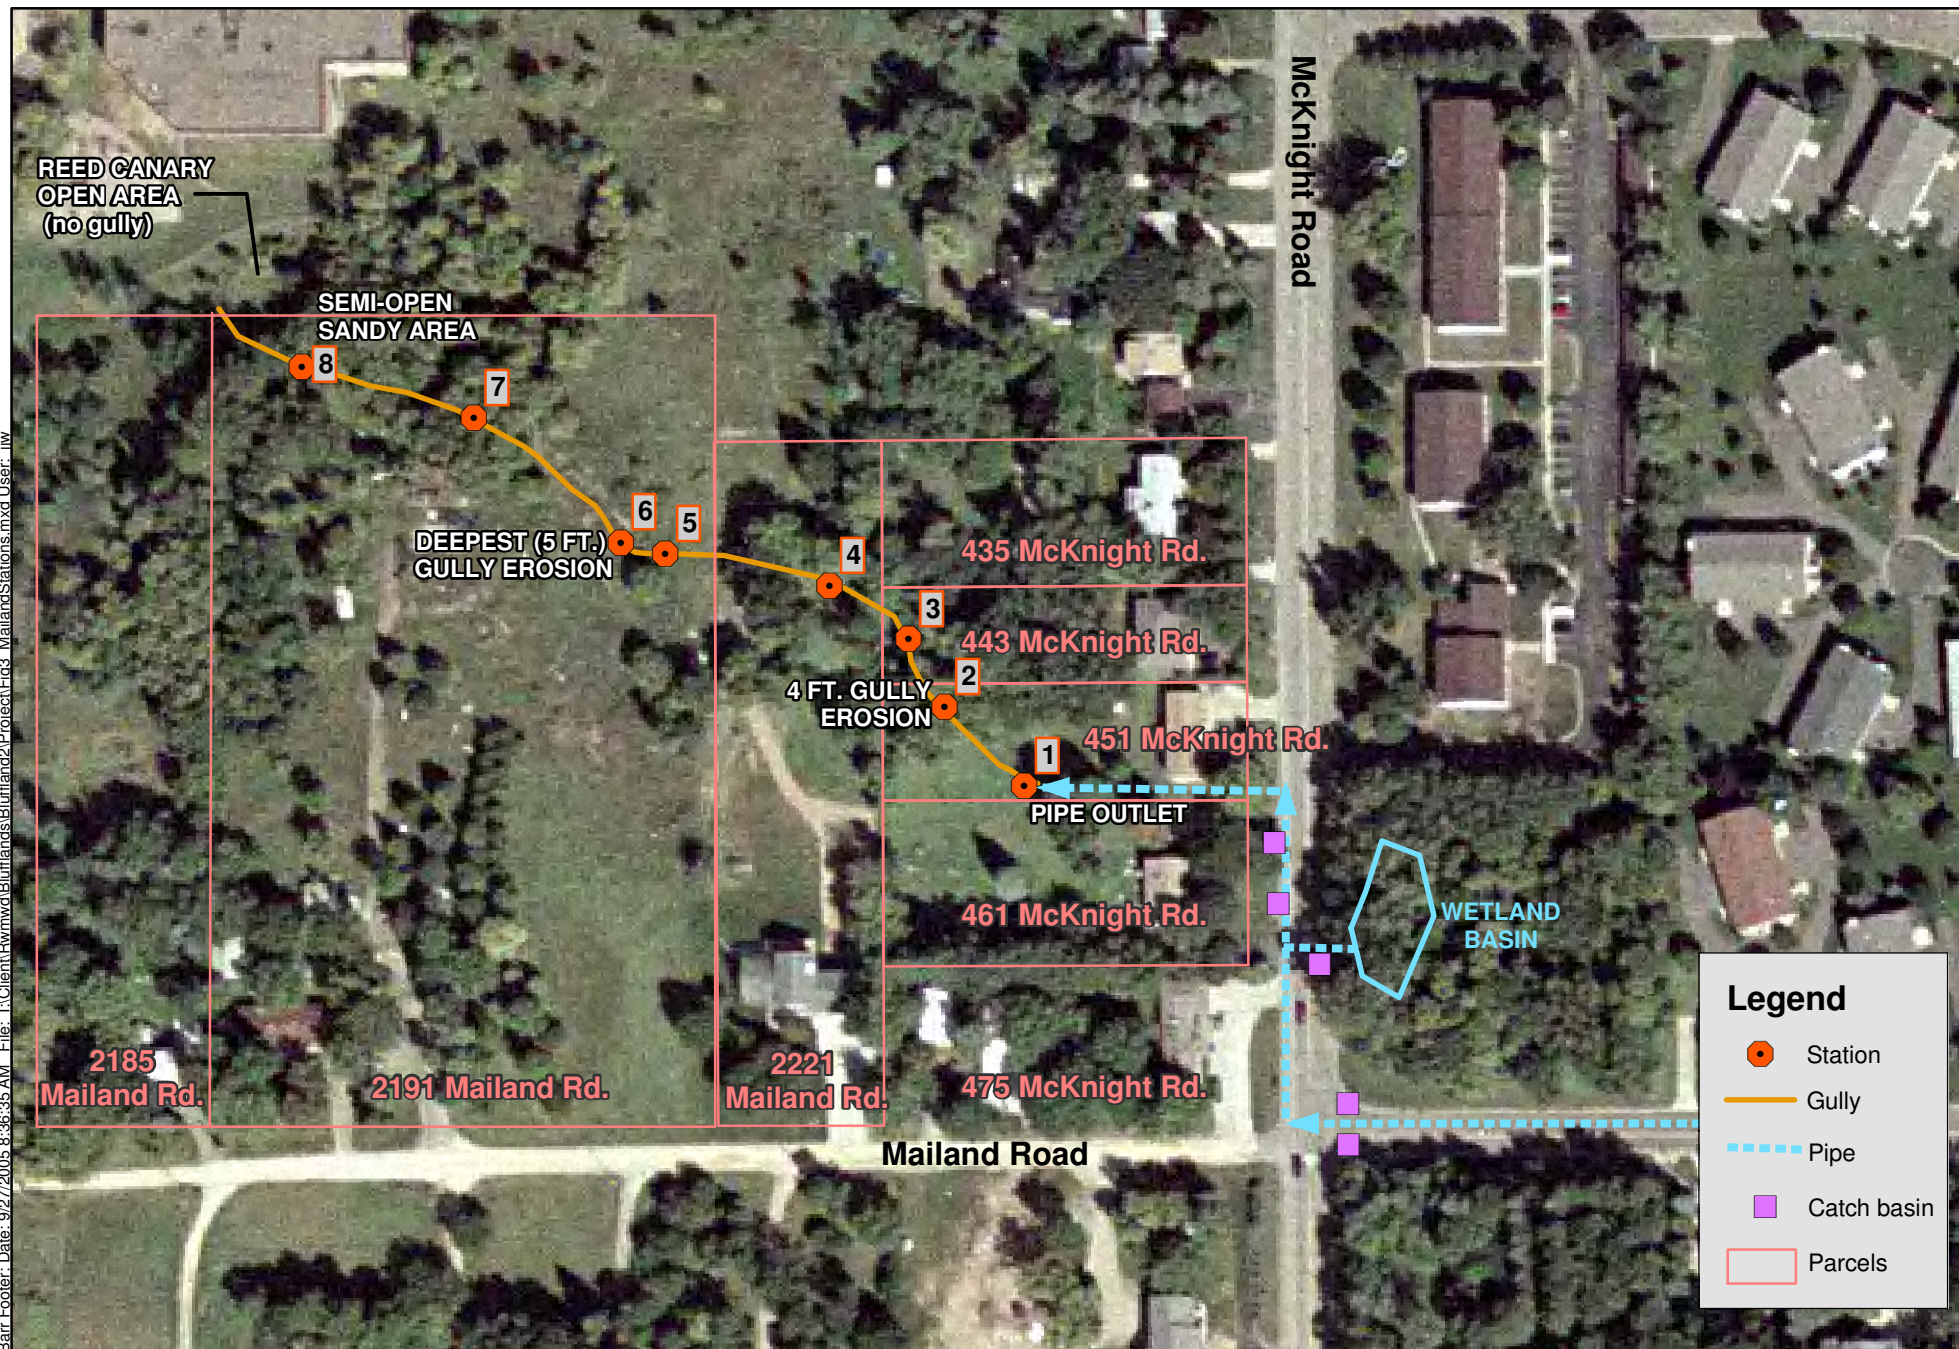
Figure 3
Mailand Gully Erosion
Ramsey Washington Metro Watershed District

The drainage channel extends from the pipe outlet located at Station 1 (Figure 3.) and runs approximately 850 feet in a generally west-northwest direction before emptying into a reed canary grass wetland. While some areas of the channel are nearly flat, with no sign of erosion, other segments are severely eroded, with active downcutting occurring as recently as summer 2004, according to McDonald.

Soil samples were collected and characterized at eight points along the channel. Figure 3 shows soil sample locations and Table 1 summarizes the findings. The data indicates that the soils are widely varied, ranging from coarse and sandy to fine and silty. As mentioned above, sandy soils are generally less cohesive and are therefore more erodible than silts or clays. At the most severe erosion locations, the soils are a mix of sandy and silty soils.
