Maplewood Mall Stormwater Retrofit Project

Five Year Project Anniversary Inspection and Inventory

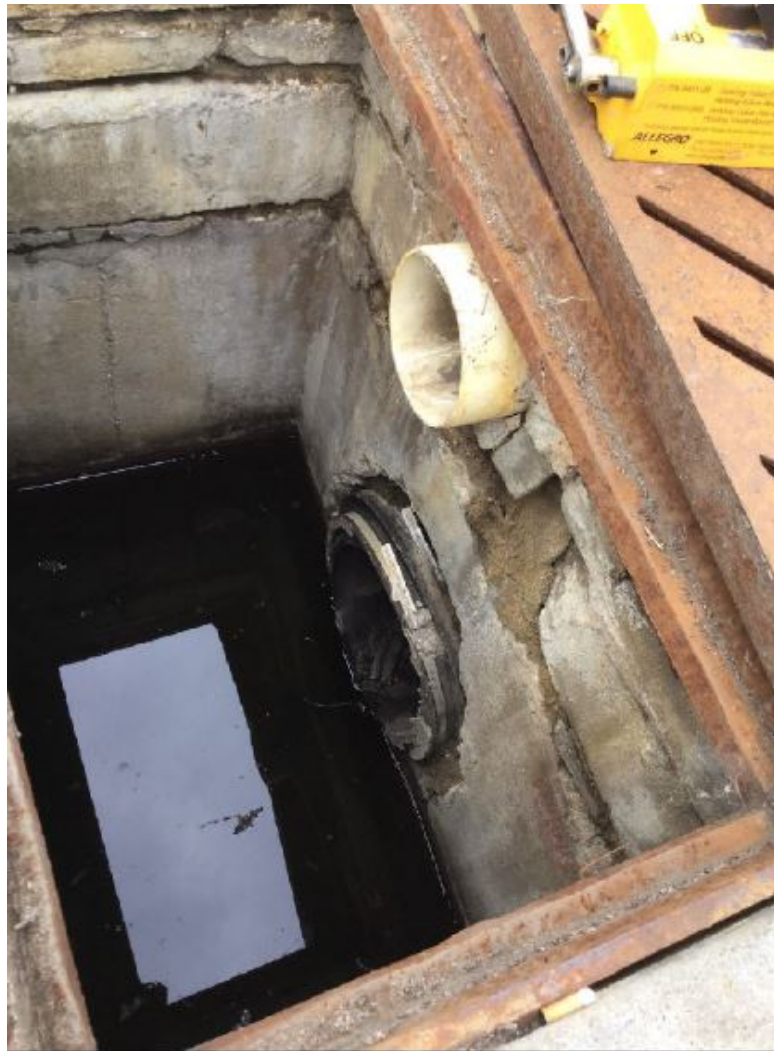
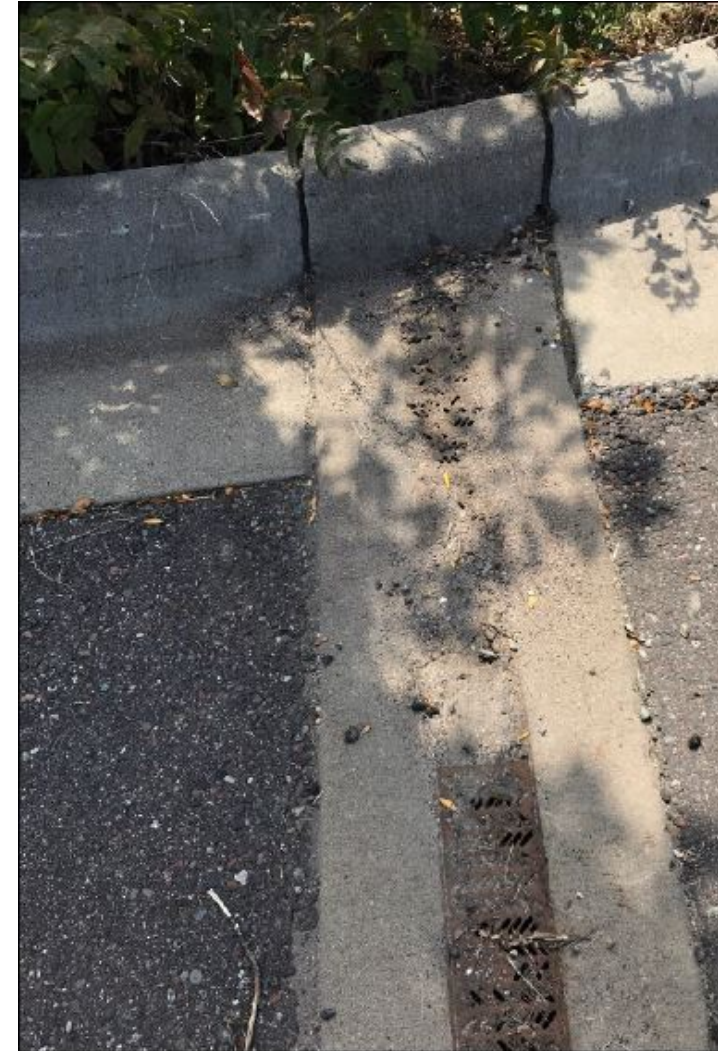
Infrastructure Condition

- Failing mortar and other construction concerns in 26 structures of the over 400 structures
- Sediments clogging trench drain inlet in some areas
- Recommend monitoring “Poor” structures, consider including in 2019/20 CIP repair work
- Assess sediment removal in Spring, coordinate with Mall staff and consider additional sweeping

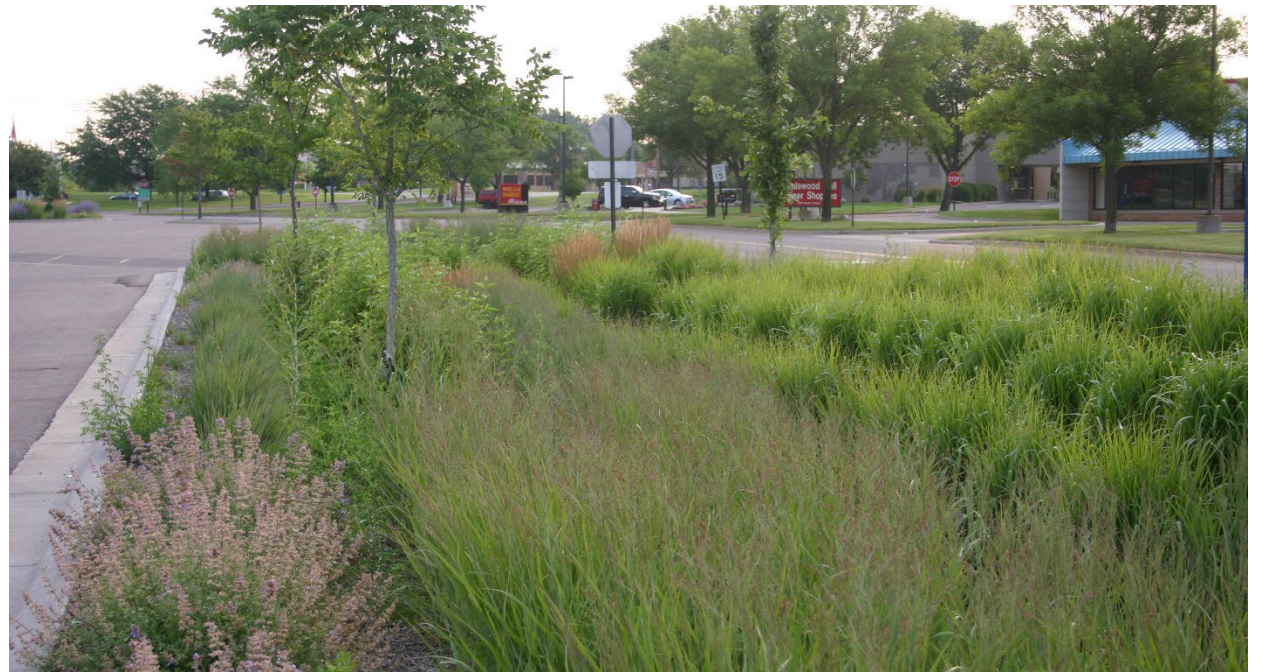
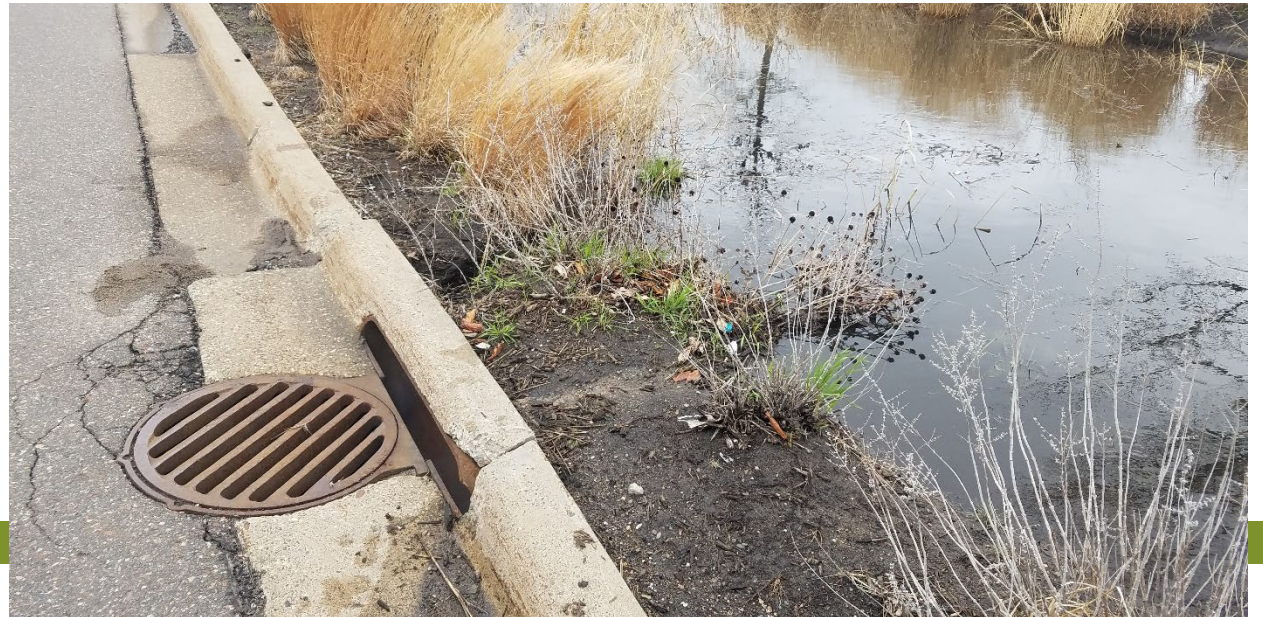
Rain Gardens

- Two of the 55 rain gardens have long term standing water
- Likely due to sediment loading and compacted planting soil during construction
- Recommend removing clogged soils, refurbishing filtration systems
- Ongoing maintenance program has been critical to healthy plantings

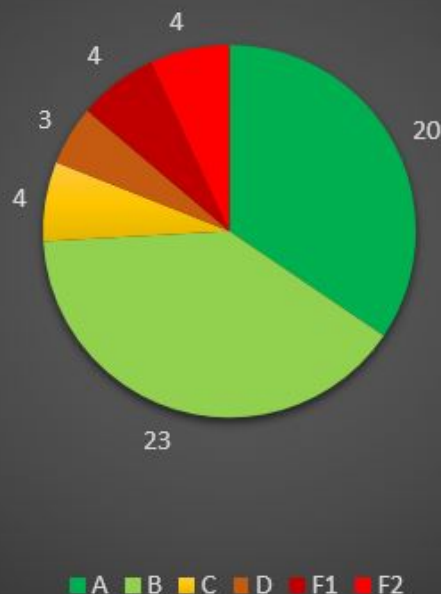
Tree Trench - South Grove

- Tree trench creates a unique growing environment well suited to some species
- Species chosen for dry conditions have struggled
- Shallower trenches have higher tree mortality

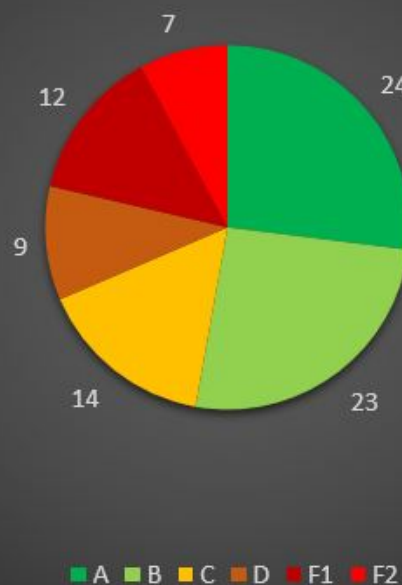
Skyline Honeylocust

- Honeylocust and Kentucky Coffeetree have struggled to thrive
- Other widely used urban trees failed to establish

- Continued sump cleanout and vegetation maintenance
- Replace entrance, select end island trees and all tree trench trees. (70 graded at D and F1)
- Use similar species to those that are currently thriving (elms, English oak/white oak hybrids, introduce river birch)
- Measure root growth and soil conditions during replacements
- Replace with younger tree stock to reduce transplant shock
