2017 Water Quality Program Summary

RAMSEY-WASHINGTON
METRO WATERSHED DISTRICT

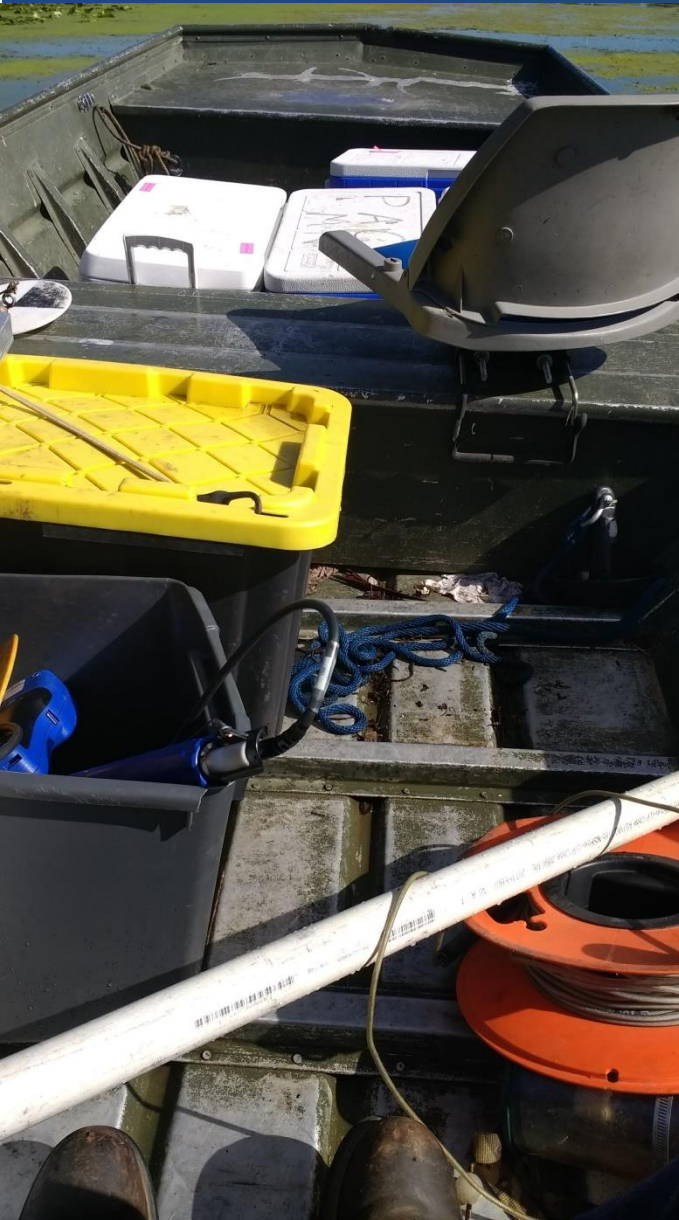
Lake and Pond Water Quality Monitoring

- Sample at deepest point
- Sample every two weeks
- Monitor June – September
- Readings at 1 meter intervals (Dissolved Oxygen, Temperature, pH, Turbidity and Conductivity)
- Water Samples (Top two meters & bottom)
 - Phosphorus
 - Chloride (also at ice out)
 - Chlorophyll A
 - Nitrogen

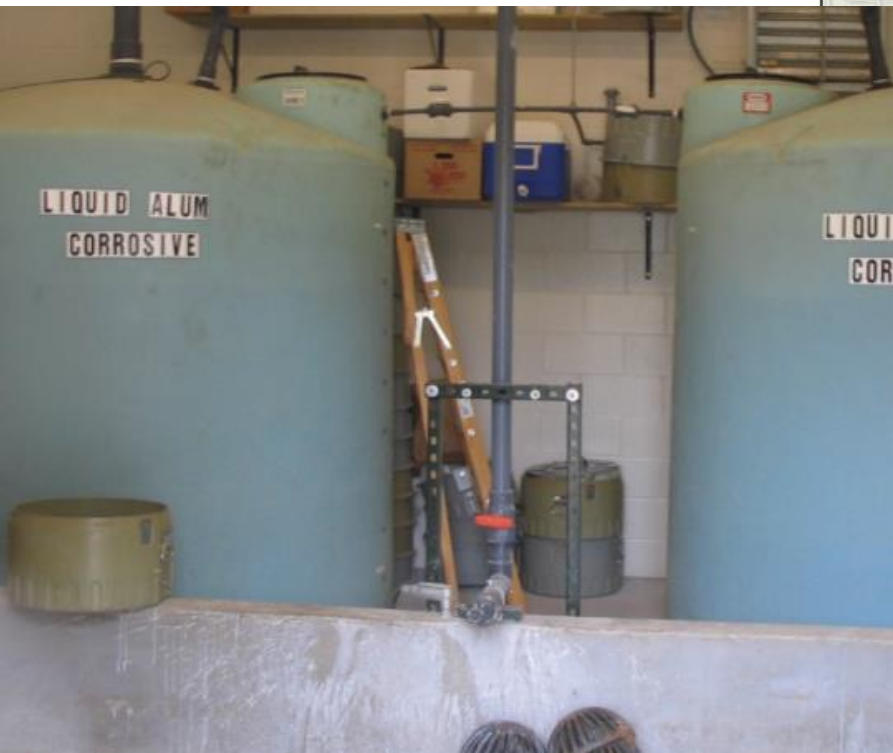
Best Management Practices – Alum Plant

- North of Tanners Lake
- Treats 60% surface water that enters Tanners
- Reduces phosphorus

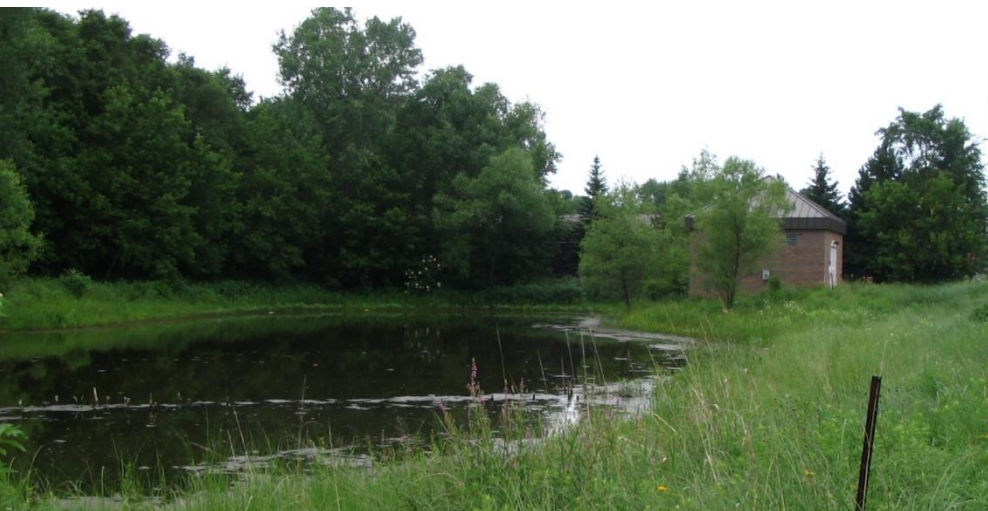
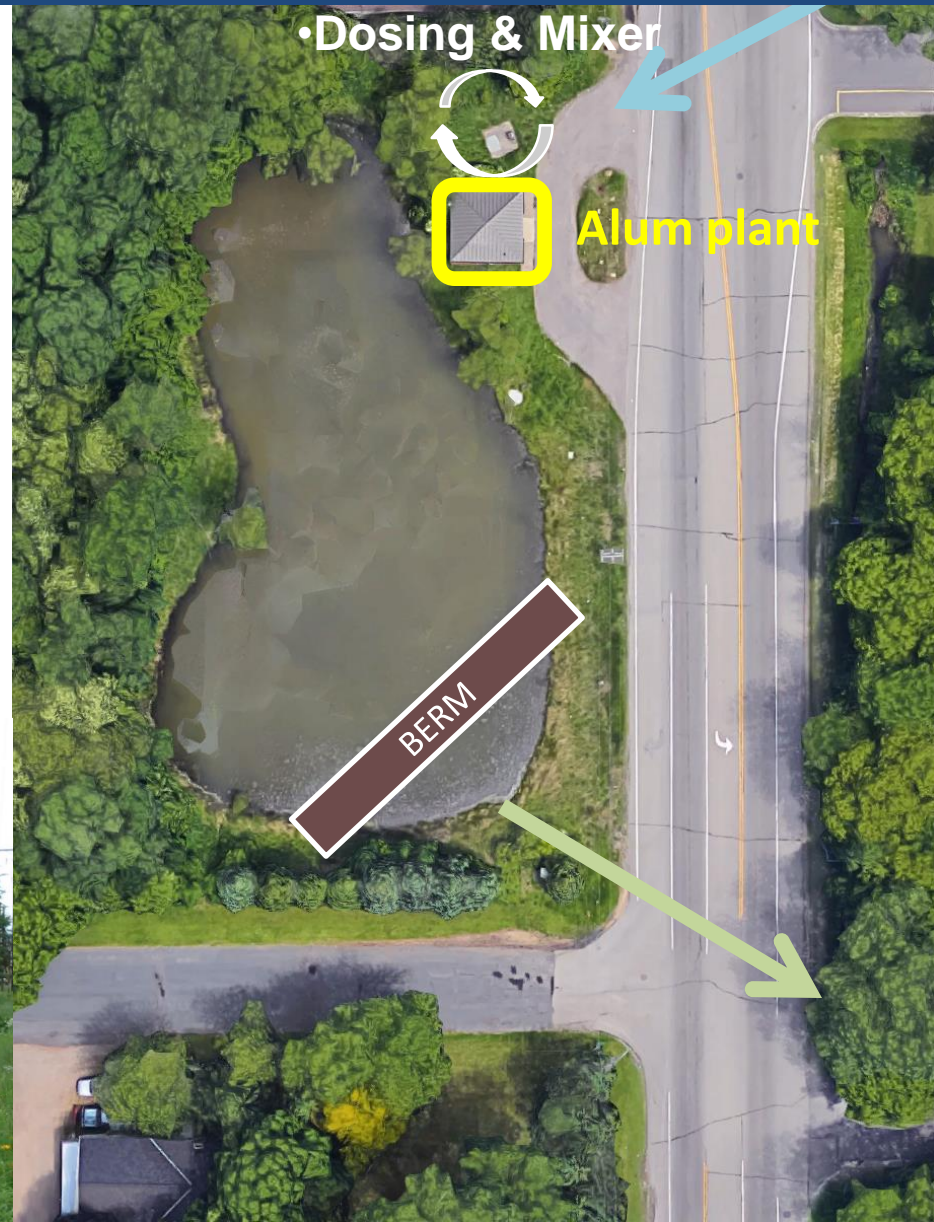
Alum Plant

- Alum added to stormwater, binds with phosphorus, creates a floc, settles out.
- In 2017
 - Ran for 7 months
 - 17,685 gallons of alum
 - Average phosphorus removal was 76%
- 1998 to present - TP removal 72%

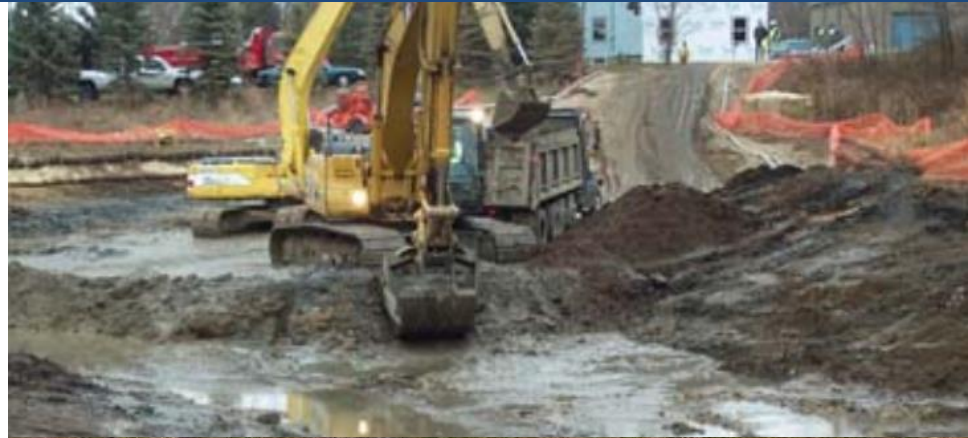
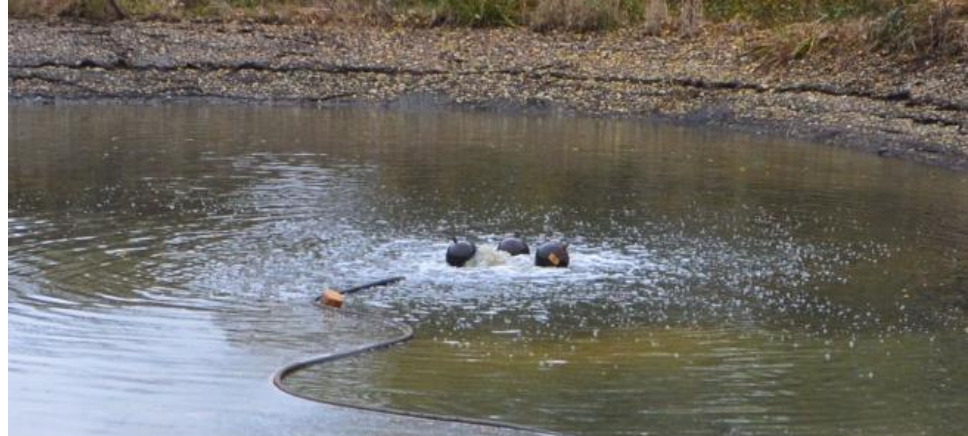
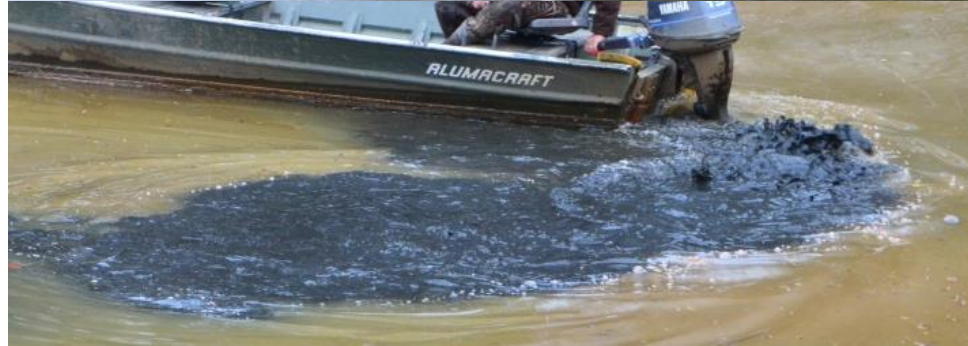
Alum Plant Drawdown History

- 2003 - added fly ash, hauled out, expensive
- 2006 - Contractor pumped into sanitary, cheaper
- 2012 - same as 2006
- 2014 - District staff run, pumps installed, minimal approach
- 2015 – mixing with air powered mixer and boat
- 2017 - added air cooled motor

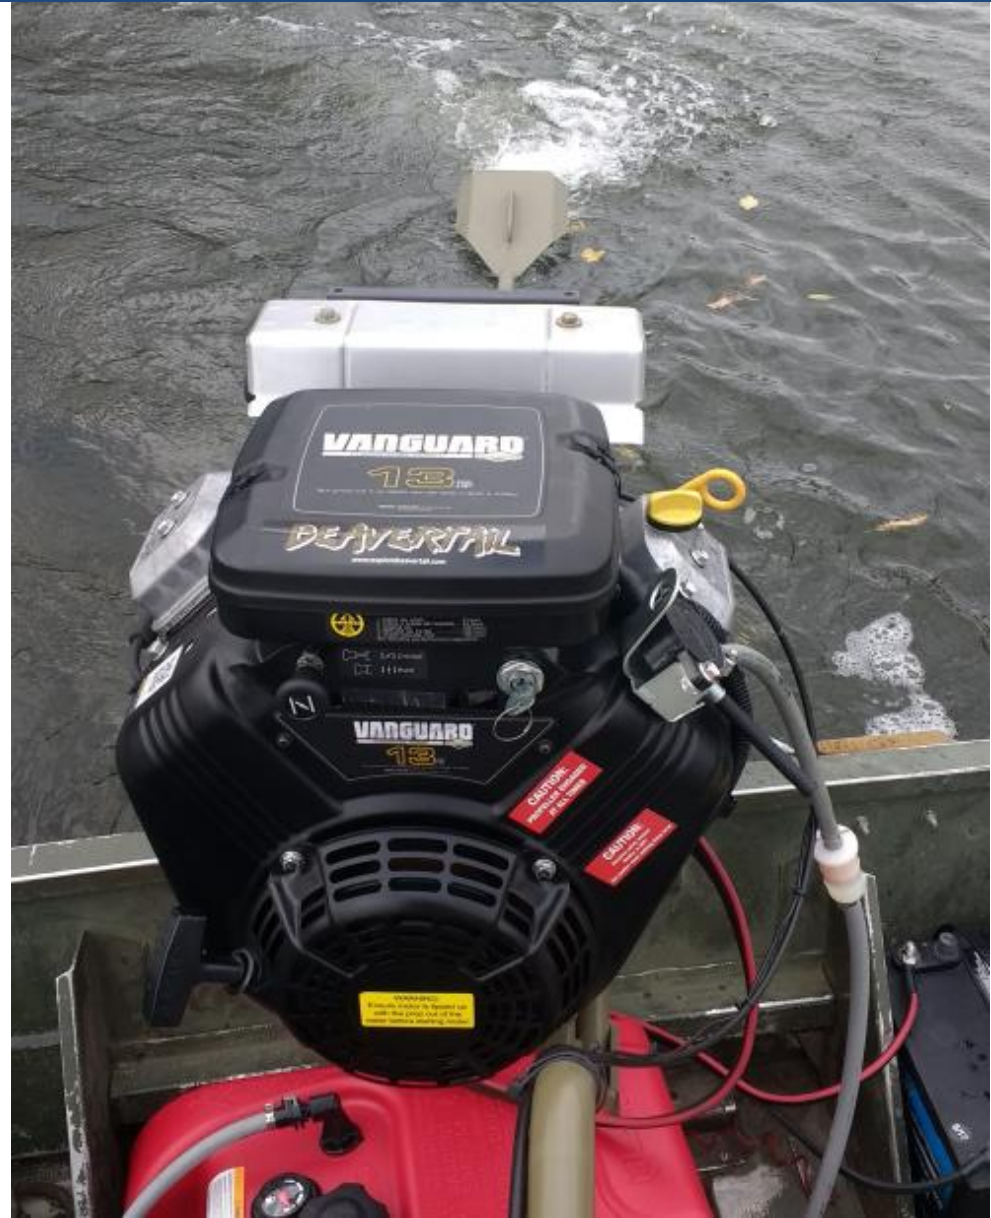
2017 Alum Plant Drawdown

- 6th Cleanout of the Pond
- Pumped out 1,100,000 gallons of water
- 14 days

- 2014 - 500 lbs
- 2015 - 62,000 lbs
- 2017 - 142,000 lbs

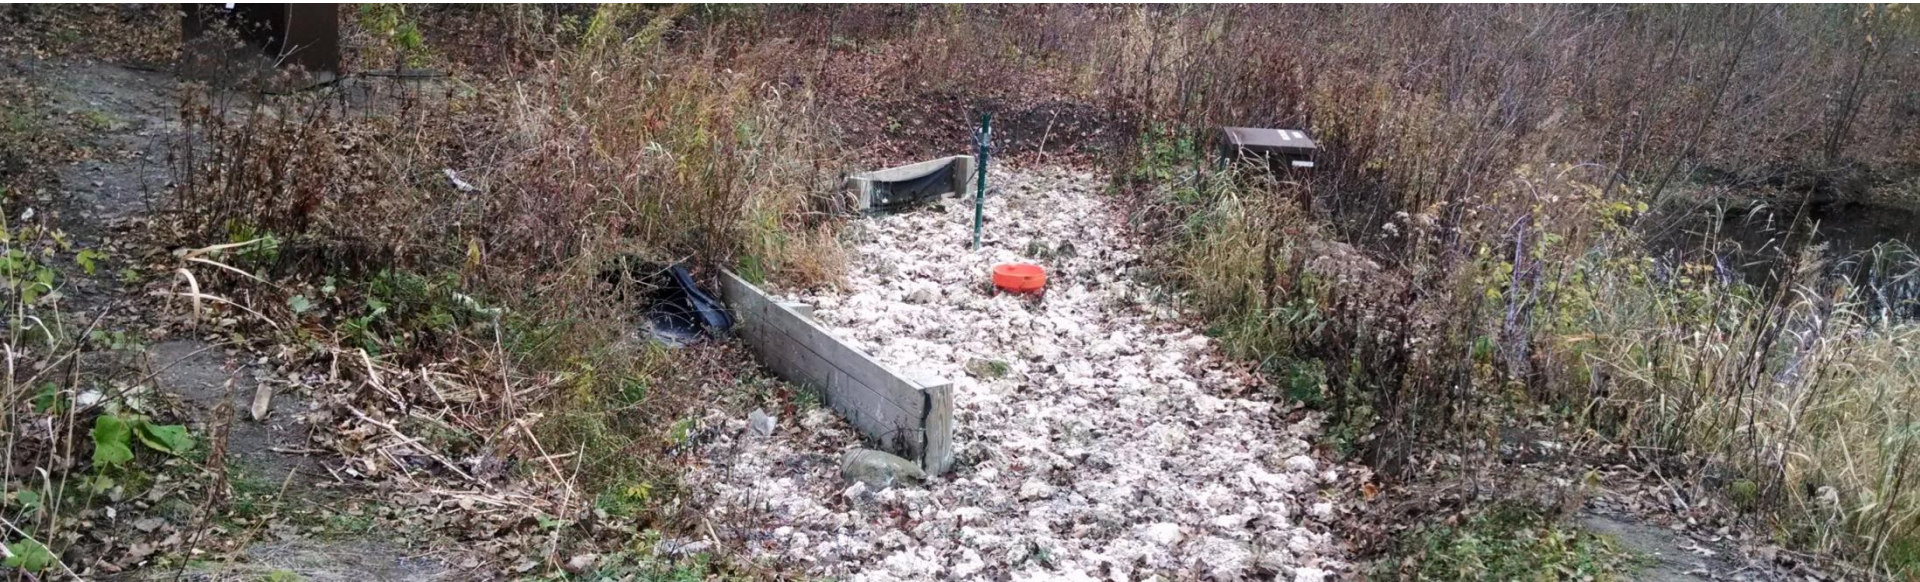
Wakefield Spent Lime Filter

- Installed in 2011
- South of Wakefield Lake
- Spent lime is waste product from drinking water facilities
- Runoff from a small part of Larpenteur Ave
- Average TP removal of 52%
- Maintenance?

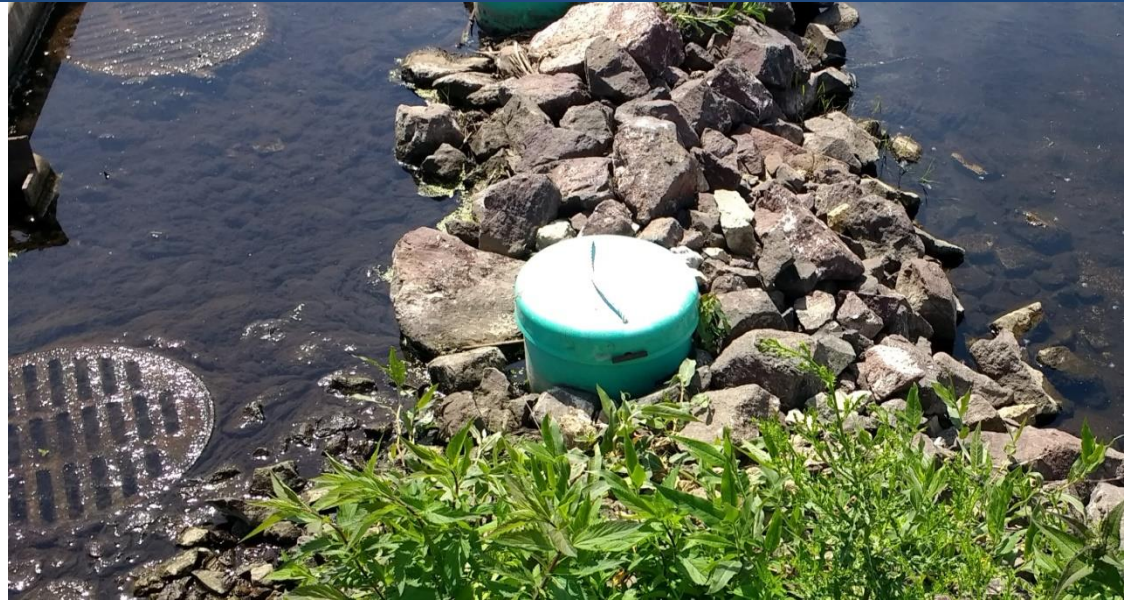
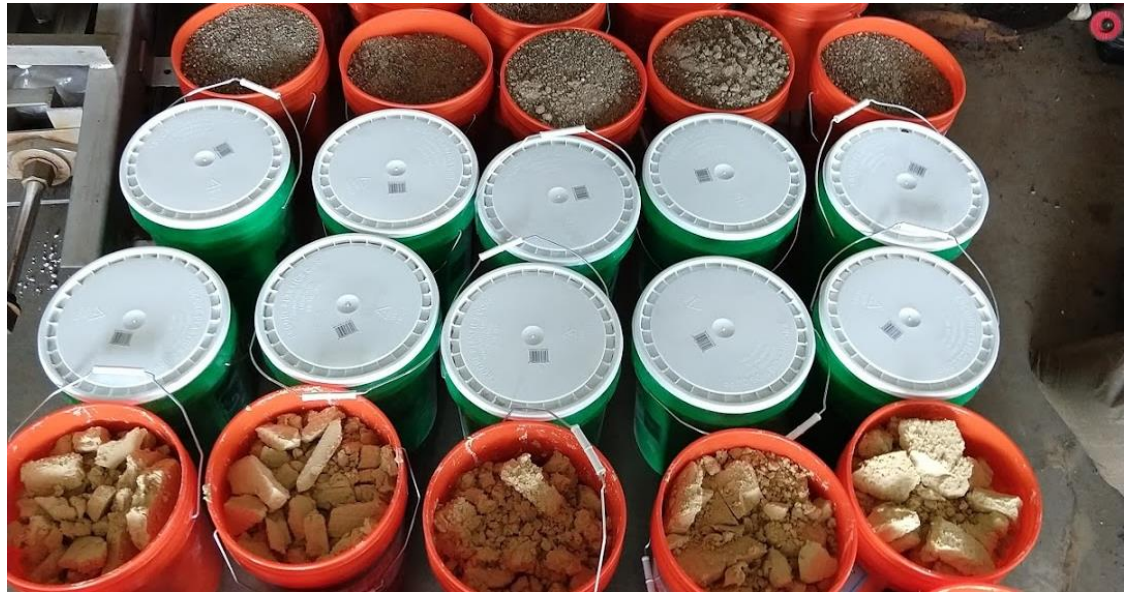
Kohlman Basin Test Chambers

- Test facility
- Upstream of Kohlman lake
- Four chambers
- Test multiple materials (biochar with sand, spent lime, spent lime mixed with iron and crush limestone)
- Test for phosphorus before and after
- Adjust flow to change contact time
- What works best?
- Finished our first run
