# Natural Resource Inventory and Enhancement Opportunities

Dayton's Bluff and Payne-Phalen Community Council

Prepared by Barr Engineering Co. for Capitol Region Watershed District

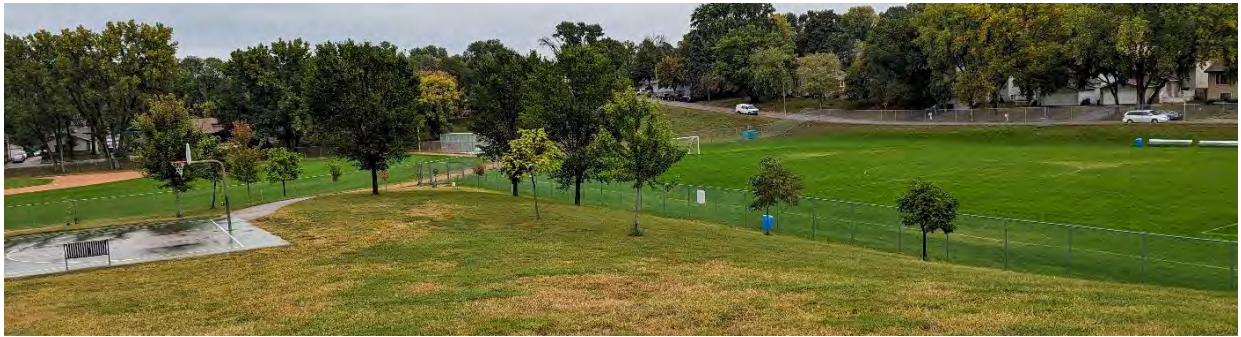
**Image 5** - Park features at Arlington/Arkwright Park are classified as "cultural" landcover for the purposes of this natural resource inventory.

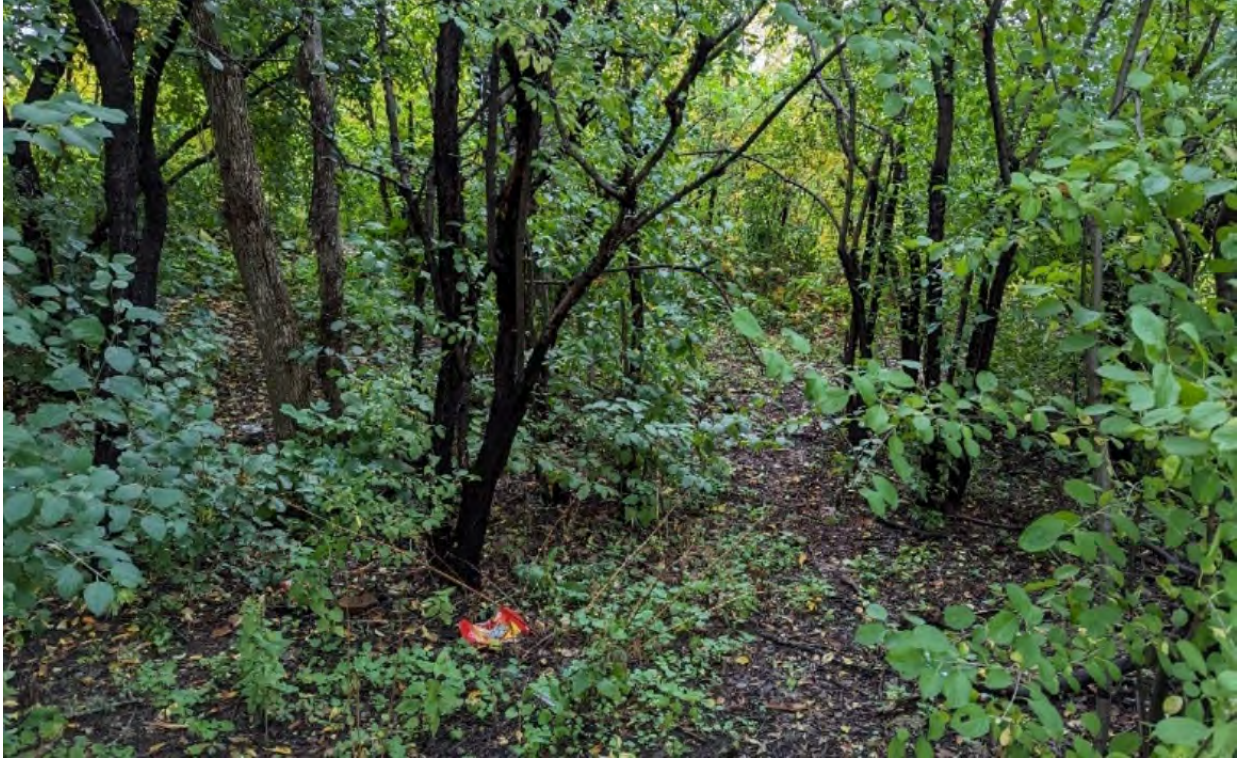
**Image 6** - Typical altered/non-native deciduous forest consisting of a buckthorn understory with sparse herbaceous groundcover.

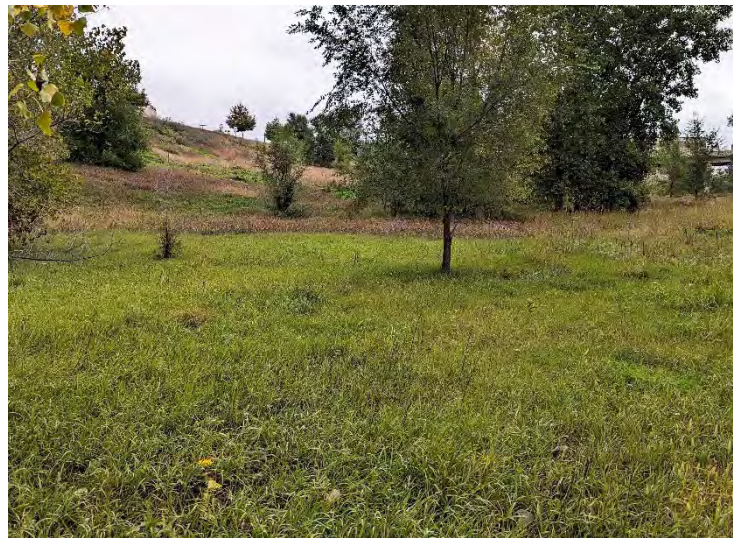
**Image 7** - Typical smooth brome dominated grassland containing little native plant diversity.

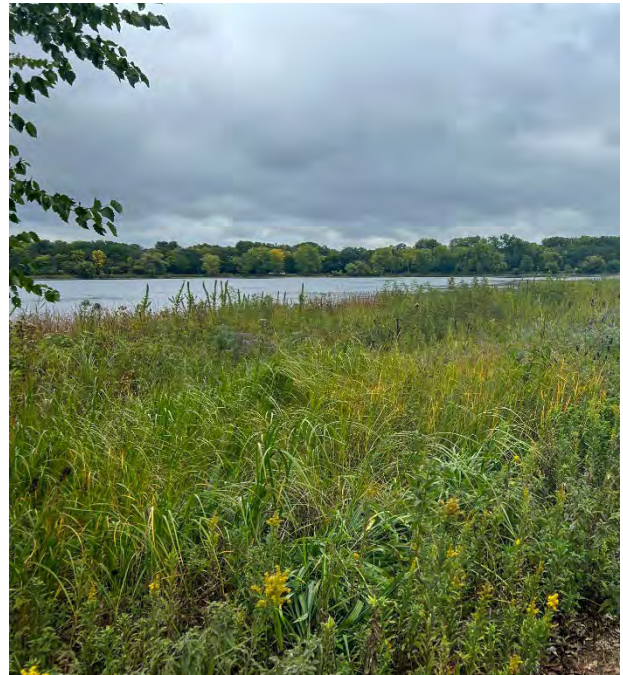
**Image 8** - Diverse mesic prairie buffer planting along Lake Phalen's shoreline.

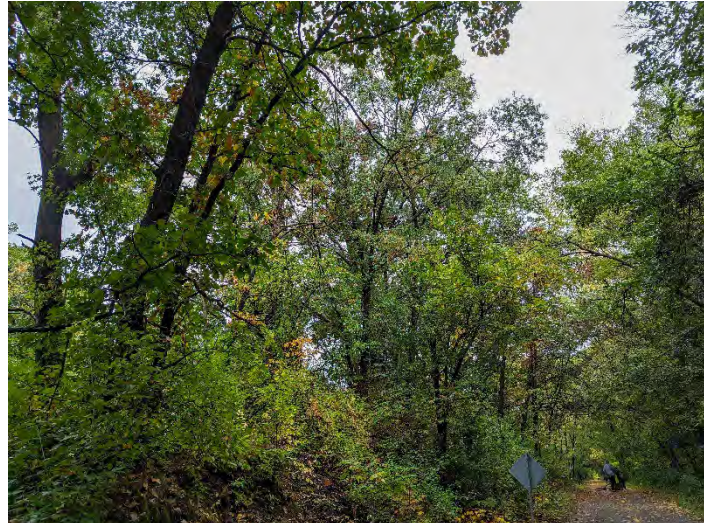
**Image 9** - Small patch of intact mature hackberry, sugar maple, and oak canopy trees along the Gateway State Trail.

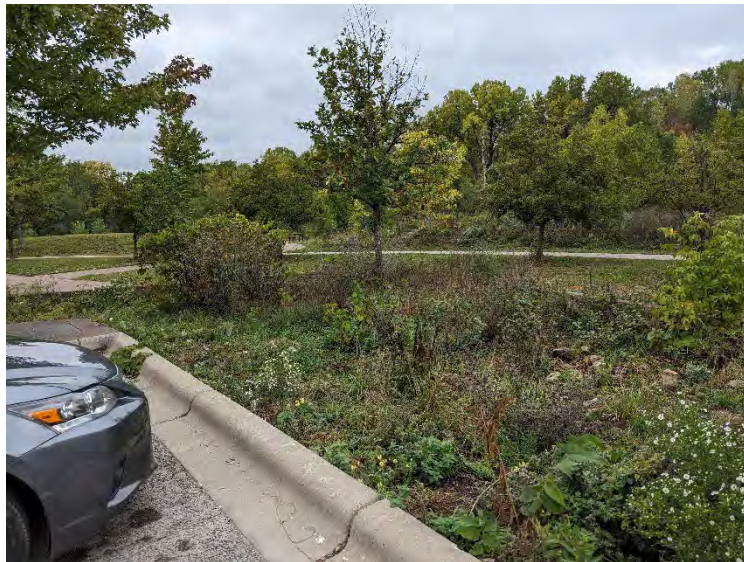
**Image 5** - Infiltration basins at Eastside Heritage Park collect stormwater runoff from adjacent parking lot.

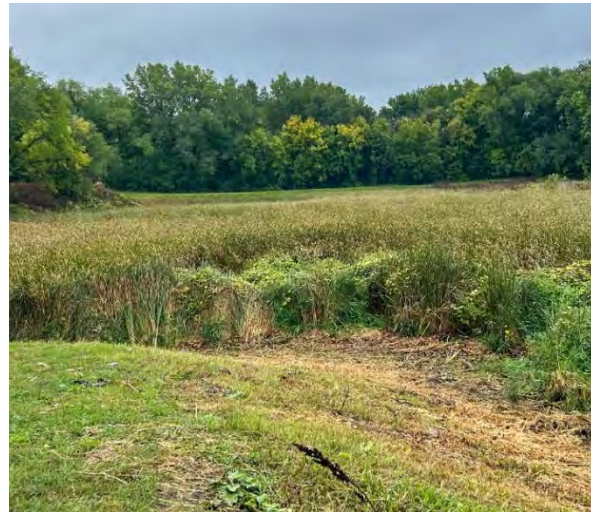
**Image 6-** Cattail dominated emergent wetland near Arlington/Arkwright Park.

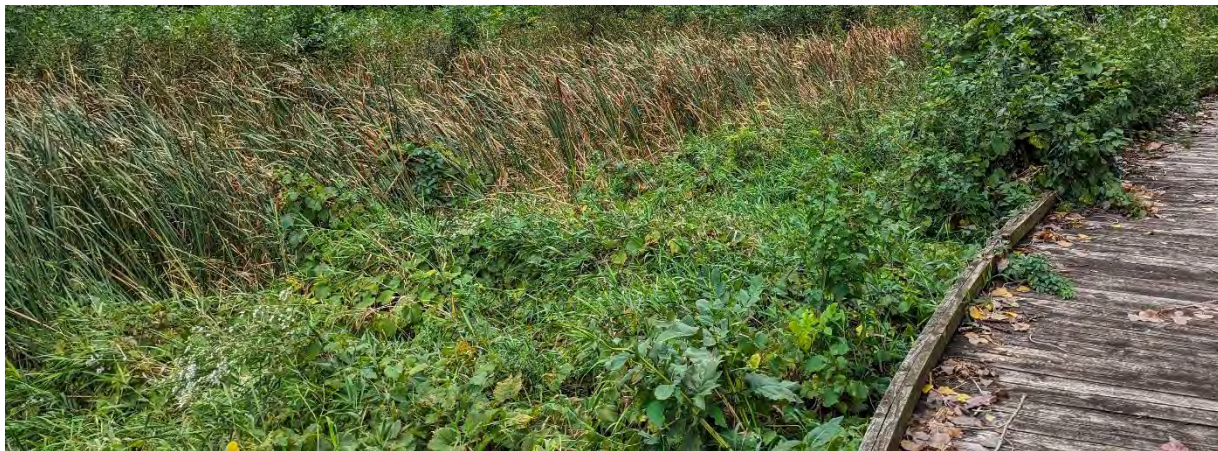
**Image 7 -** Reed canary grass dominating the transition from cattail emergent wetland to upland areas at the boardwalk near the south Lake Phalen Trail Parking lot.

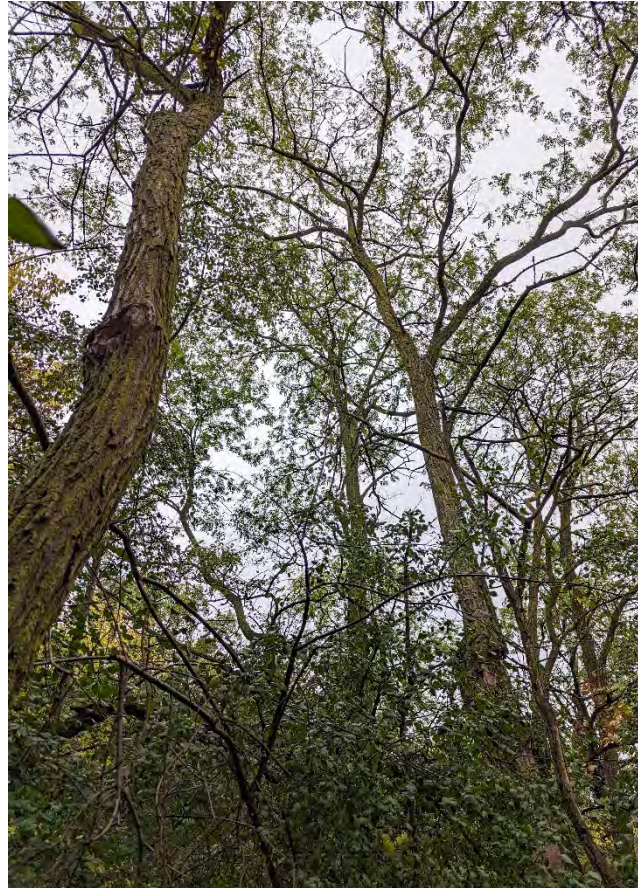
**Image 14** - Black locust is an aggressive tree that can outcompete native woodland species.

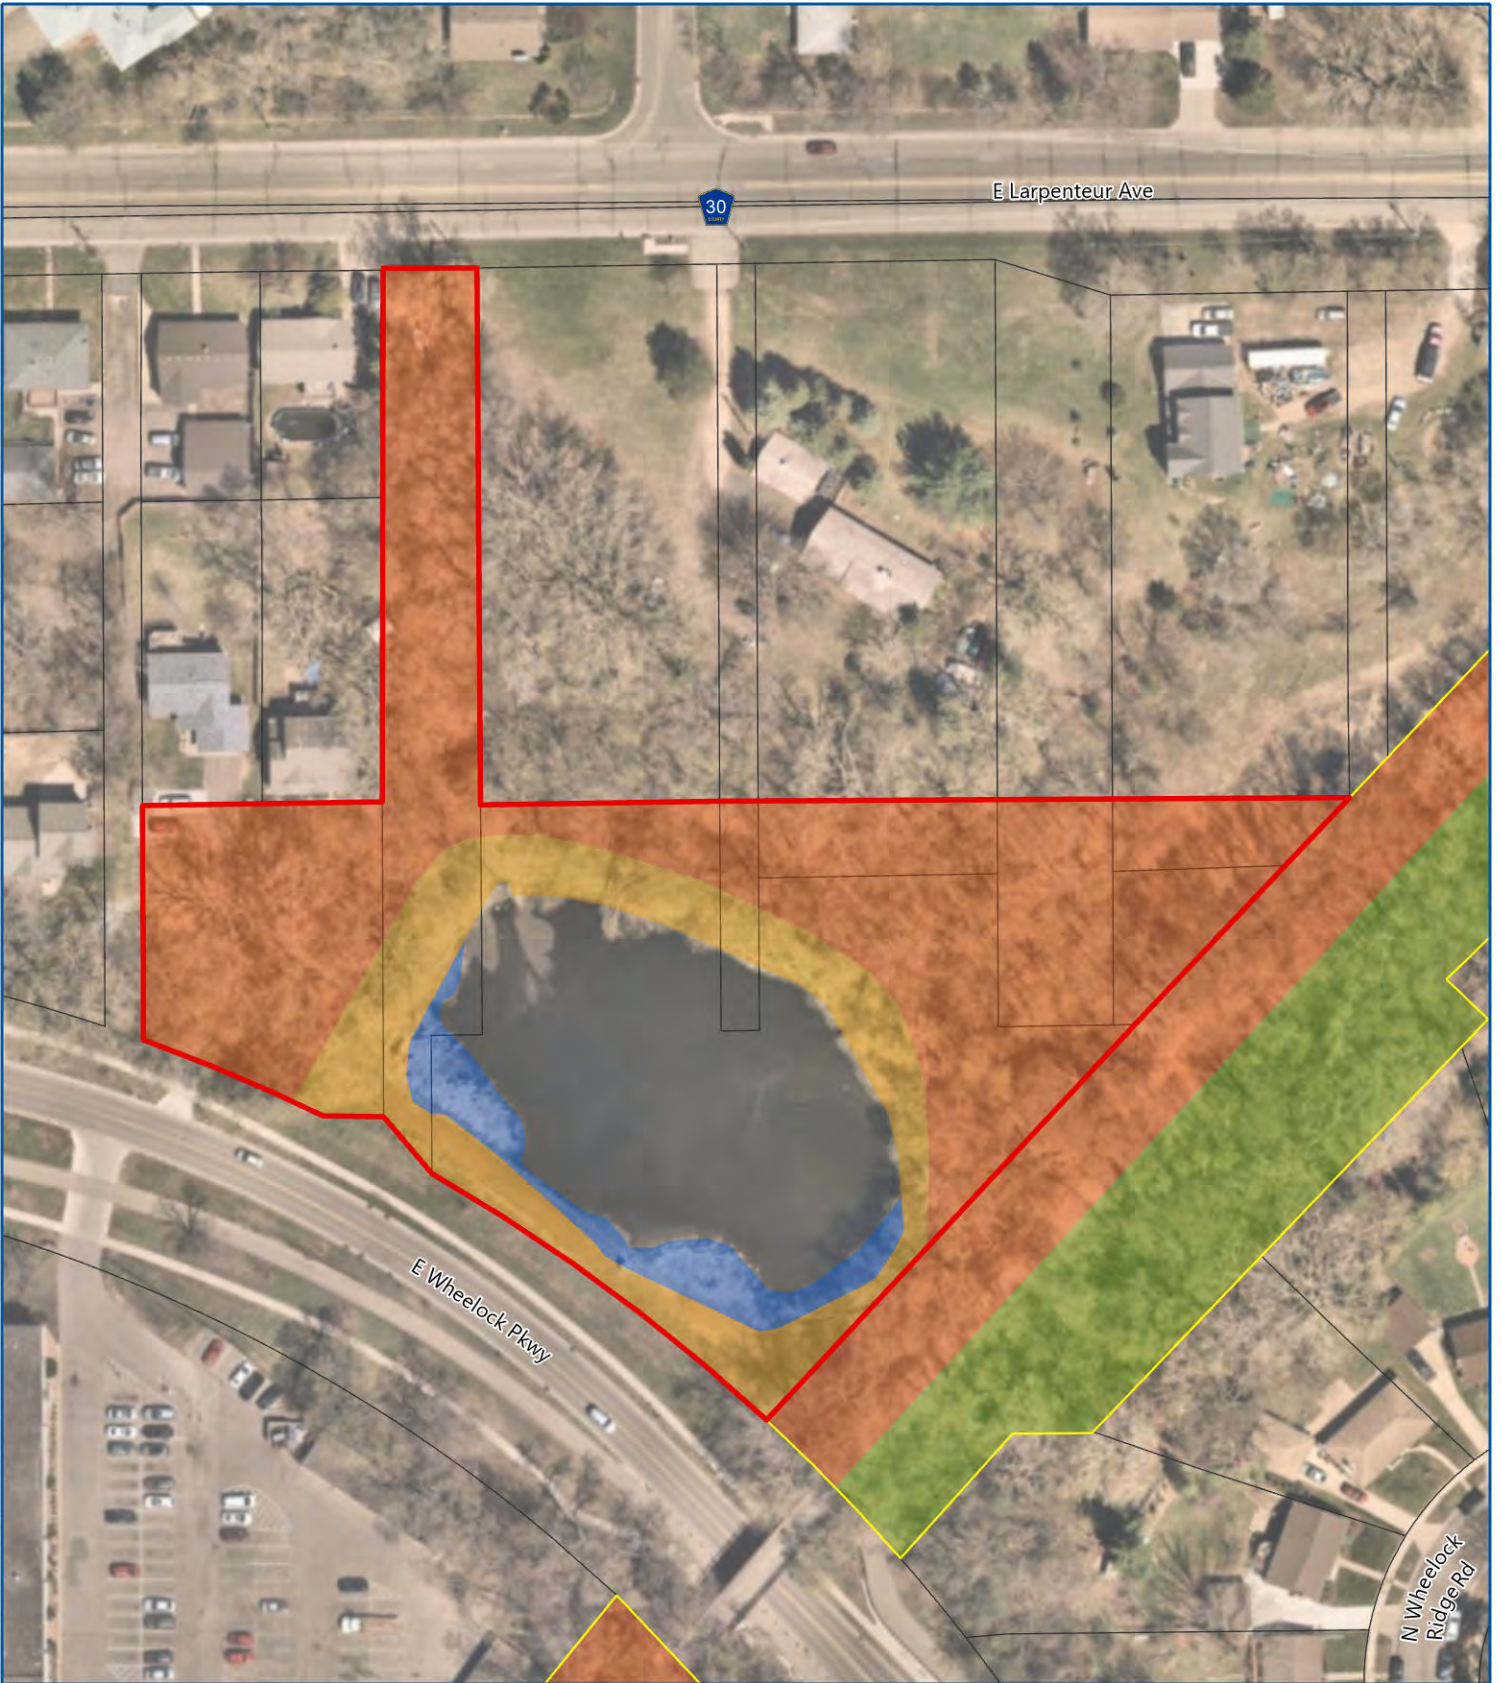
**SITE - 1**  
Wheelock Parkway Stormwater Pond

**Existing Land Cover Type**

- Altered/Non-Native Deciduous Forest
- Grassland - Non-Native
- Maple-Basswood Forest
- Wetland - Cattail

**EXISTING LAND COVER**  
Natural Resources Inventory  
Capitol Region  
Watershed District

- Restore upland buffer around pond to increase native plant diversity for birds and pollinator species (managing cattails in pond would be difficult and would remain an ongoing issue)

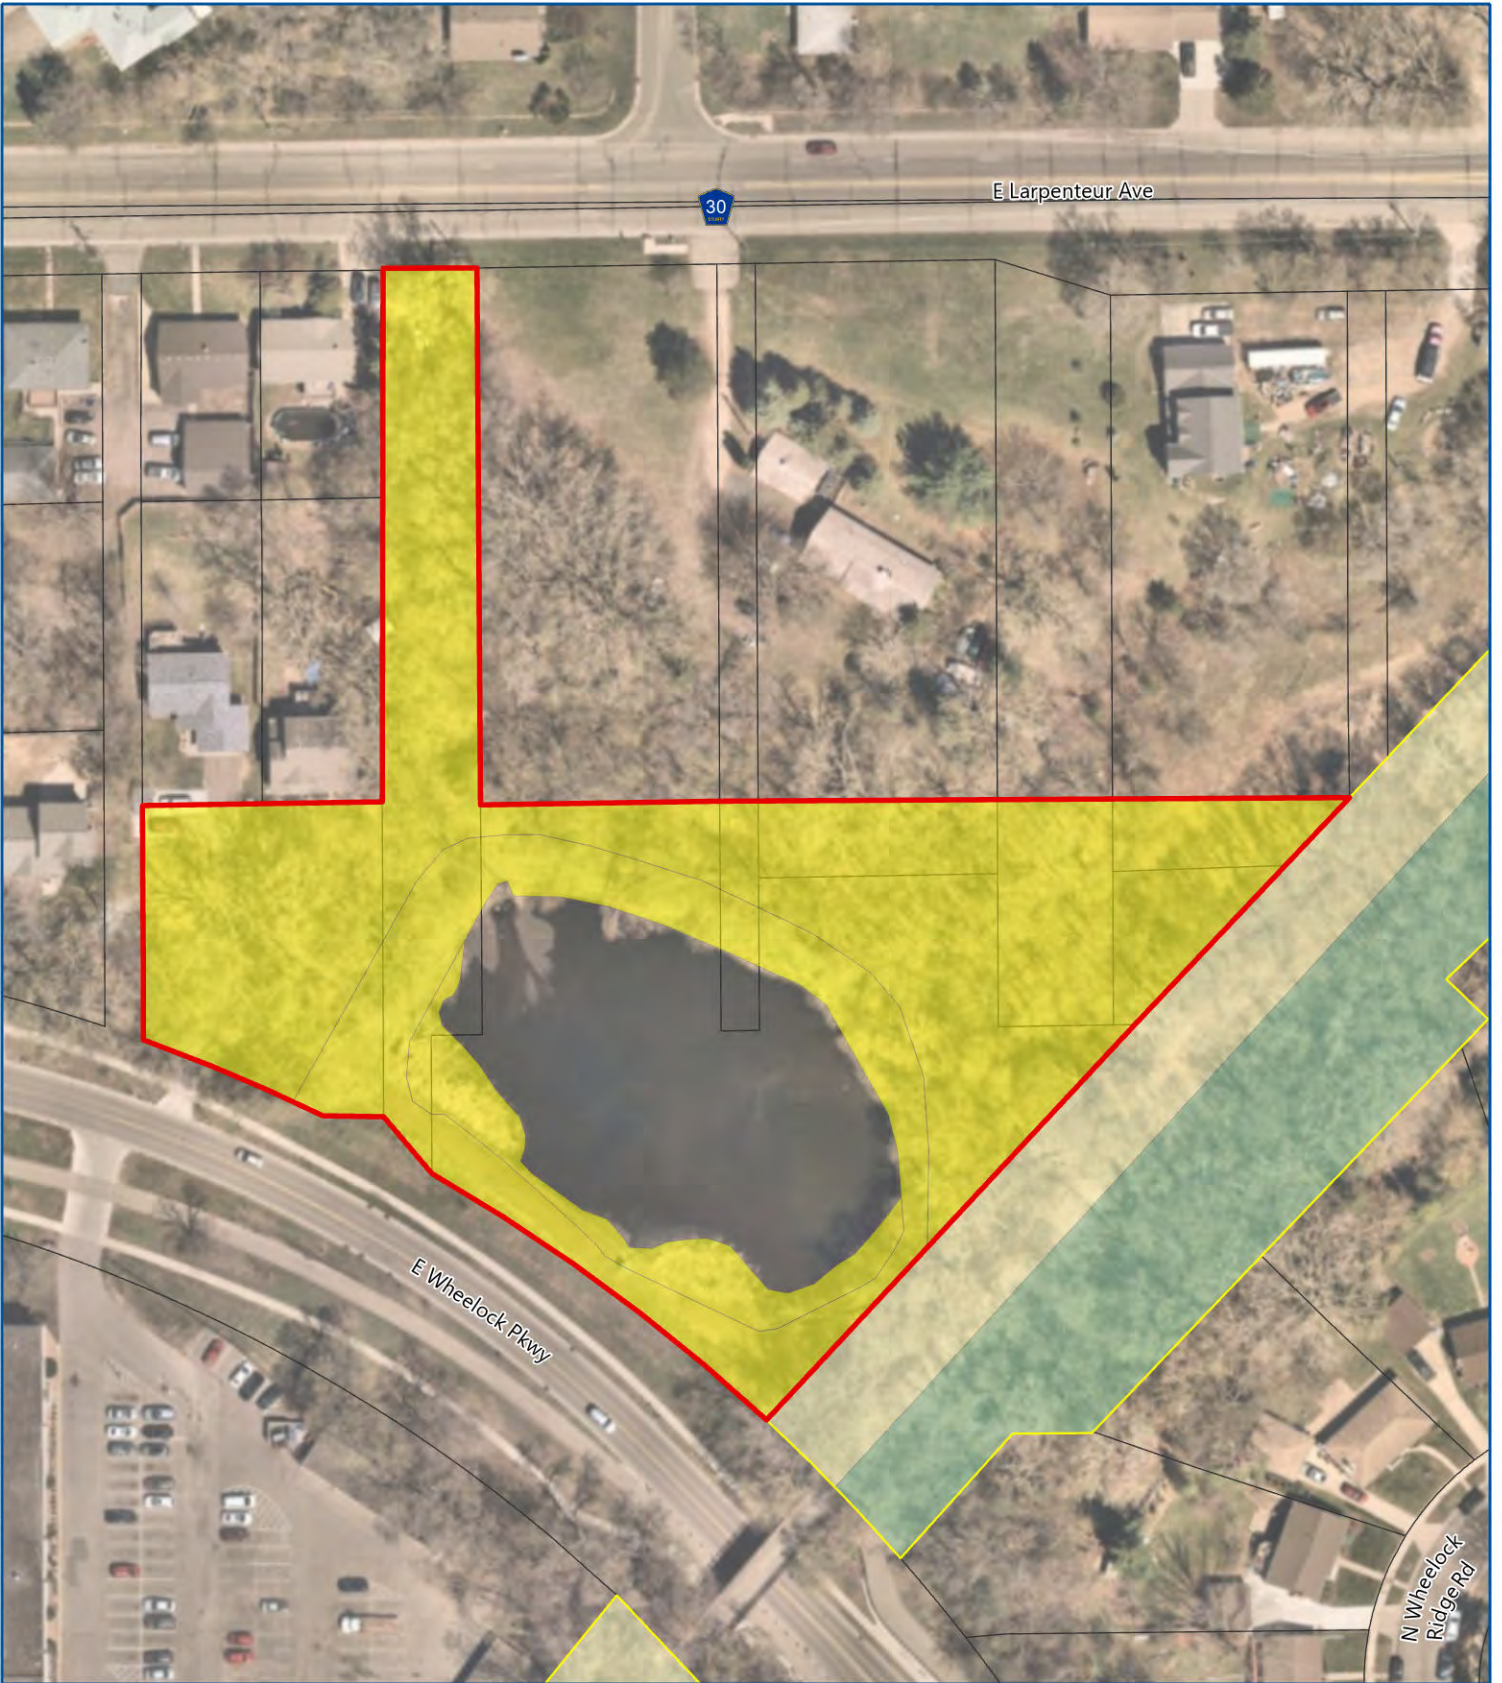
**SITE - 1**  
Wheelock Parkway Stormwater  
Pond

**Ecological Quality Ranking**

**ECOLOGICAL QUALITY**  
Natural Resources Inventory  
Capitol Region  
Watershed District

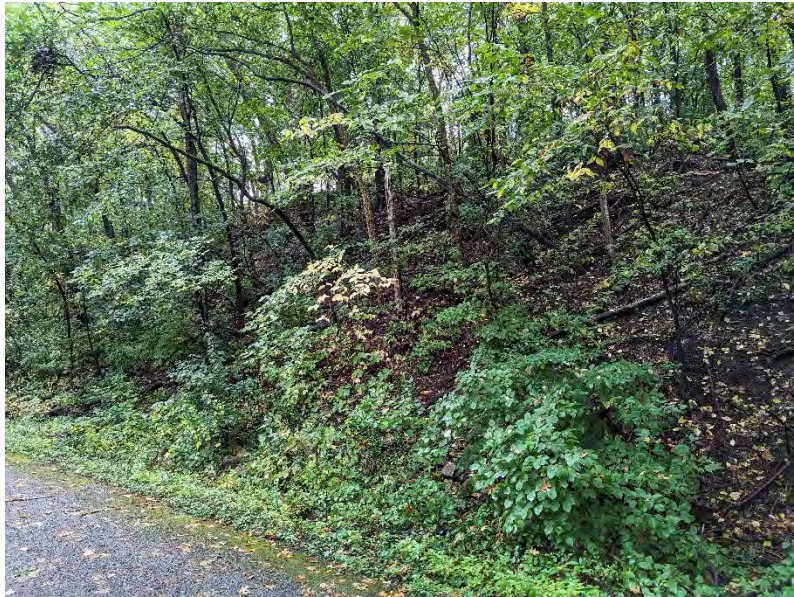
**Condition Summary:** Site 2 is comprised of MNDNR-owned parcels of the Gateway State Trail between 35 E (on the south) and Larpenteur Avenue (on the north). A parking lot and community garden is located at the far south end of the site. The paved trail is elevated along an old railroad corridor and is bordered by woodland habitat on either side. Except for the northeast corner of the site, the wooded areas are degraded and contain little diversity in the canopy layer. Boxelder and green ash are the most abundant

canopy trees with buckthorn dominating the understory and shrub layer. Black locust, cottonwood, mulberry (*Morus spp.*), silver maple (*Acer saccharinum*), bur oak, and aspen (*Populus tremuloides*) tree species were also present in limited abundance. Exposed soils and exotic species comprise most of the understory and herbaceous ground layers.

A high-quality maple-basswood forest is present along a steep (2H:1V) slope in the northern most portion of the site. This high-quality forest contains few invasive species and a diverse mix of native trees and shrubs. Canopy trees include aspen, hackberry, American elm (*Ulmus americana*), bur oak, basswood and sugar maples. The shrub and ground layer is diverse and is composed of pagoda dogwood (*Cornus alternifolia*), woodbine, pin cherry saplings (*Prunus pensylvanica*), red elderberry (*Sambucus racemose*), spikenard (*Aralia racemose*), bedstraw (*Gallium spp.*), creeping Charlie, and white snakeroot. Exposed soil is present throughout, likely as a result of earthworm disturbance and deer browse.

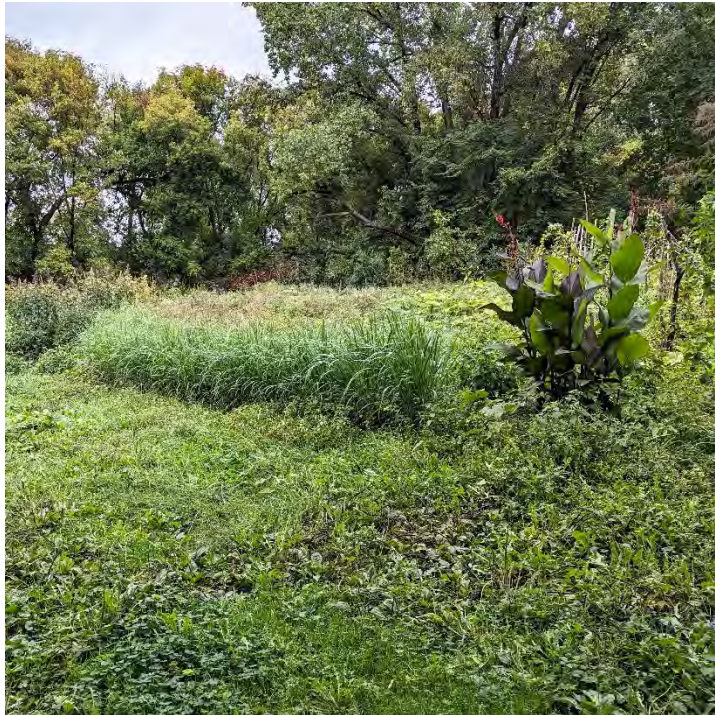
**Condition Summary:** Site 3 contains a 1.82-acre degraded woodland surrounding a 0.75-acre community garden. The site is located adjacent to the Gateway State Trail at the terminus of Nebraska Avenue East. The canopy is mostly boxelder, Siberian elm, and black walnut. The shrub layer is comprised of buckthorn, boxelder, and green ash saplings. The herbaceous ground layer is dominated by non-native common burdock (*Arctium minus*), nightshade (*Atropa belladonna*), reed canary grass, Asiatic dayflower (*Commelina communis*), garlic mustard, and creeping Charlie. Common native species such as white snakeroot, woodbine, and Canada goldenrod were also present.

- Woodland edges are a considerable source for weed species (garlic mustard, buckthorn, burdock, thistle, etc.)
- Woodlands have low plant diversity

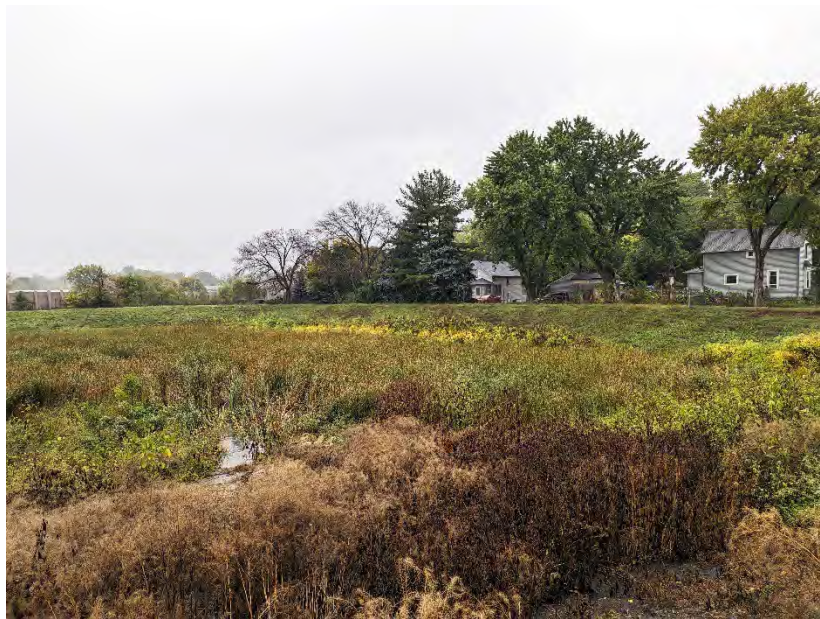
**Condition Summary:** The east side of the site contains a 1.2-acre City of Saint Paul-owned stormwater detention/retention pond that is dominated by cattails. The adjacent upland vegetation is composed of non-native perennial and annual weed species. Reed canary grass, burdock, garlic mustard, yellow rocket (*Barbarea vulgaris*), and giant ragweed are the dominant species on 3:1 slopes directly surrounding the NWI-mapped wetland. A 30-foot-wide strip of lawn is maintained along a fence line surrounding the pond.

The west parcel is a federally-owned right-of-way (ROW) (adjacent to interstate 35-E) consisting of a 0.6-acre cattail wetland. The surrounding upland area is a dense massing of shrubby boxelder regrowth with a low diversity burdock dominated understory.

This site is located within what was historically part of a larger wetland complex, but the soils and vegetation have since been altered significantly due to urban development.

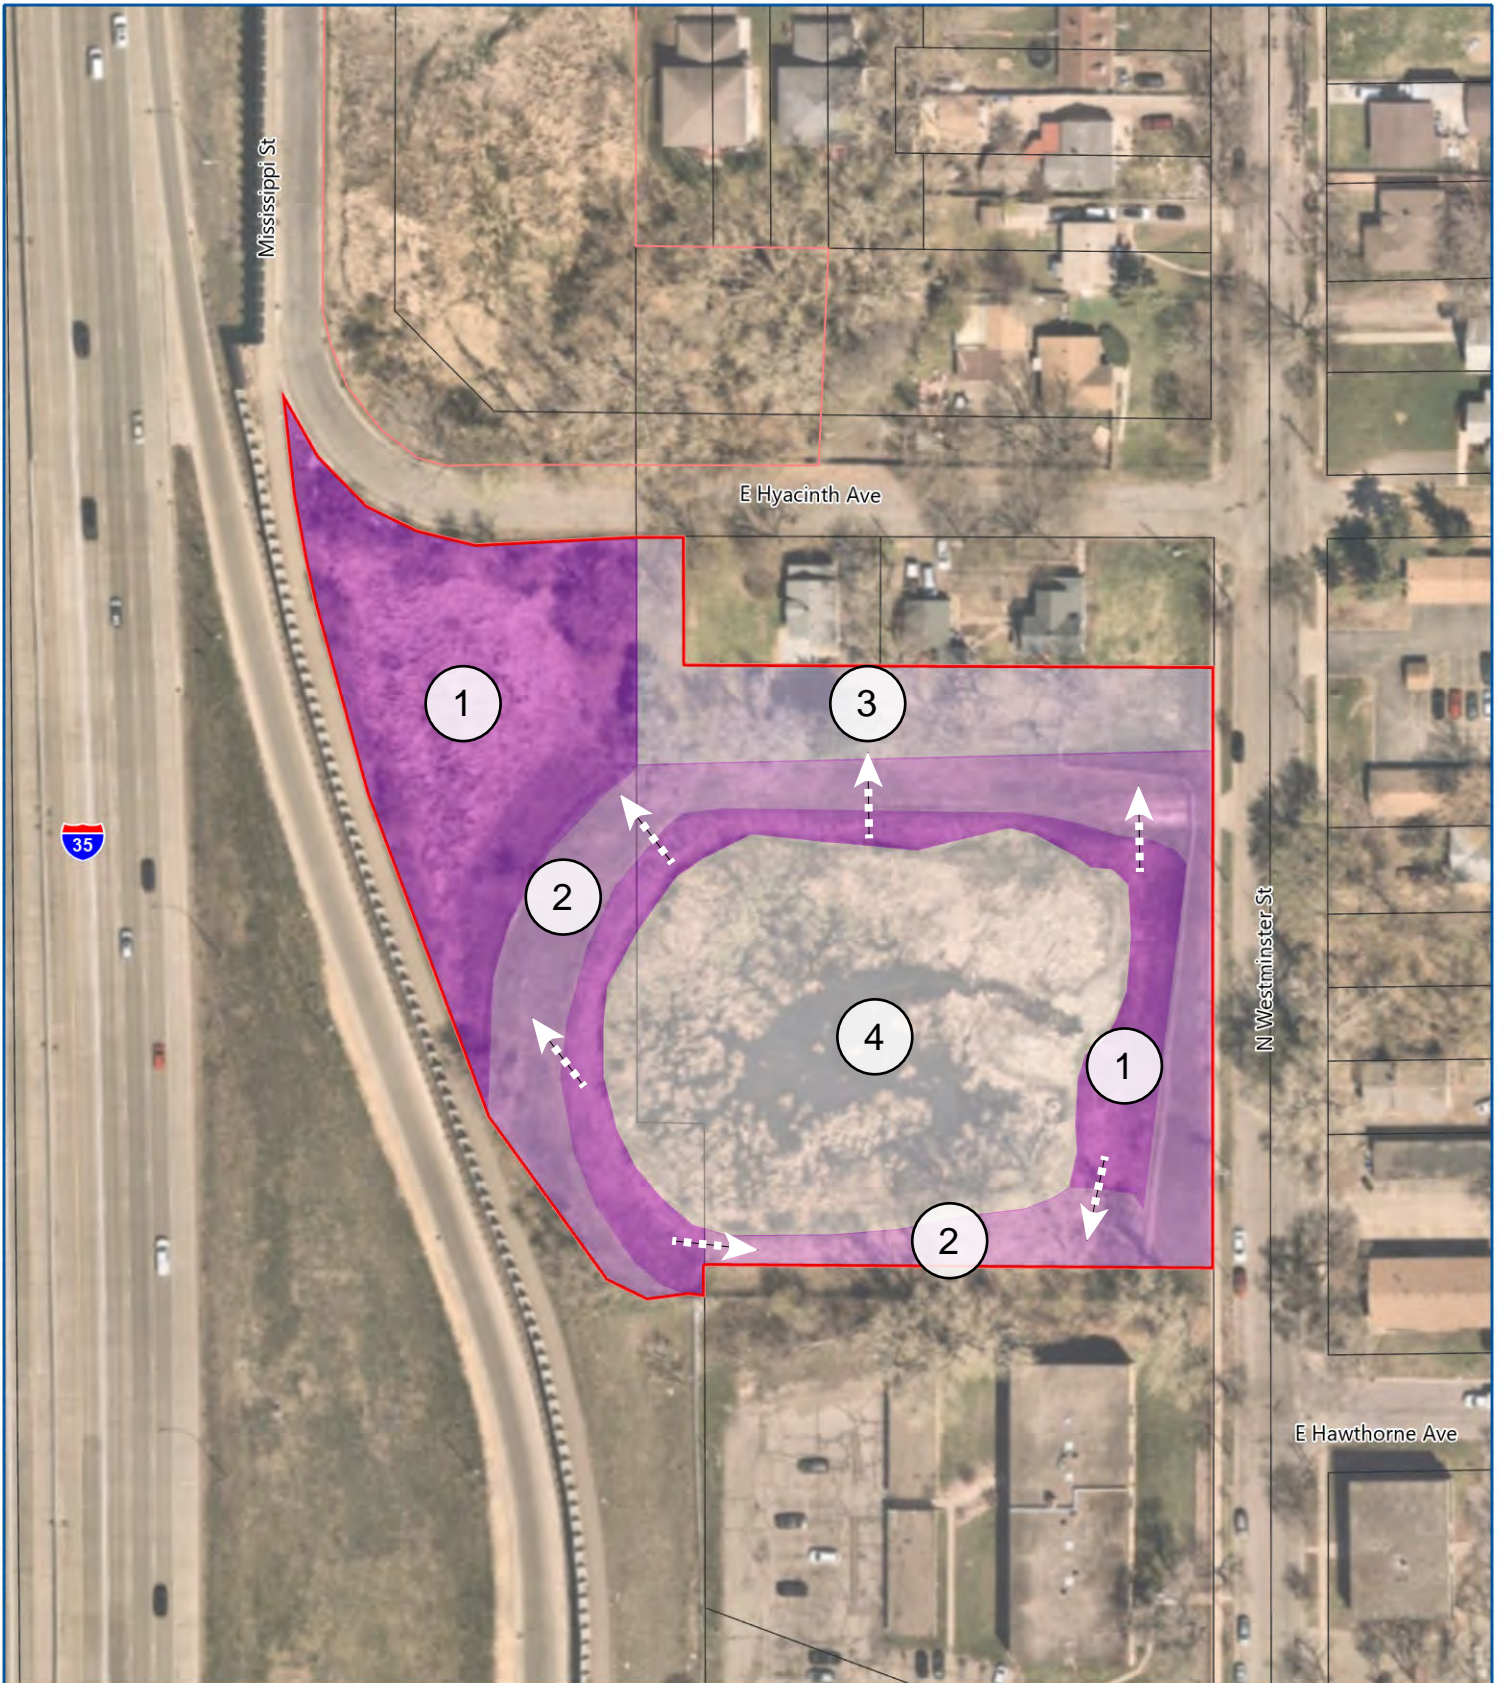
**SITE - 5**  
Westminster Pond

**TARGET PLANT COMMUNITY**  
Natural Resources Inventory  
Capitol Region  
Watershed District

- 1** - Restoration efforts begin in these areas.
- 2** - Second priority for restoration. Move restoration efforts to these areas once phase 1 restoration efforts are complete. Continue maintaining phase 1 to retain restoration success.
- 3** - Expand restoration to these areas as resources allow. It is critical to maintain previously restored areas.
- 4** - Last priority for restoration due to the extent of degradation.

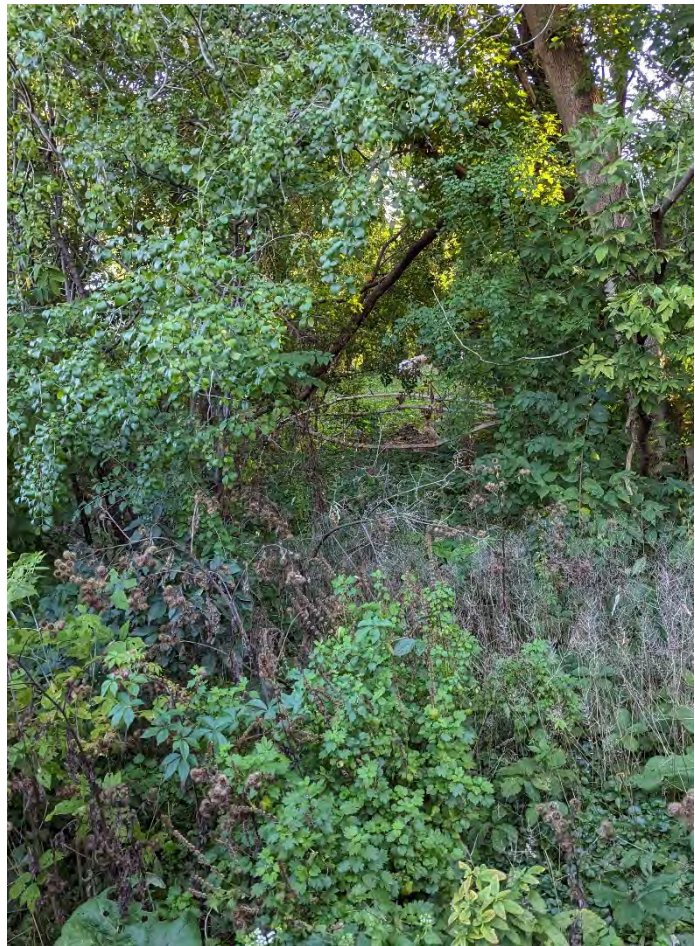
**Condition Summary:** Site 6 encompasses an undeveloped 1-acre privately owned parcel and a 700 x 60-foot public ROW extending to the north. The canopy of the public ROW is dominated by 30 to 50-foot-tall boxelders, black walnut, and cottonwood tree species. Similarly, the canopy of the 1-acre parcel is dominated by boxelder and black walnut but also contains mature bur oak trees throughout. The woody understory is comprised primarily of dense thickets of buckthorn and boxelder saplings. The herbaceous ground layer contains low plant diversity and is primarily dominated by burdock, garlic mustard, riverbank grape, woodbine, motherwort, and creeping Charlie. Common native species such as white snakeroot, stinging nettle (*Urtica dioica*), and Canada goldenrod were also present in lower quantities. The site is surrounded by fence and inaccessible without gate access.

Trout Brook was once located on south half of the site but has since been buried/filled.

- Difficult to access - site is isolated between private residential parcels
- Buckthorn – nearly all parts of the forested areas are highly degraded

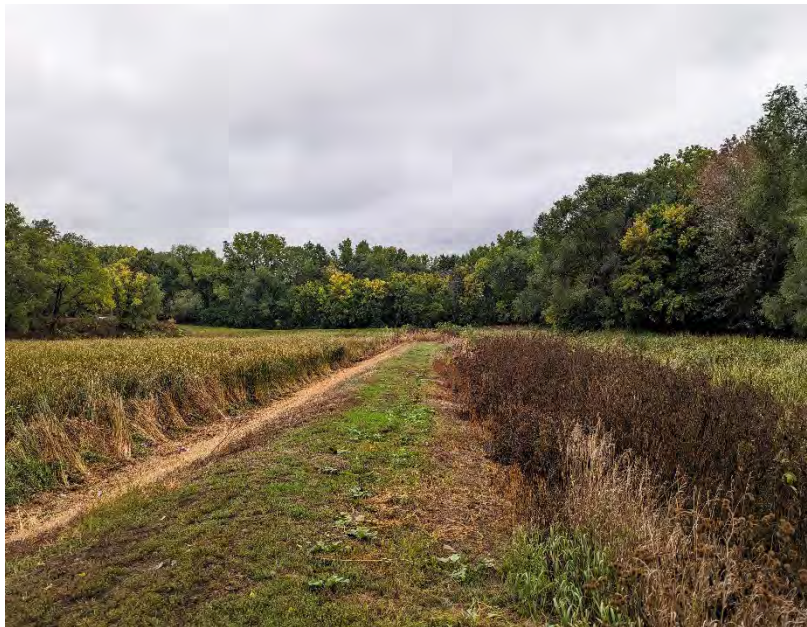
**Condition Summary:** The 2.5-acre stormwater basin on the south-west corner of Arlington Avenue and Arkwright Street is a monotypic stand of narrow leaved cattails. The 3H:1V slopes adjacent to the stormwater basin are composed primarily of giant ragweed, burdock, and Canada thistle. More drought-tolerant perennial weed species such as spotted knapweed and smooth brome grass are more abundant on the top of the basin slopes. The central berm bisecting the basin (maintenance access trail) and the north and east edges of the site are maintained as turf.

A low-quality altered woodland is present along the west and south edges of the site. Historical imagery from 1991 shows this wooded area was an open grassland being void of mature canopy tree species. Currently, the 1.5-acre woodland canopy is primarily composed of boxelder, green ash, and Siberian elm tree species. The understory is primarily composed of burdock, motherwort, and buckthorn. Large areas of exposed soil are present throughout.

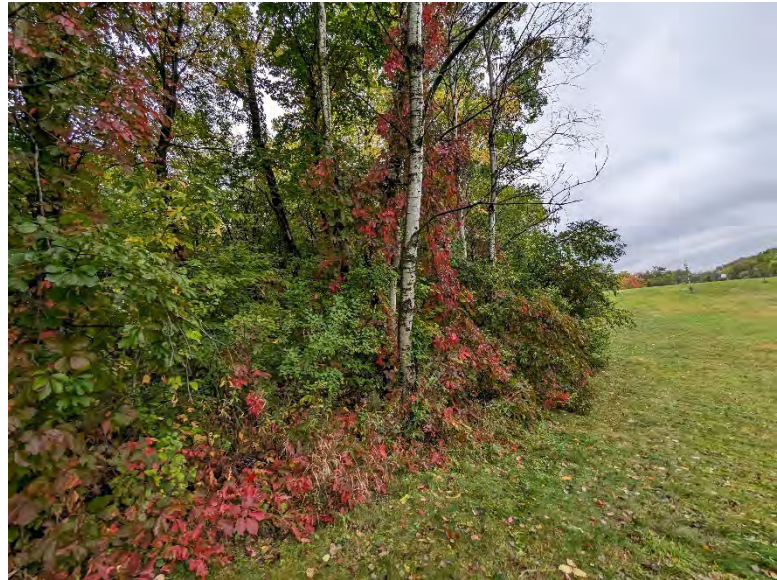
The southern half of the site is primarily wooded with a majority of the dog park area being highly degraded and having native low plant diversity. Boxelder, green ash, cottonwood, black walnut, black locust, and Siberian elm were common canopy trees throughout the forested areas. A high-quality mature oak stand (approximately 0.75-acre canopy area) near the west central portion of the dog park appears to be in good health. Throughout the dog park the herbaceous ground layer is sparse. A majority of the exposed soils throughout the dog park are highly compacted through foot traffic. The limited vegetation that is present is primarily of burdock, snakeroot, common plantain (*Plantago major*), ragweed (*Ambrosia artemisiifolia*), and burdock. The worst areas of existing erosion are along the west side of the dog park on west facing slopes leading down to Arkwright Street.

East of the dog park is a 2.9-acre maple-basswood forest community containing a diverse native tree canopy of aspen, basswood, black walnut, cottonwood, red maple, black cherry (*Prunus serotina*), hackberry, and white oak (*Quercus alba*) tree species. Dense stands of 30-foot-tall black locust have invaded portions of the forest. Buckthorn is the most common midstory tree species and is present throughout. The ground cover is composed of dense carpets of buckthorn saplings, chokecherry (*Prunus virginiana*), woodbine, and riverbank grape.

- Foot traffic and off-leash dogs have caused soil disturbance and erosion
- Extensive network of informal trails with increased widening and erosion
- Nonnative plant species
- Ongoing use of dog park area would make restoration establishment difficult

- Expand higher quality forested areas to create one of the largest and more diverse woodlands in the project area
- Large oaks in woodland areas should be managed and buckthorn cleared out in the understory to improve habitat quality for birds
- Restore and selectively close eroded footpaths through signage or strategic plantings
- Restore historic wetland plant community (detailed plan should be developed to identify areas for potential wetland restoration)
- Identify opportunities to utilize lawn or degraded natural areas for green infrastructure practices (stormwater quality/quantity control)
- Convert unused/unnecessary mowed turf areas with native grasses, forbs, and/or tree species
- Manage invasive tree species to prevent continued encroachment

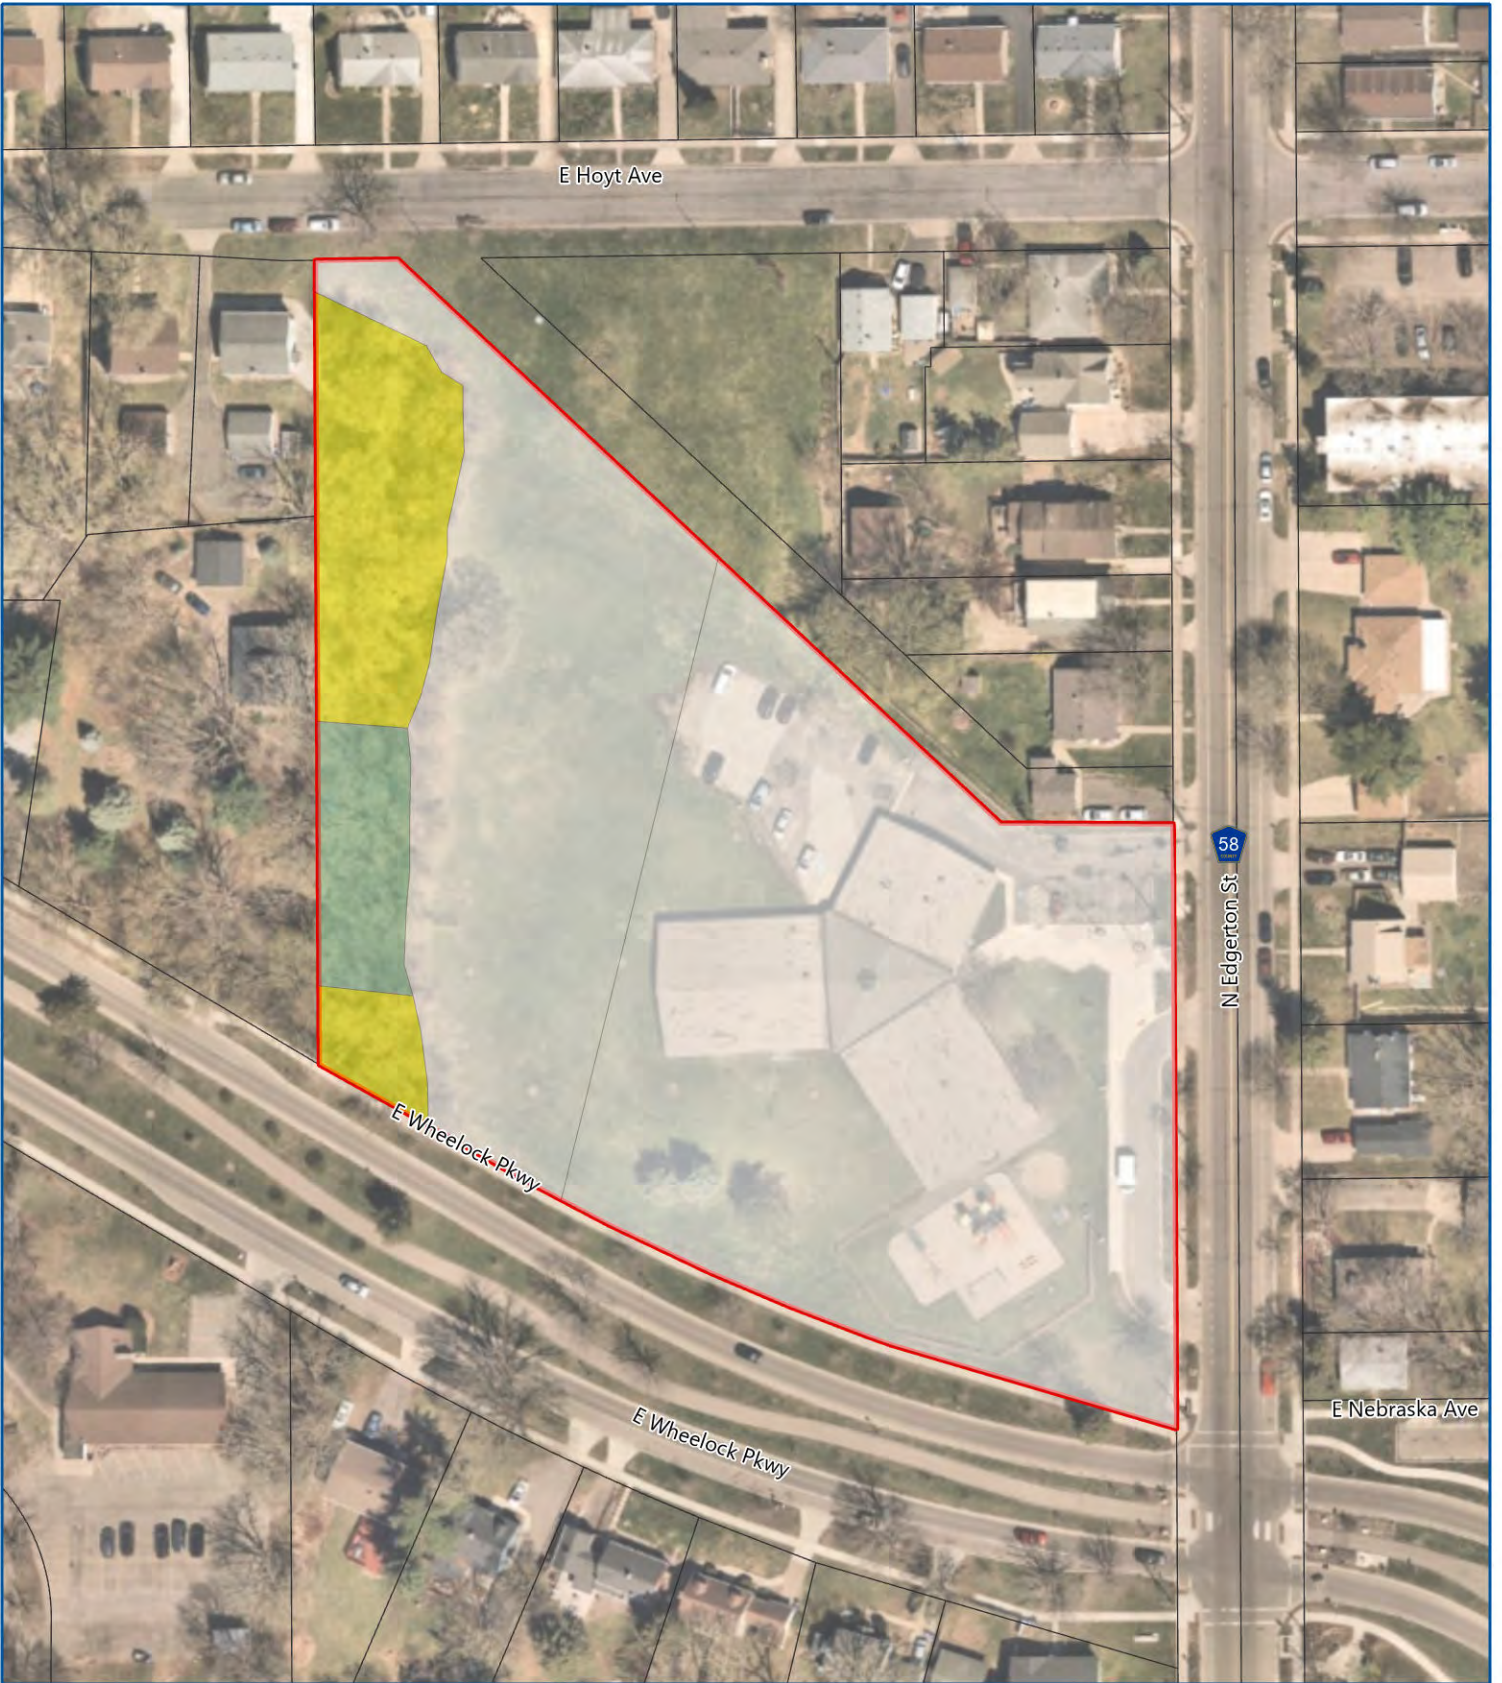
**SITE - 9**  
Wheelock Early Learning Center

**EXISTING LAND COVER**  
Natural Resources Inventory  
Capitol Region  
Watershed District

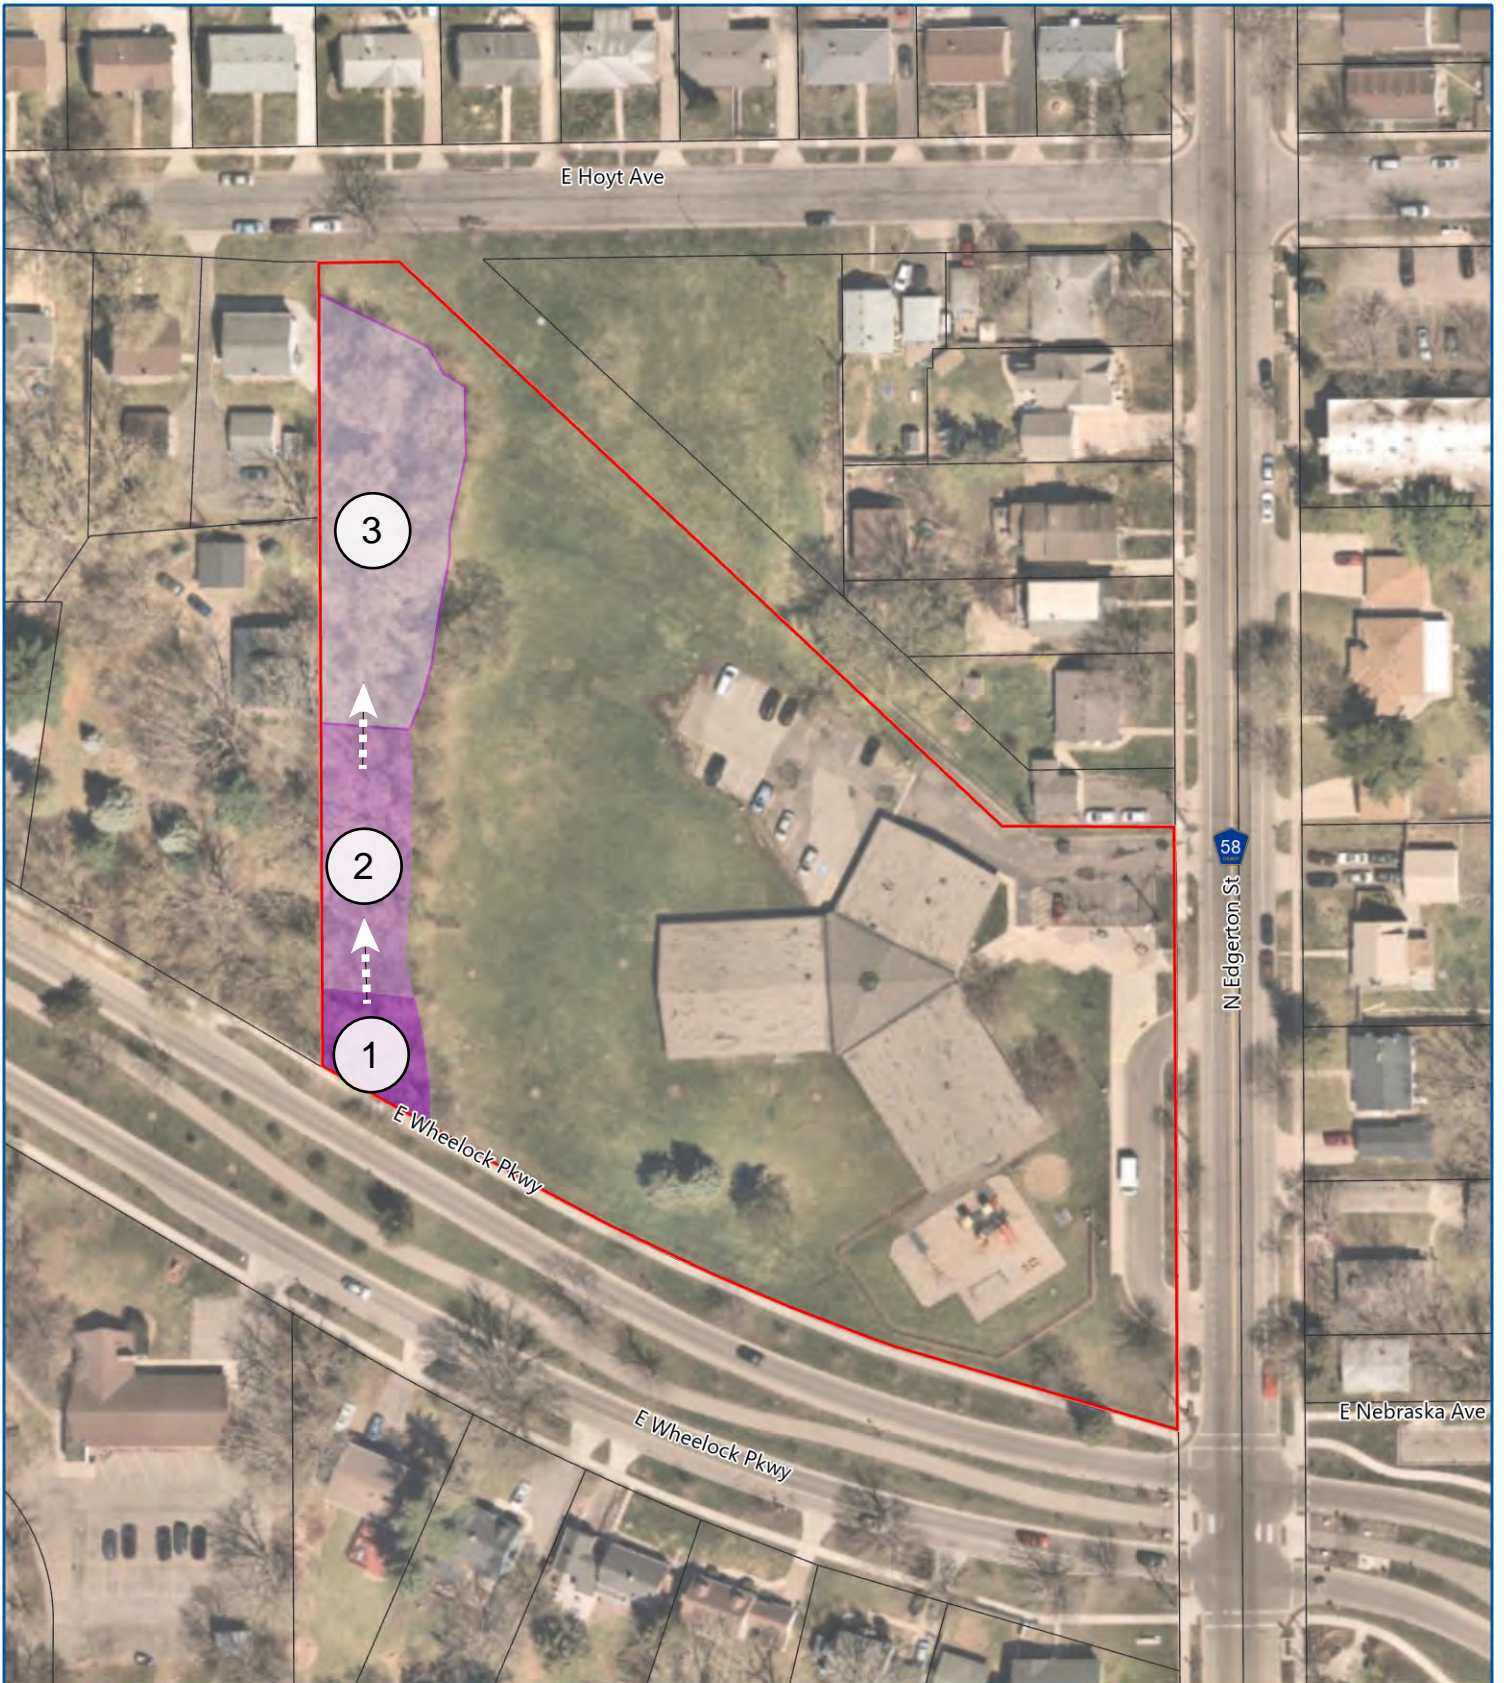
**SITE - 9**  
Wheelock Early Learning Center

**TARGET PLANT COMMUNITY**  
Natural Resources Inventory  
Capitol Region  
Watershed District

- Site 9 Boundary
  - Parcel
- Restoration Priority**
- High
  - Medium
  - Low
  - Lowest
  - Maintain
