# Natural Resource Inventory and Enhancement Opportunities

Dayton's Bluff and Payne-Phalen Community Council

Prepared by Barr Engineering Co. for Capitol Region Watershed District

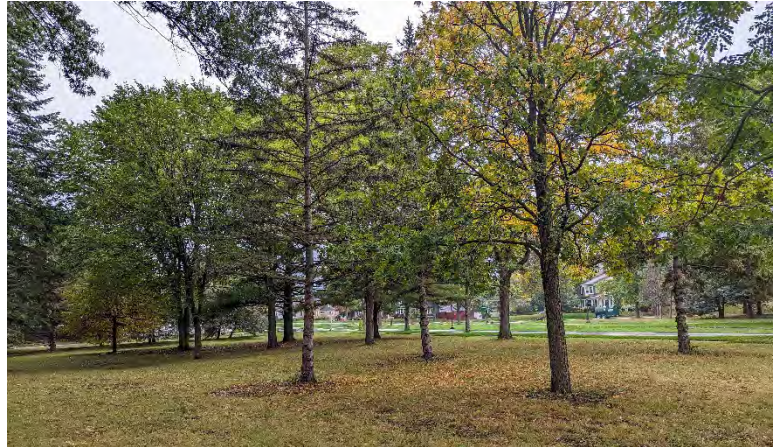
**Condition Summary:** The Wheelock Parkway Triangles is city parkland maintained as turf. A diverse number of mature tree species are scattered throughout. There is no subcanopy, understory, or shrub layer. The site is directly adjacent to a wide paved throughfare which may be a good candidate for conversion of turf grass into stormwater management BMPs.

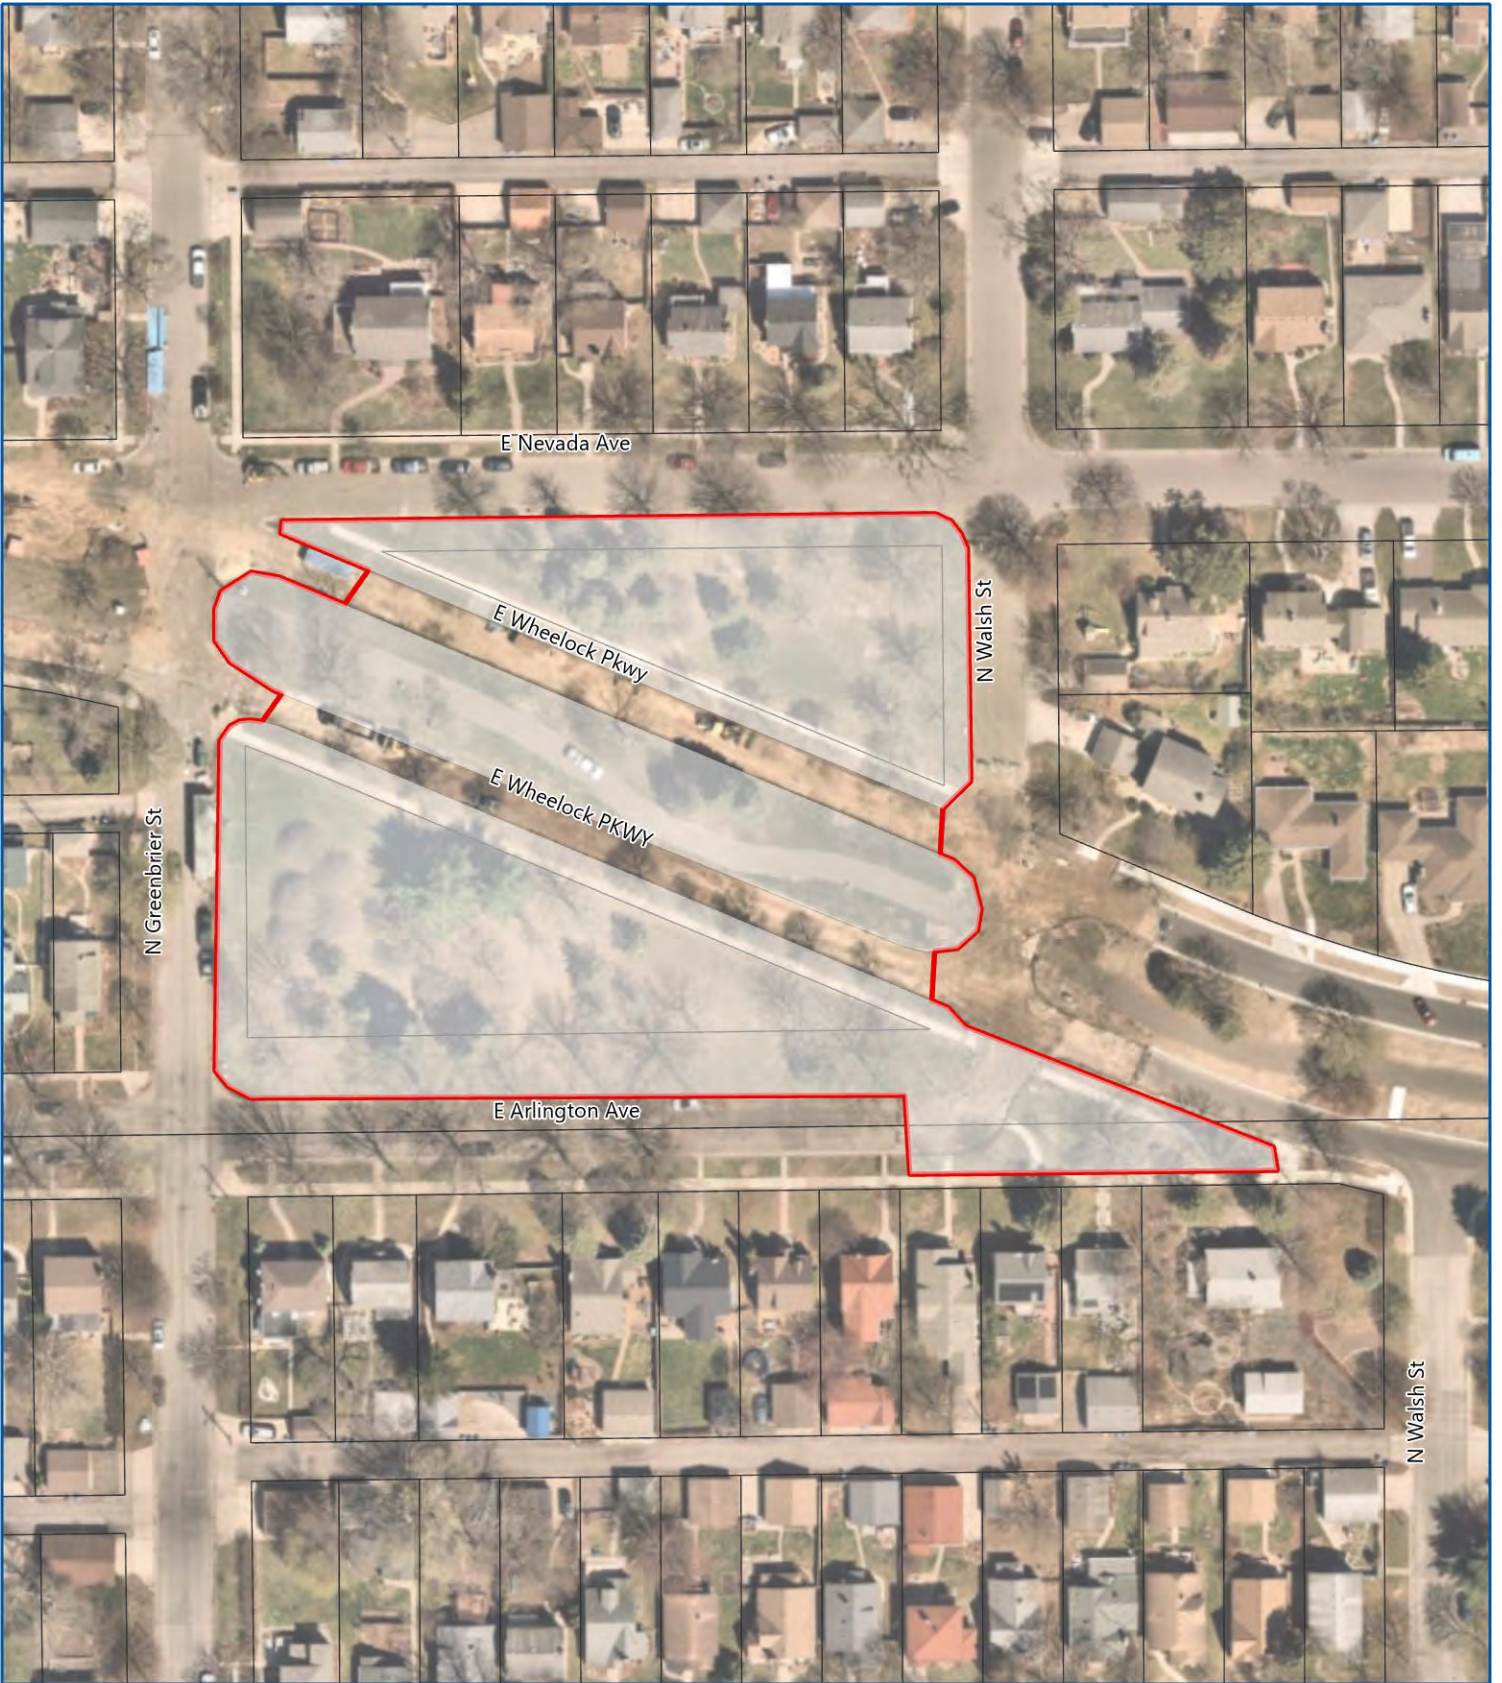
**SITE - 10**  
Wheelock Triangles

**EXISTING LAND COVER**  
Natural Resources Inventory  
Capitol Region  
Watershed District

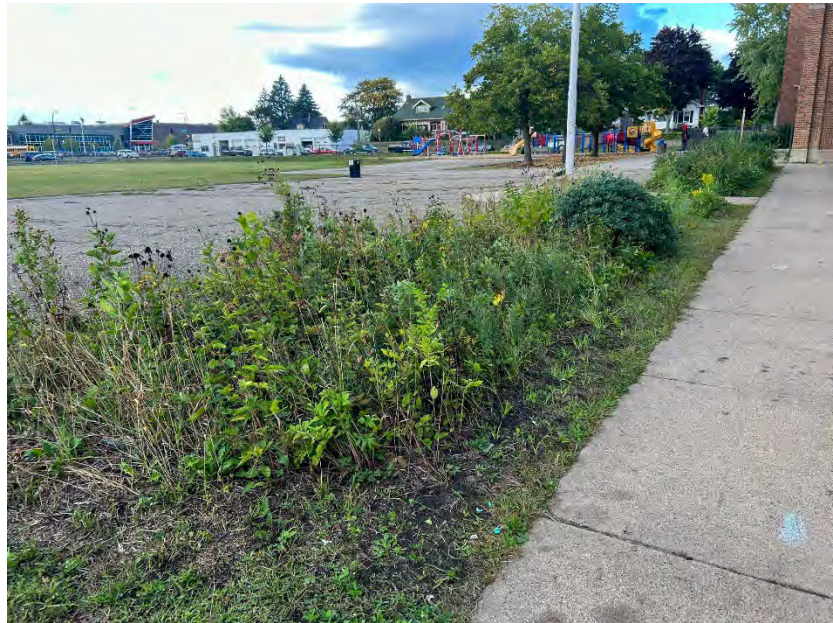
**Condition Summary:** Site 11 is a 3.6-acre school campus containing few natural features. A small demonstration native planting is present along the southeast side of the building. Nearly all other pervious areas are maintained as turf grass. Lawn areas are generally in poor condition due to intense foot traffic and poor drainage.

Many of the boulevard trees were recently removed due to an EAB infestation. Mature canopy trees are present only on the south and east edges of the site.

- Identify opportunities to utilize lawn for green infrastructure practices (stormwater quality/quantity control)
- Expand existing native demonstration plantings
- Collaborate with school to develop educational or interpretive opportunities about the importance of pollinator plantings
- Replace tree canopy lost due to EAB. Consider replacement trees that help mitigate UHI effect and are suitable under projected climate change conditions.

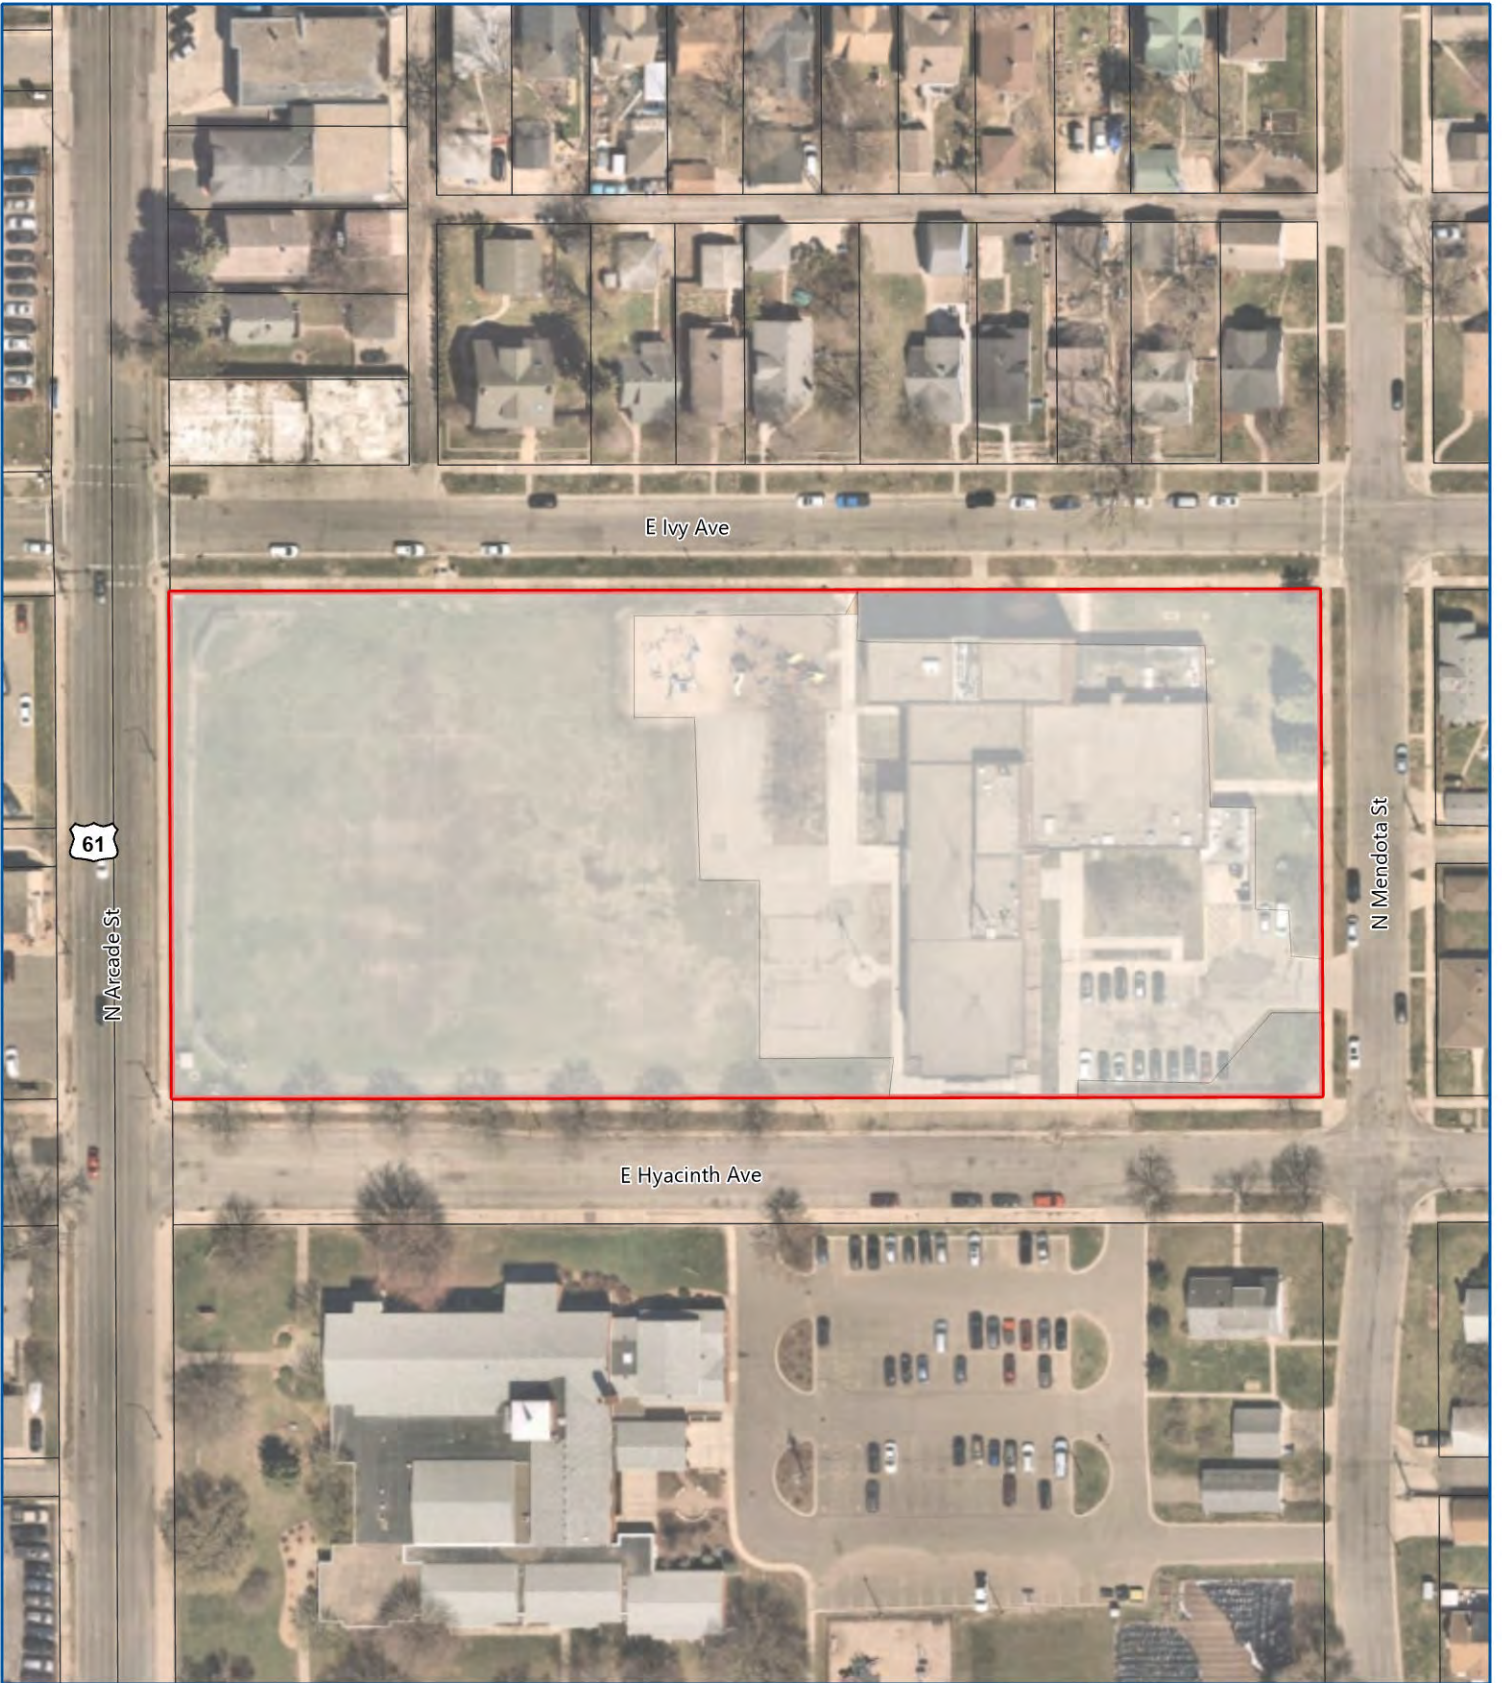
**SITE - 11**  
Farnsworth Pre K

**EXISTING LAND COVER**  
Natural Resources Inventory  
Capitol Region  
Watershed District

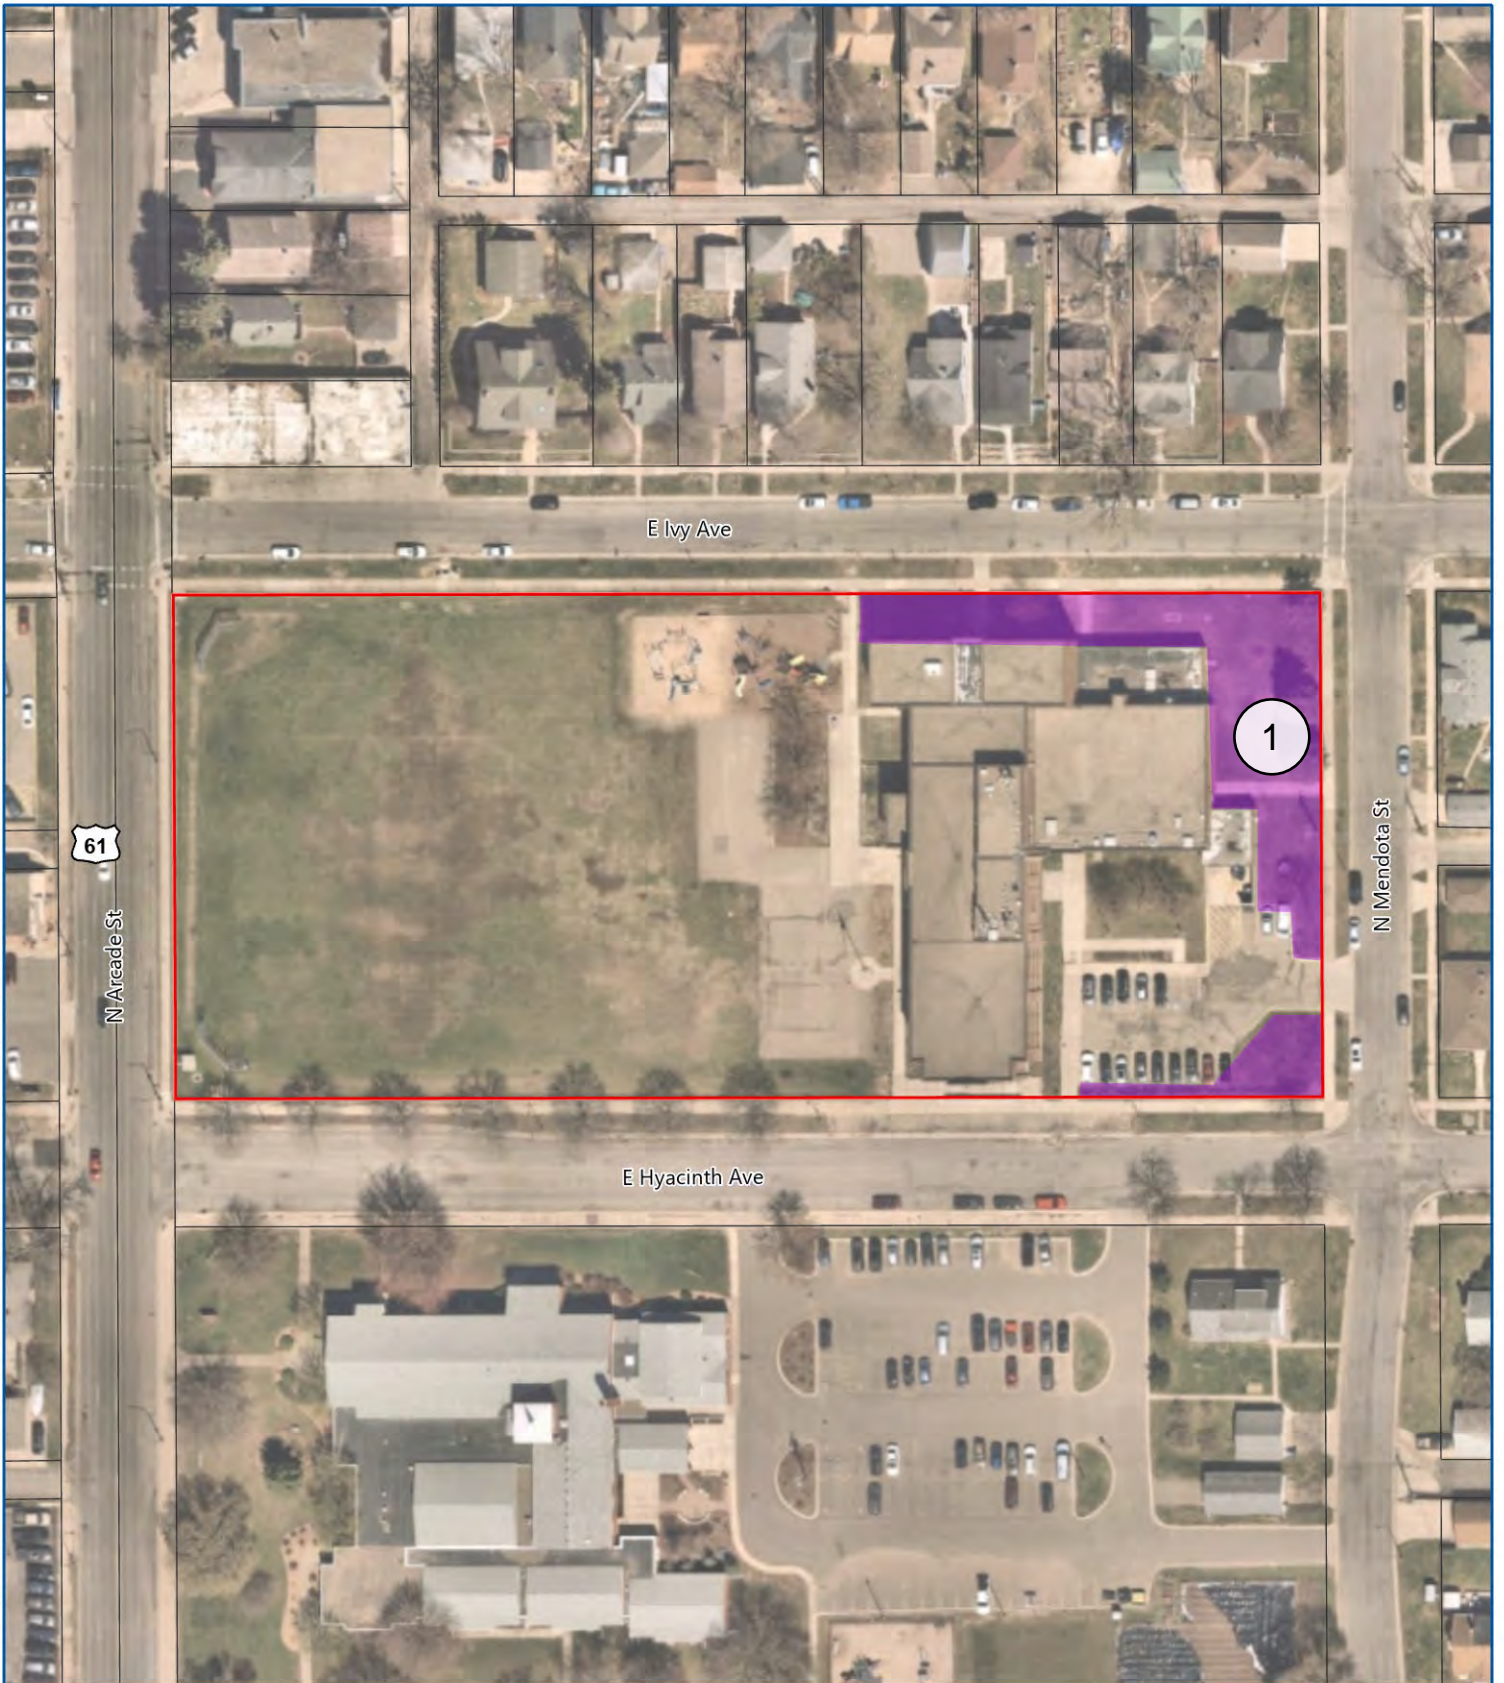
**SITE - 11**  
Farnsworth Pre K

**TARGET PLANT COMMUNITY**  
Natural Resources Inventory  
Capitol Region  
Watershed District

**Restoration Phasing**  
**1** - Restoration efforts begin in these areas.

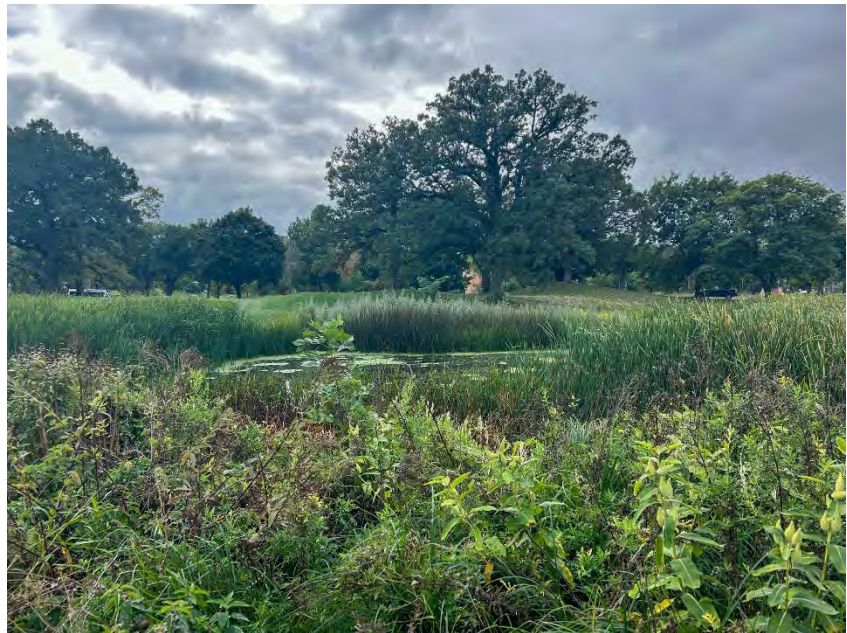
Two NWI-mapped wetlands are located within the course and are both categorized as freshwater ponds. The ponds contain cattails along the edges. Non-native species like reed canary grass and Canada thistle grow adjacent to the

pond banks along with few patches of native giant bur-reed. The remaining areas are lawns (golf course fairways, rough, and greens) with well-maintained mature oak, hackberry, maple, pine, and spruce trees.

- Majority of the site is currently maintained as lawn for recreational activities
- Wetlands buffers are less than 25 feet wide in areas (encroachment by mowing)

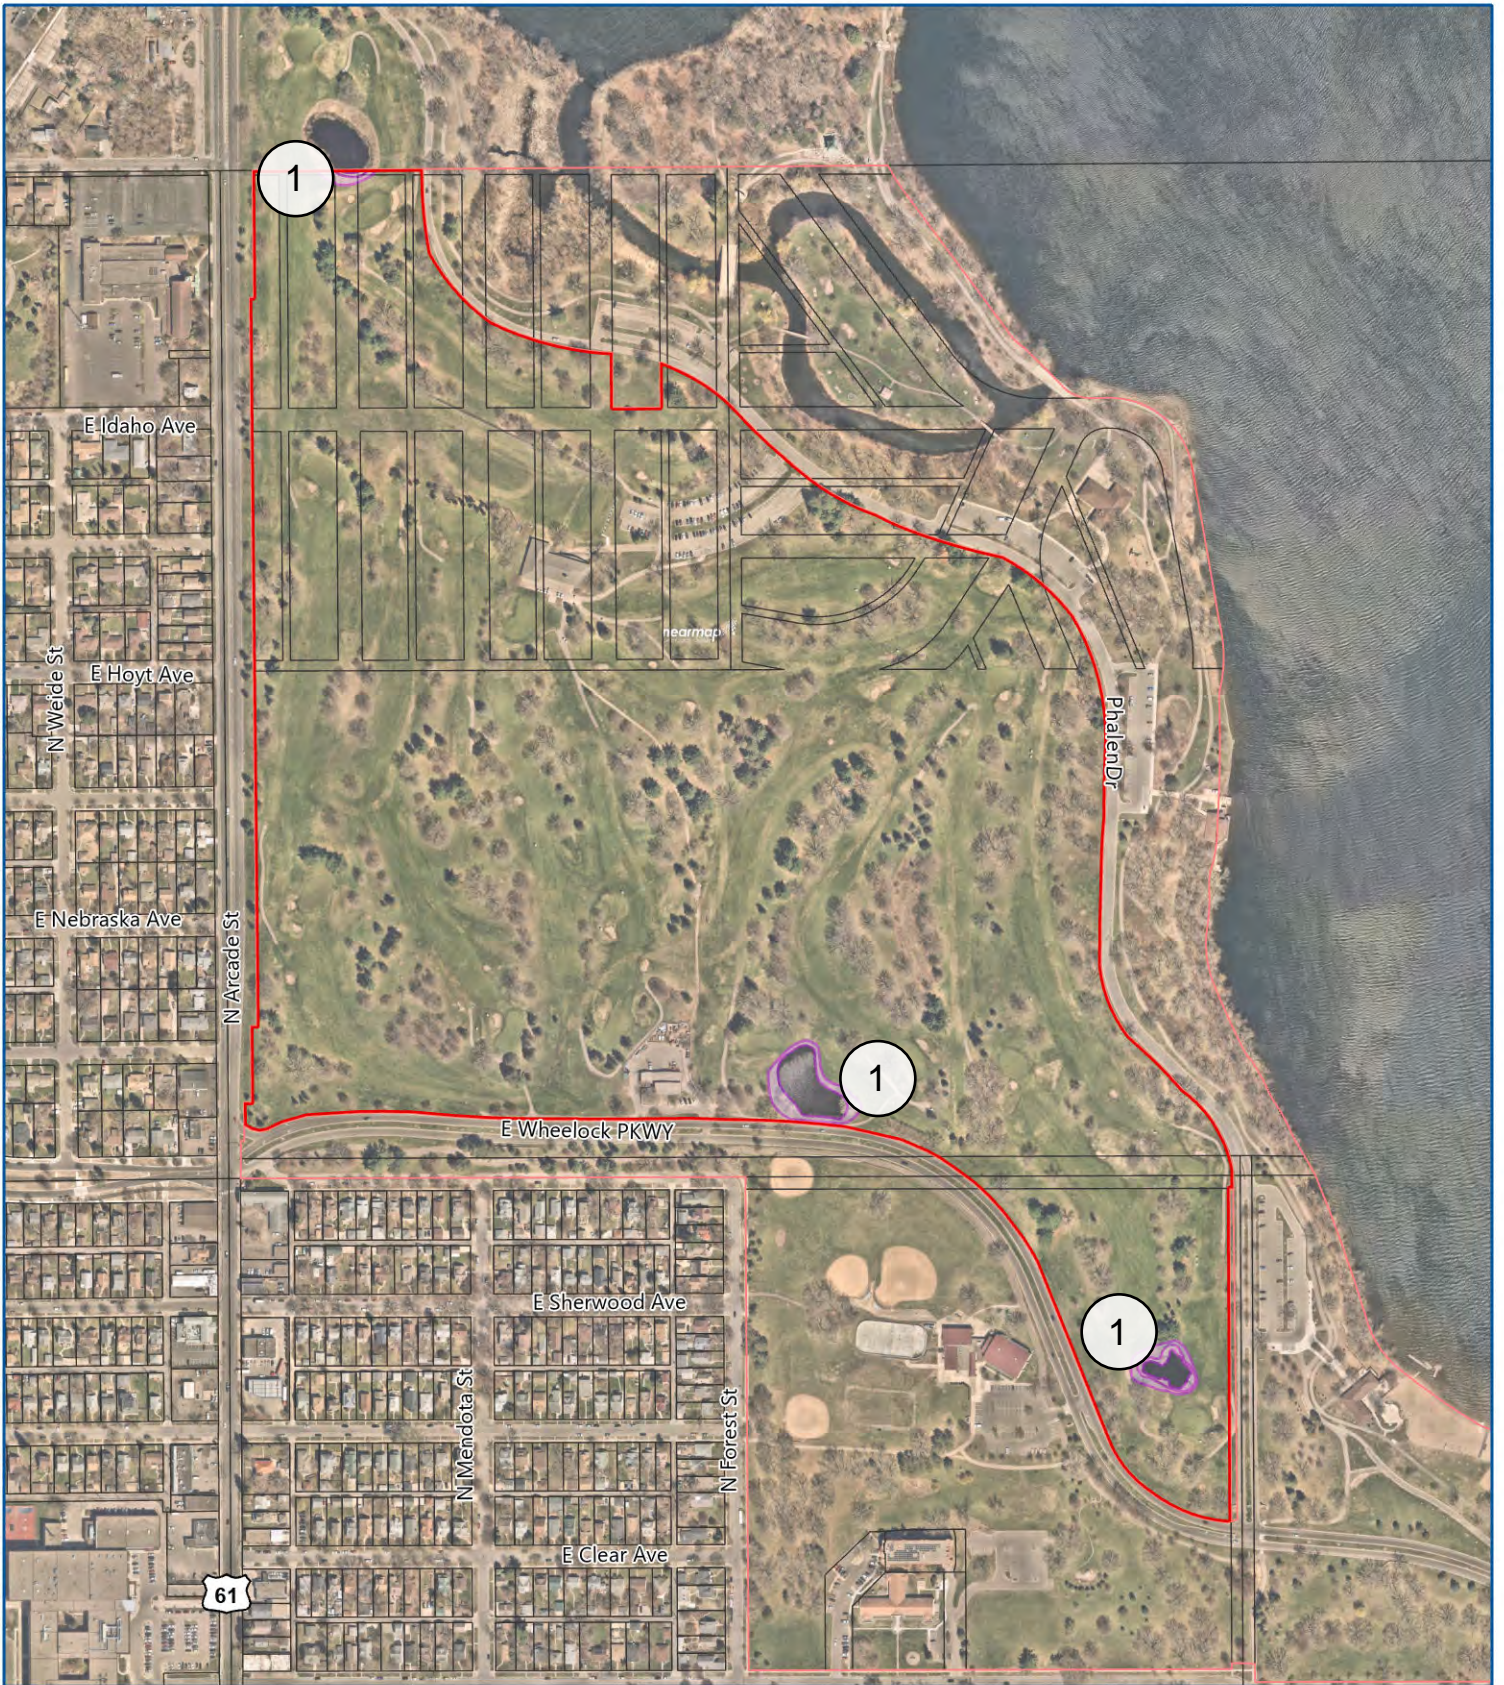
**SITE - 12**  
Phalen Golf Course

**TARGET PLANT COMMUNITY**  
Natural Resources Inventory  
Capitol Region  
Watershed District

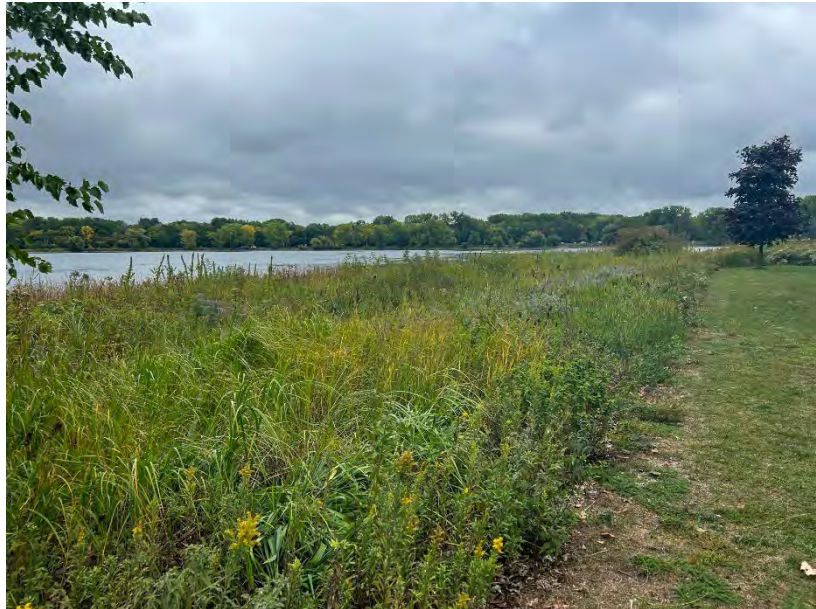
**Condition Summary:** Located just south of the Phalen Golf Course, Phalen Regional Park is comprised of oak savanna plantings, restored lakeshore, and recreation areas for fishing, swimming, and picnicking. Phalen Regional Park is bounded by the Bruce Vento Regional Trail to the east, East Wheelock Parkway to the South, and Phalen Drive to the west. The Phalen Regional Park provides recreation for walking, cycling, fishing, swimming, paddling, and wildlife photography.

Along East Wheelock Parkway and Phalen Drive, maintained turf grass is ubiquitous. Lawn areas contain a variety of mature tree species such as oak, maple, crabapple (*Malus* spp.), hackberry, elm, and black spruce. The area south of Wheelock Parkway is maintained as lawn for active and passive recreation (baseball and soccer fields). The Changsha China Friendship Garden is located on the northwest side of the lake and contains many tree and shrub species native to China.

- A great example of a well-maintained lakeshore buffer restoration with native plant diversity (continue to maintain these areas of high-quality habitat)
- High visibility and use within the park could help leverage support for additional resources for on-going management efforts
- Formalize and stabilize lakeshore access points to prevent erosion
- Identify opportunities to utilize lawn for green infrastructure practices (stormwater quality/quantity control)

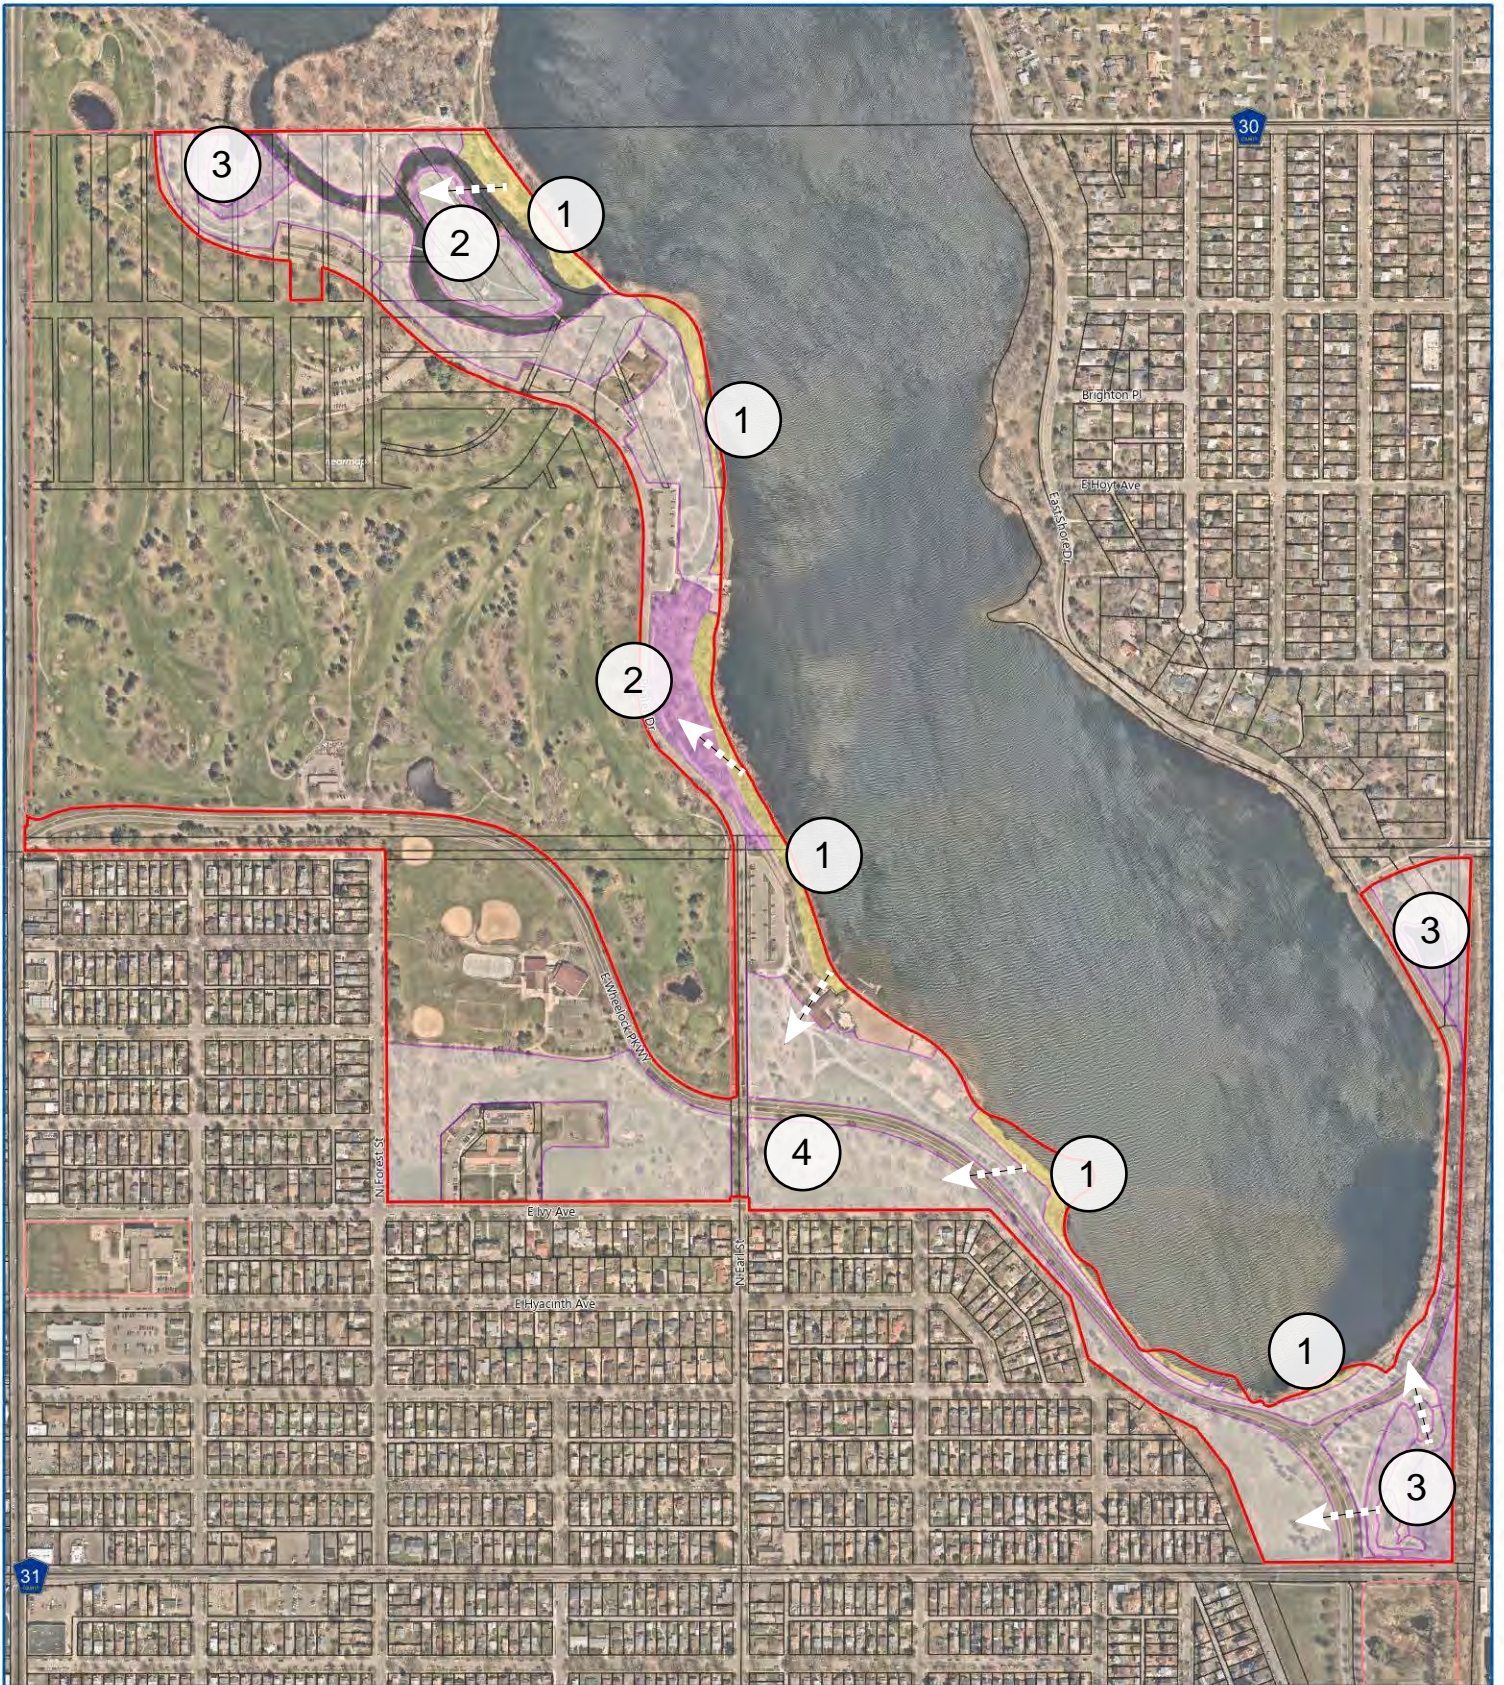
**SITE - 13**  
Phalen Regional Park

**TARGET PLANT COMMUNITY**  
Natural Resources Inventory  
Capitol Region  
Watershed District

- 1** - Restoration efforts begin in these areas.
- 2** - Second priority for restoration. Move restoration efforts to these areas once phase 1 restoration efforts are complete. Continue maintaining phase 1 to retain restoration success.
- 3** - Expand restoration to these areas as resources allow. It is critical to maintain previously restored areas.
- 4** - Last priority for restoration due to the extent of degradation.

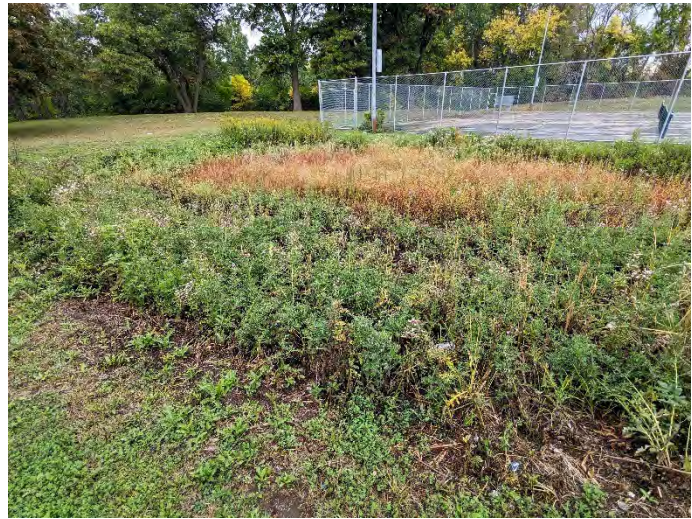
**Condition Summary:** Site 14 is a public parcel bound by Maryland Avenue to the north, Johnson Parkway to the south and west, and a shopping center to the east. The north end of the site contains an NWI-mapped freshwater pond. The lowest point of the wetland is dominated by non-native cattails. Reed canary grass, common burdock, and lake sedge (*Carex lacustris*) are growing on the periphery of the cattail wetland. Cottonwood and black willow trees tower over the wetland (30 to 50-foot-tall). Open upland areas are dominated by dense stands of staghorn sumac (*Rhus typhina*). Burdock, common ox-eye (*Heliopsis helianthoides*), black-eyed Susan, and wild bergamot (*Monarda fistulosa*) were present in areas where the sumac had been mown down to the ground.

Turf grass, tennis courts, and a parking lot cover the south half of the site. A small, poorly functioning BMP dominated by non-native species is located near the northwest corner of the tennis courts. East of the tennis courts, a narrow and degraded forest is composed of boxelder, cottonwood, and a red oak trees (*Quercus rubra*). A dense thicket of buckthorn covers the outer edge of the woodland.

- Reed canary grass and cattails dominate the wetland
- Buckthorn – Nearly all parts of the forested areas are infested with buckthorn (no ongoing management efforts)

- Ecological connections to Phalen Regional Park and Bruce Vento Regional Trail (create habitat corridor)
- Control the most aggressive non-native species to prevent them from spreading to adjacent natural areas
- Explore opportunity for SSGI improvements connected to the Metro Transit Purple Line BRT project (proposed along east edge of site)

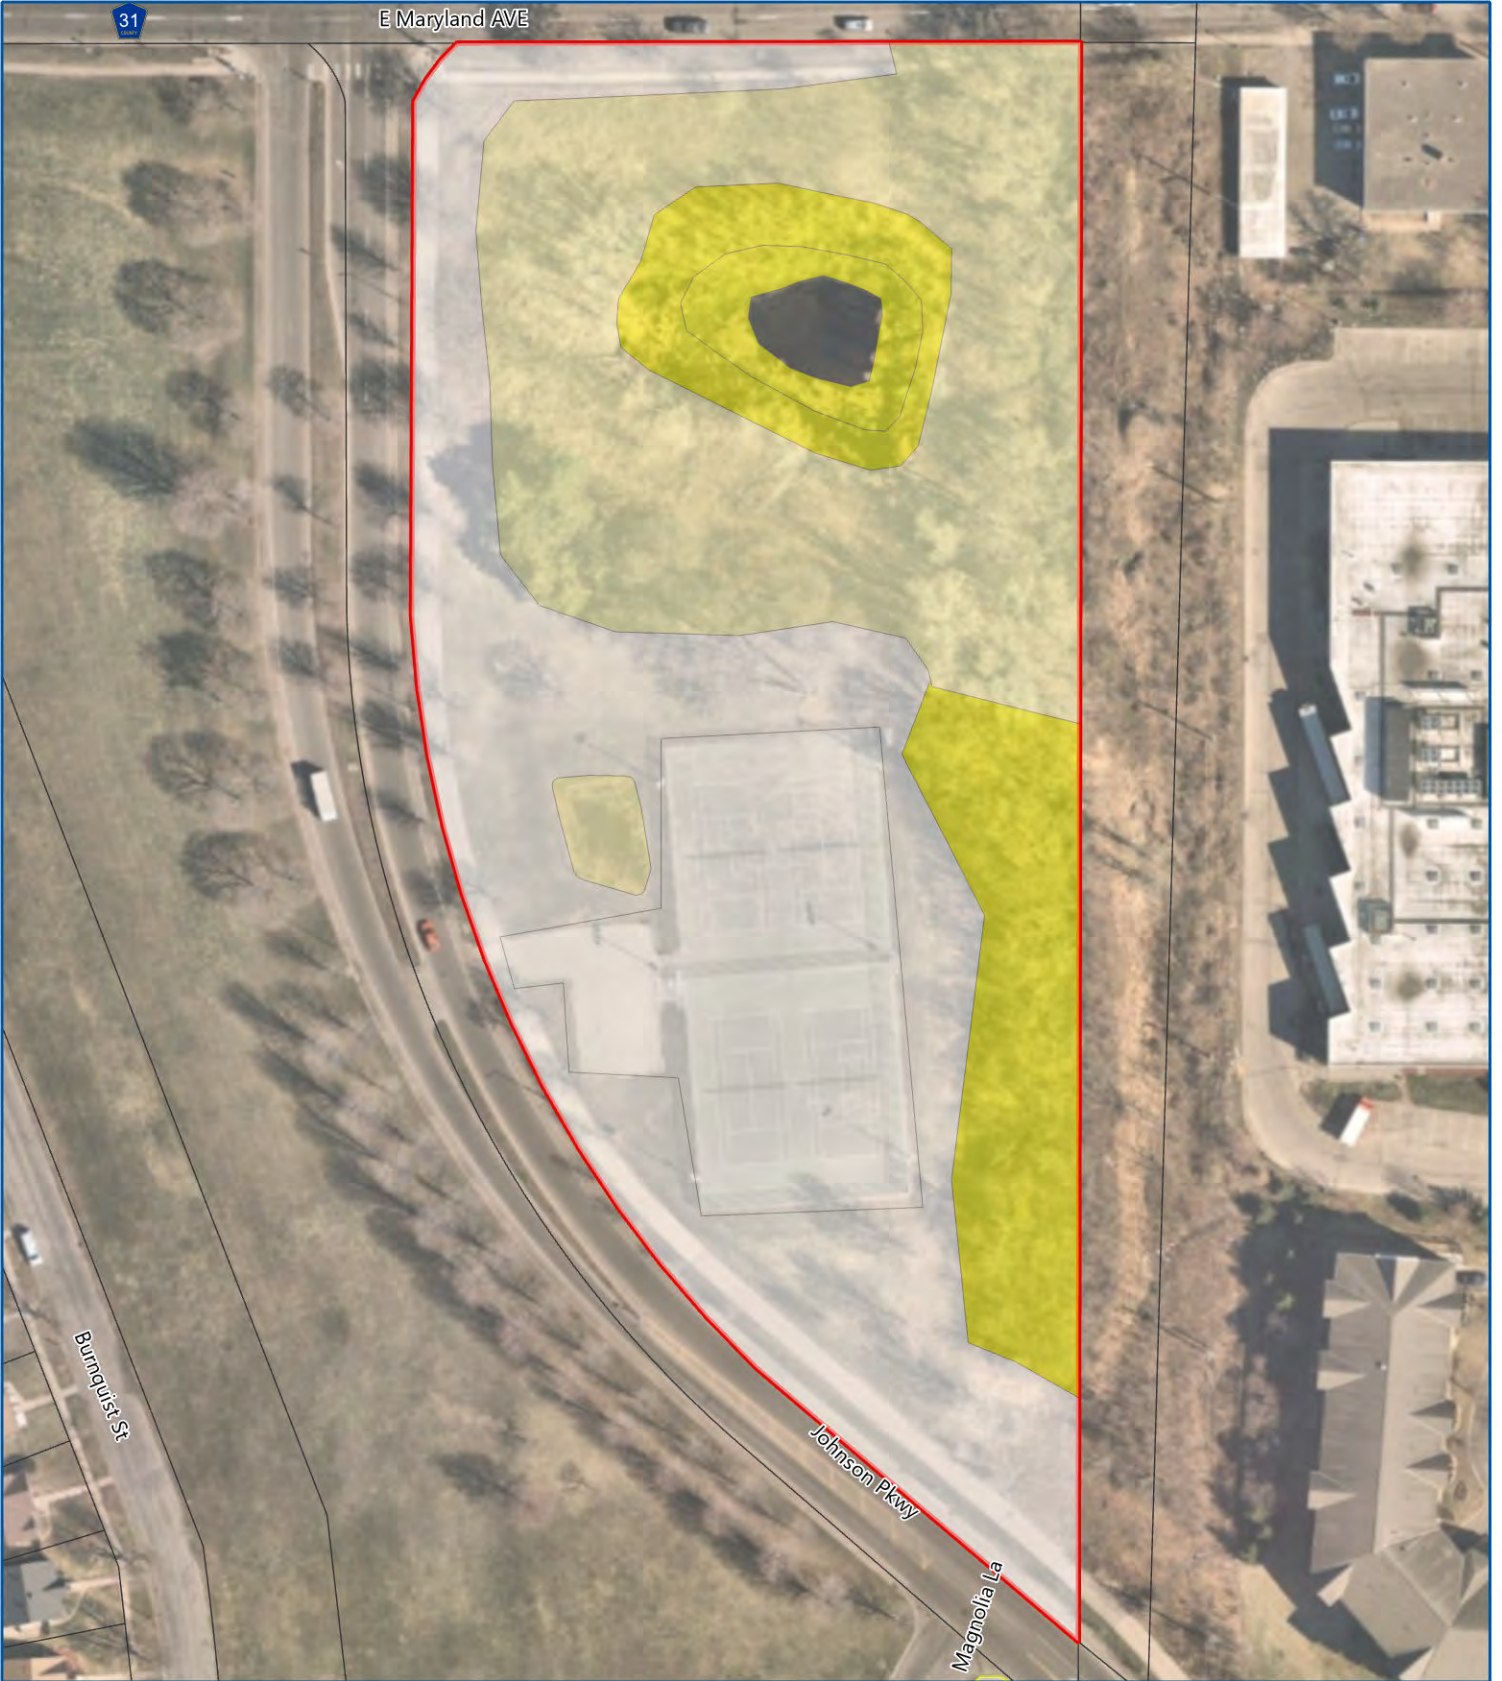
**SITE - 14**  
Johnson Parkway Tennis Courts

**EXISTING LAND COVER**  
Natural Resources Inventory  
Capitol Region  
Watershed District

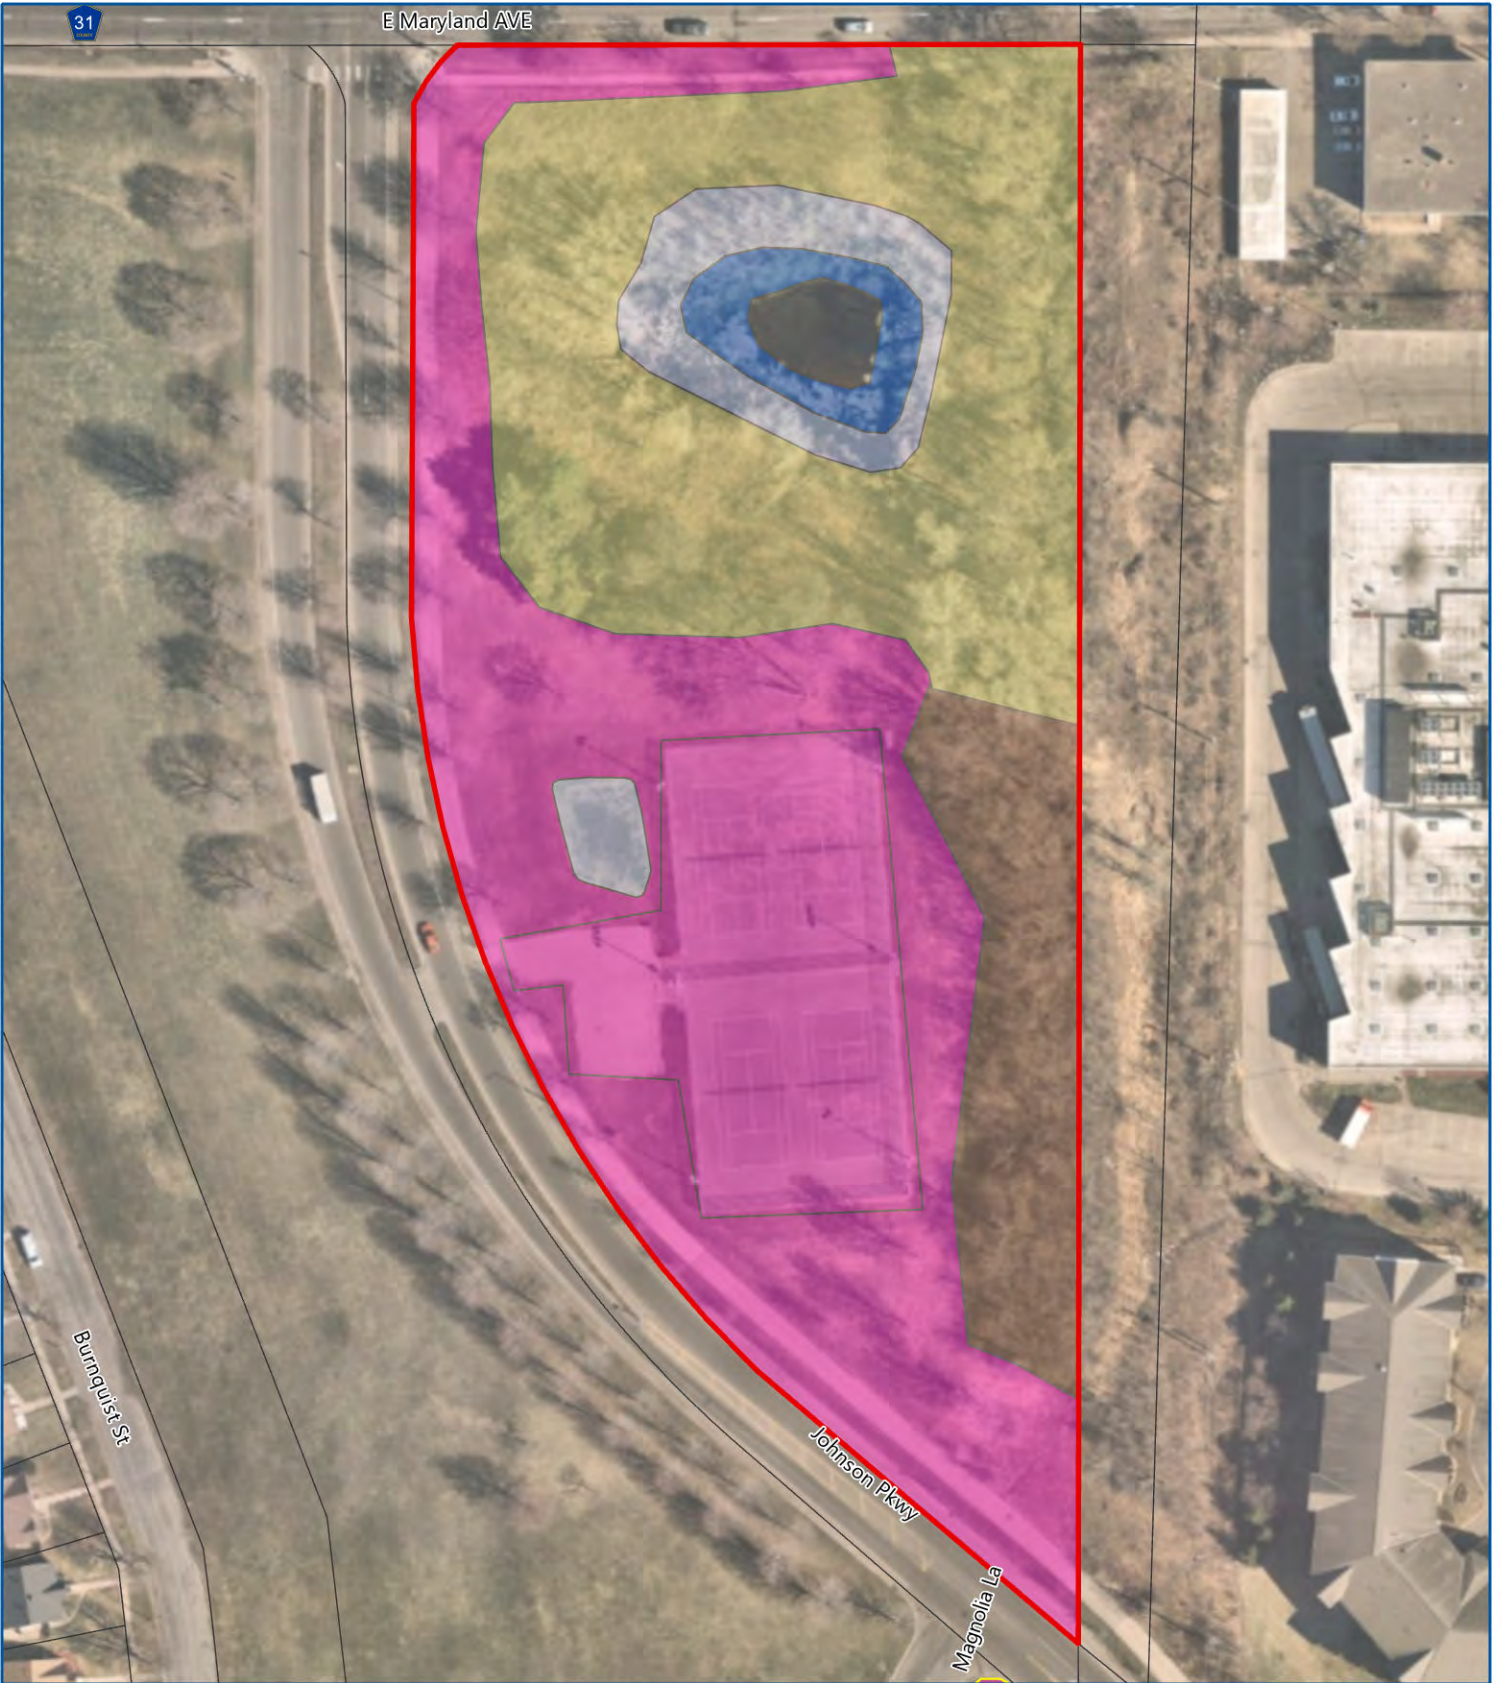
**SITE - 14**  
Johnson Parkway Tennis Courts

**ECOLOGICAL QUALITY**  
Natural Resources Inventory  
Capitol Region  
Watershed District
