# Natural Resource Inventory and Enhancement Opportunities

Dayton's Bluff and Payne-Phalen Community Council

Prepared by Barr Engineering Co. for Capitol Region Watershed District

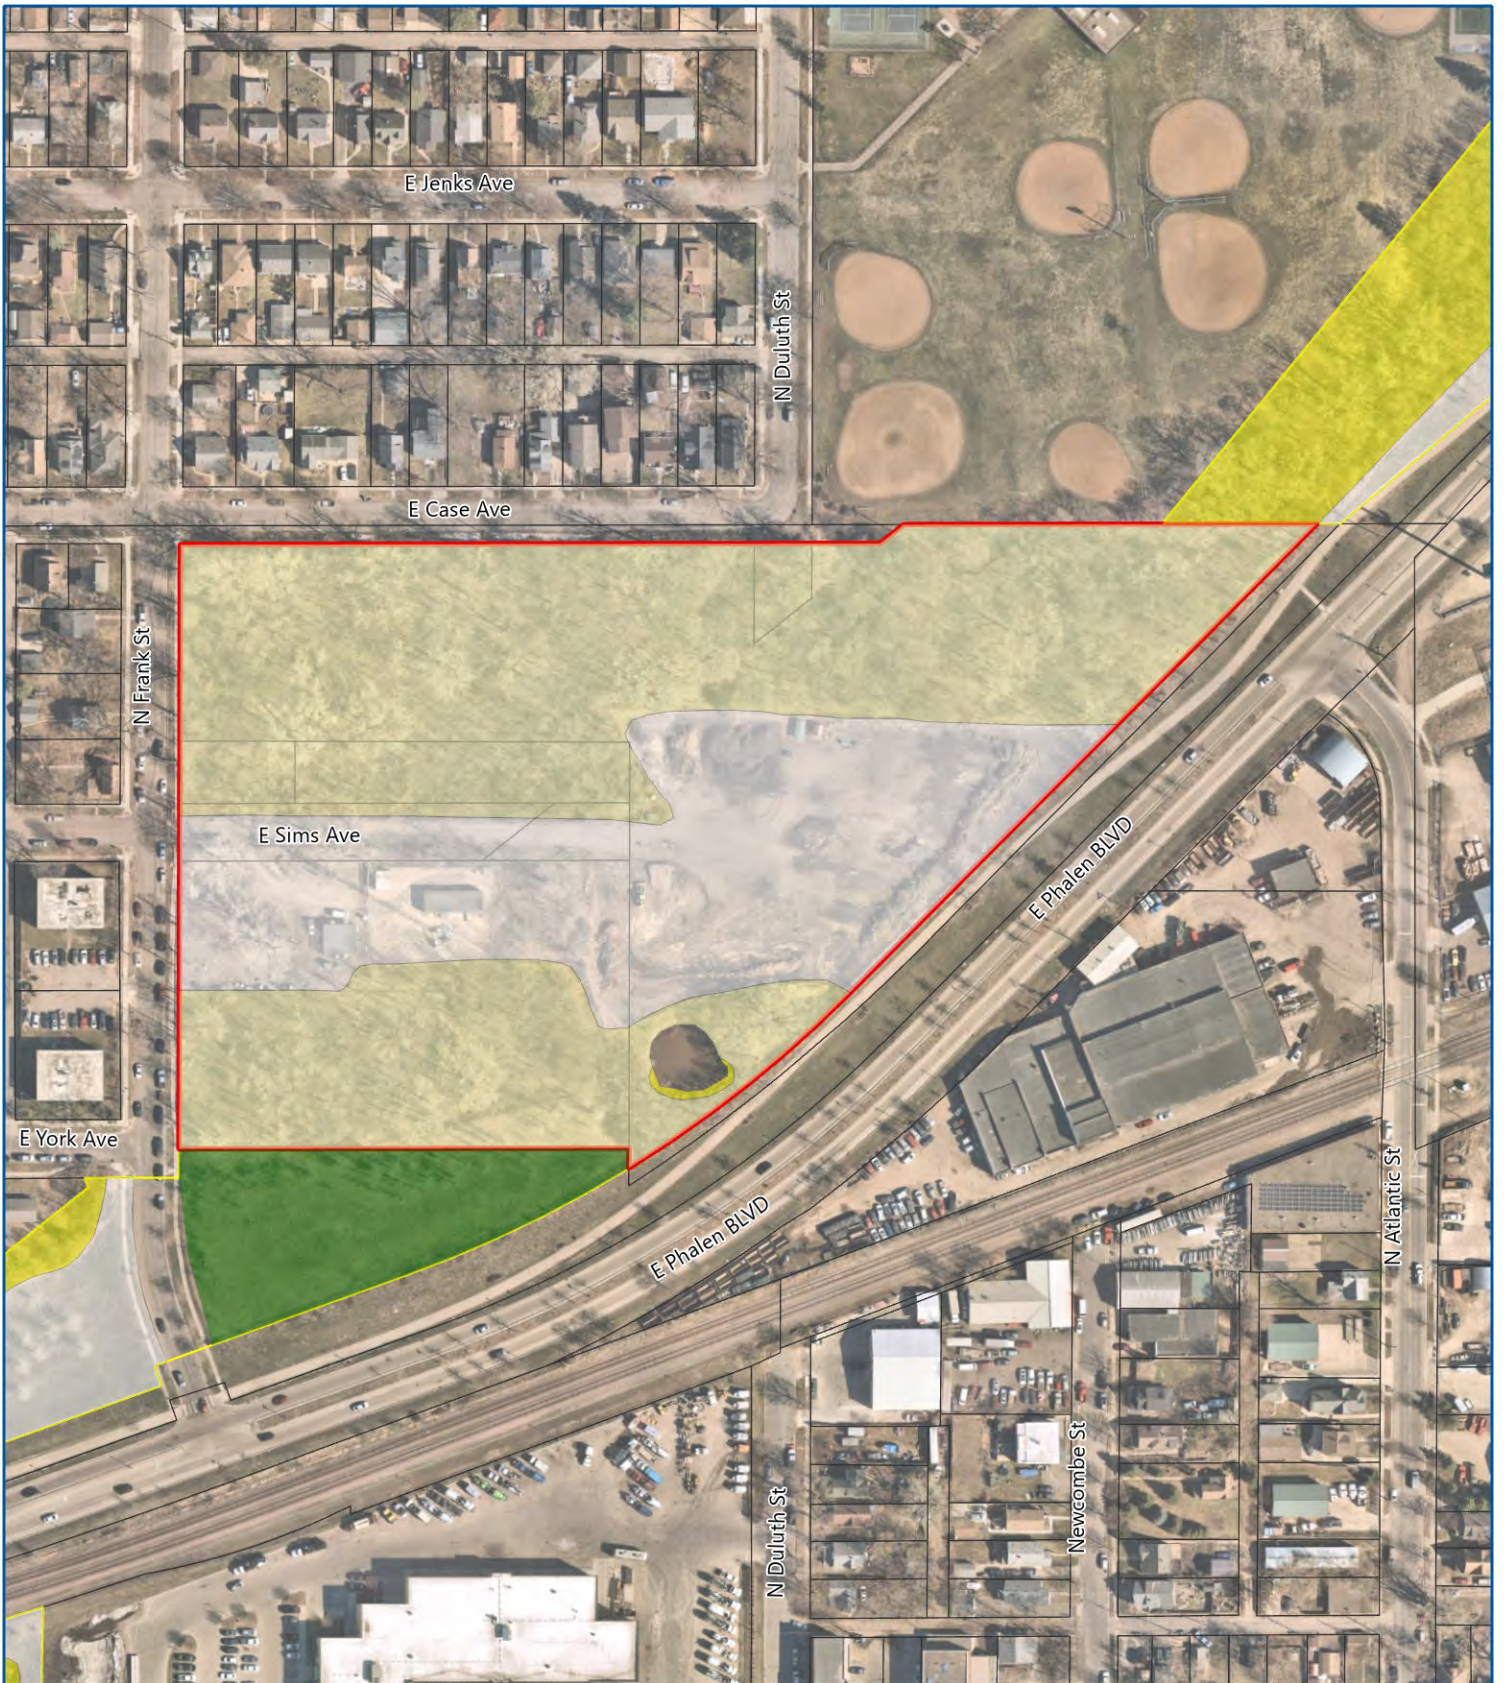
**SITE - 16**  
Frank and Sims Yard Waste Collection Site

**EXISTING LAND COVER**  
Natural Resources Inventory  
Capitol Region  
Watershed District
