SITE - 16

Frank and Sims Yard Waste
Collection Site

Natural Resources Inventory
Capitol Region
Watershed District

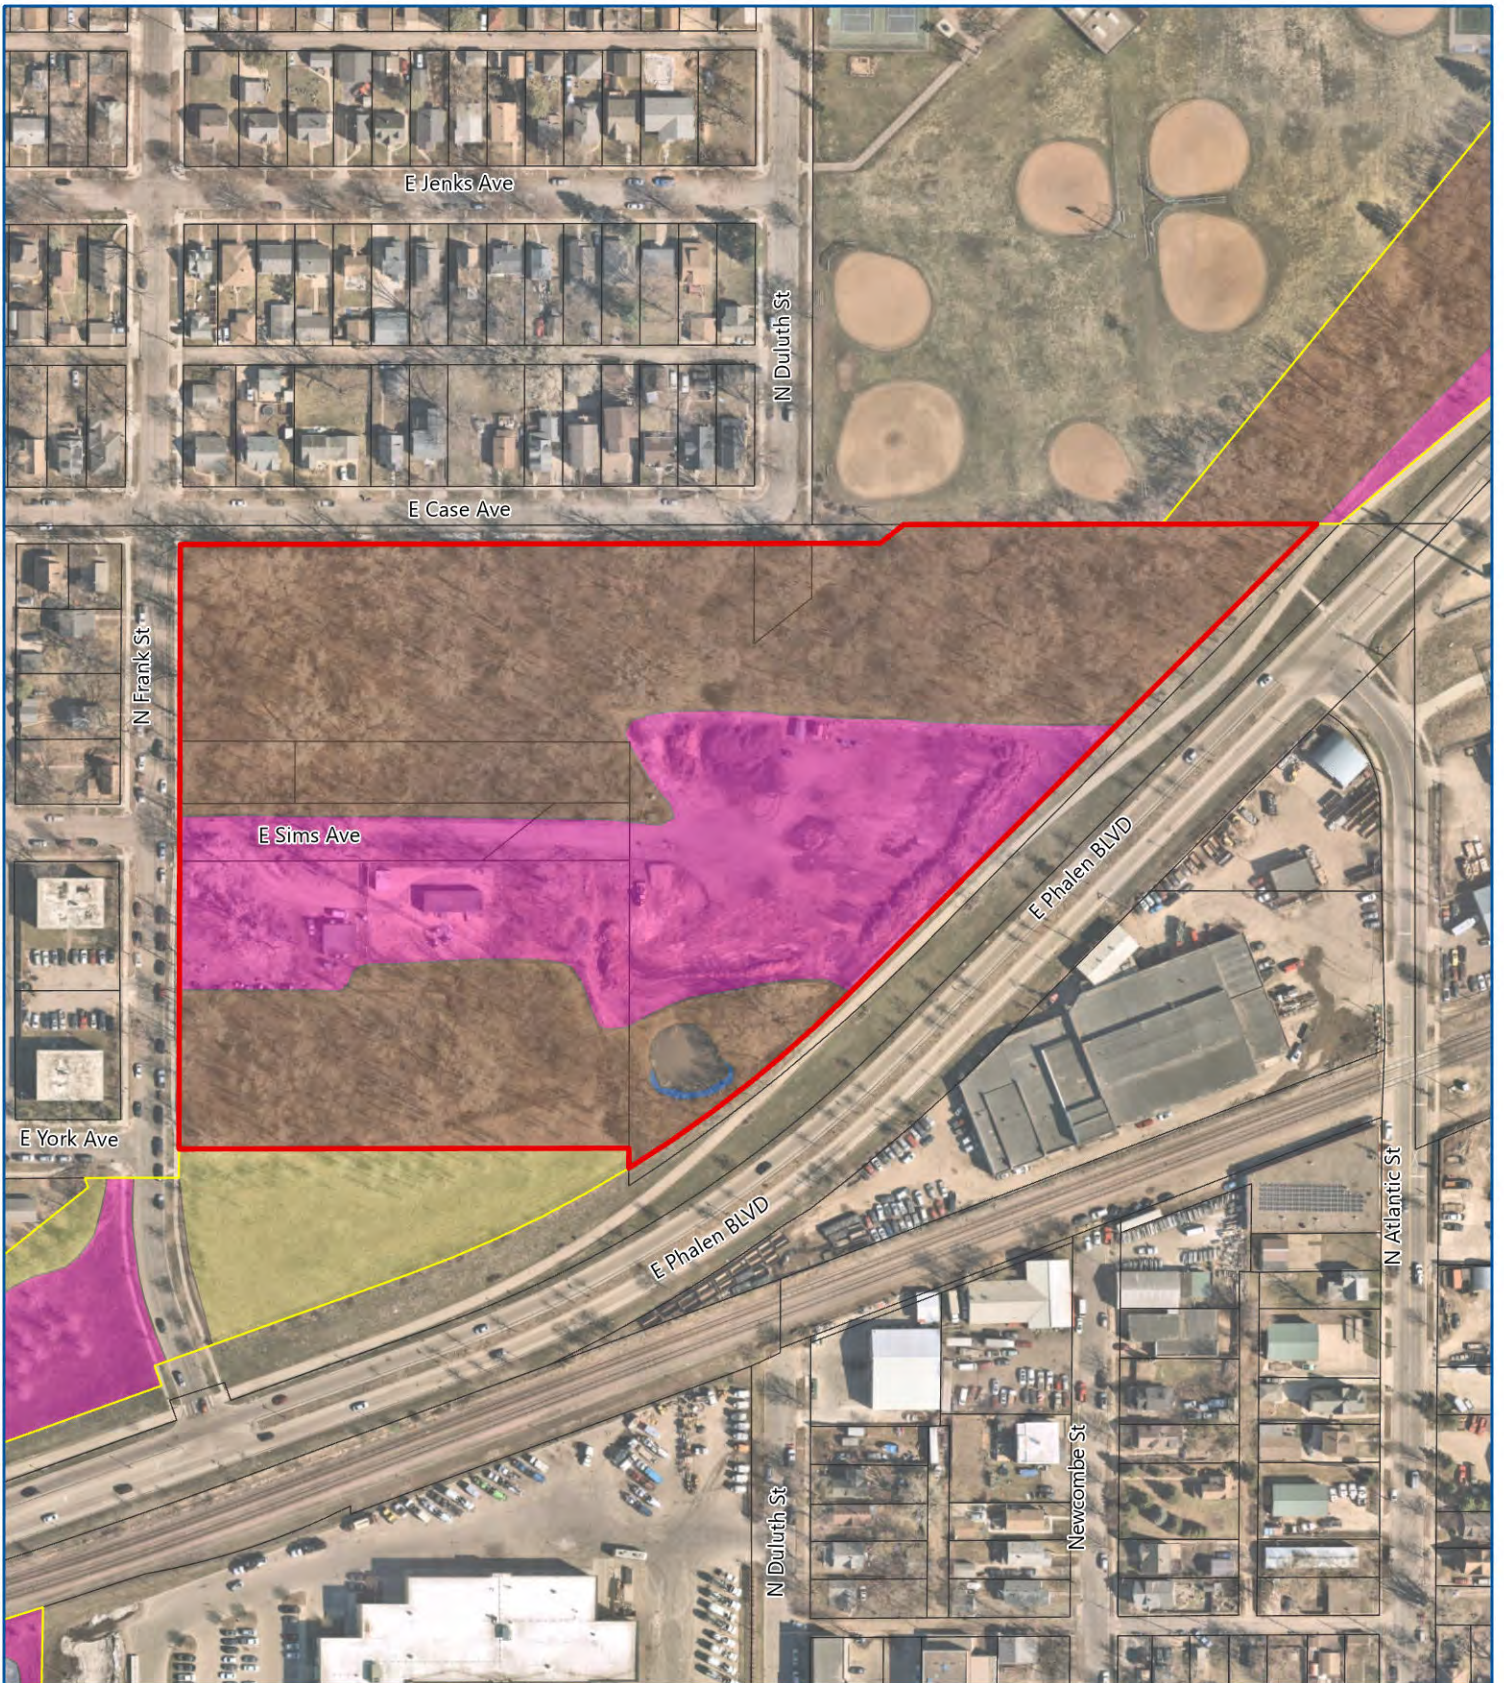
TARGET PLANT COMMUNITY

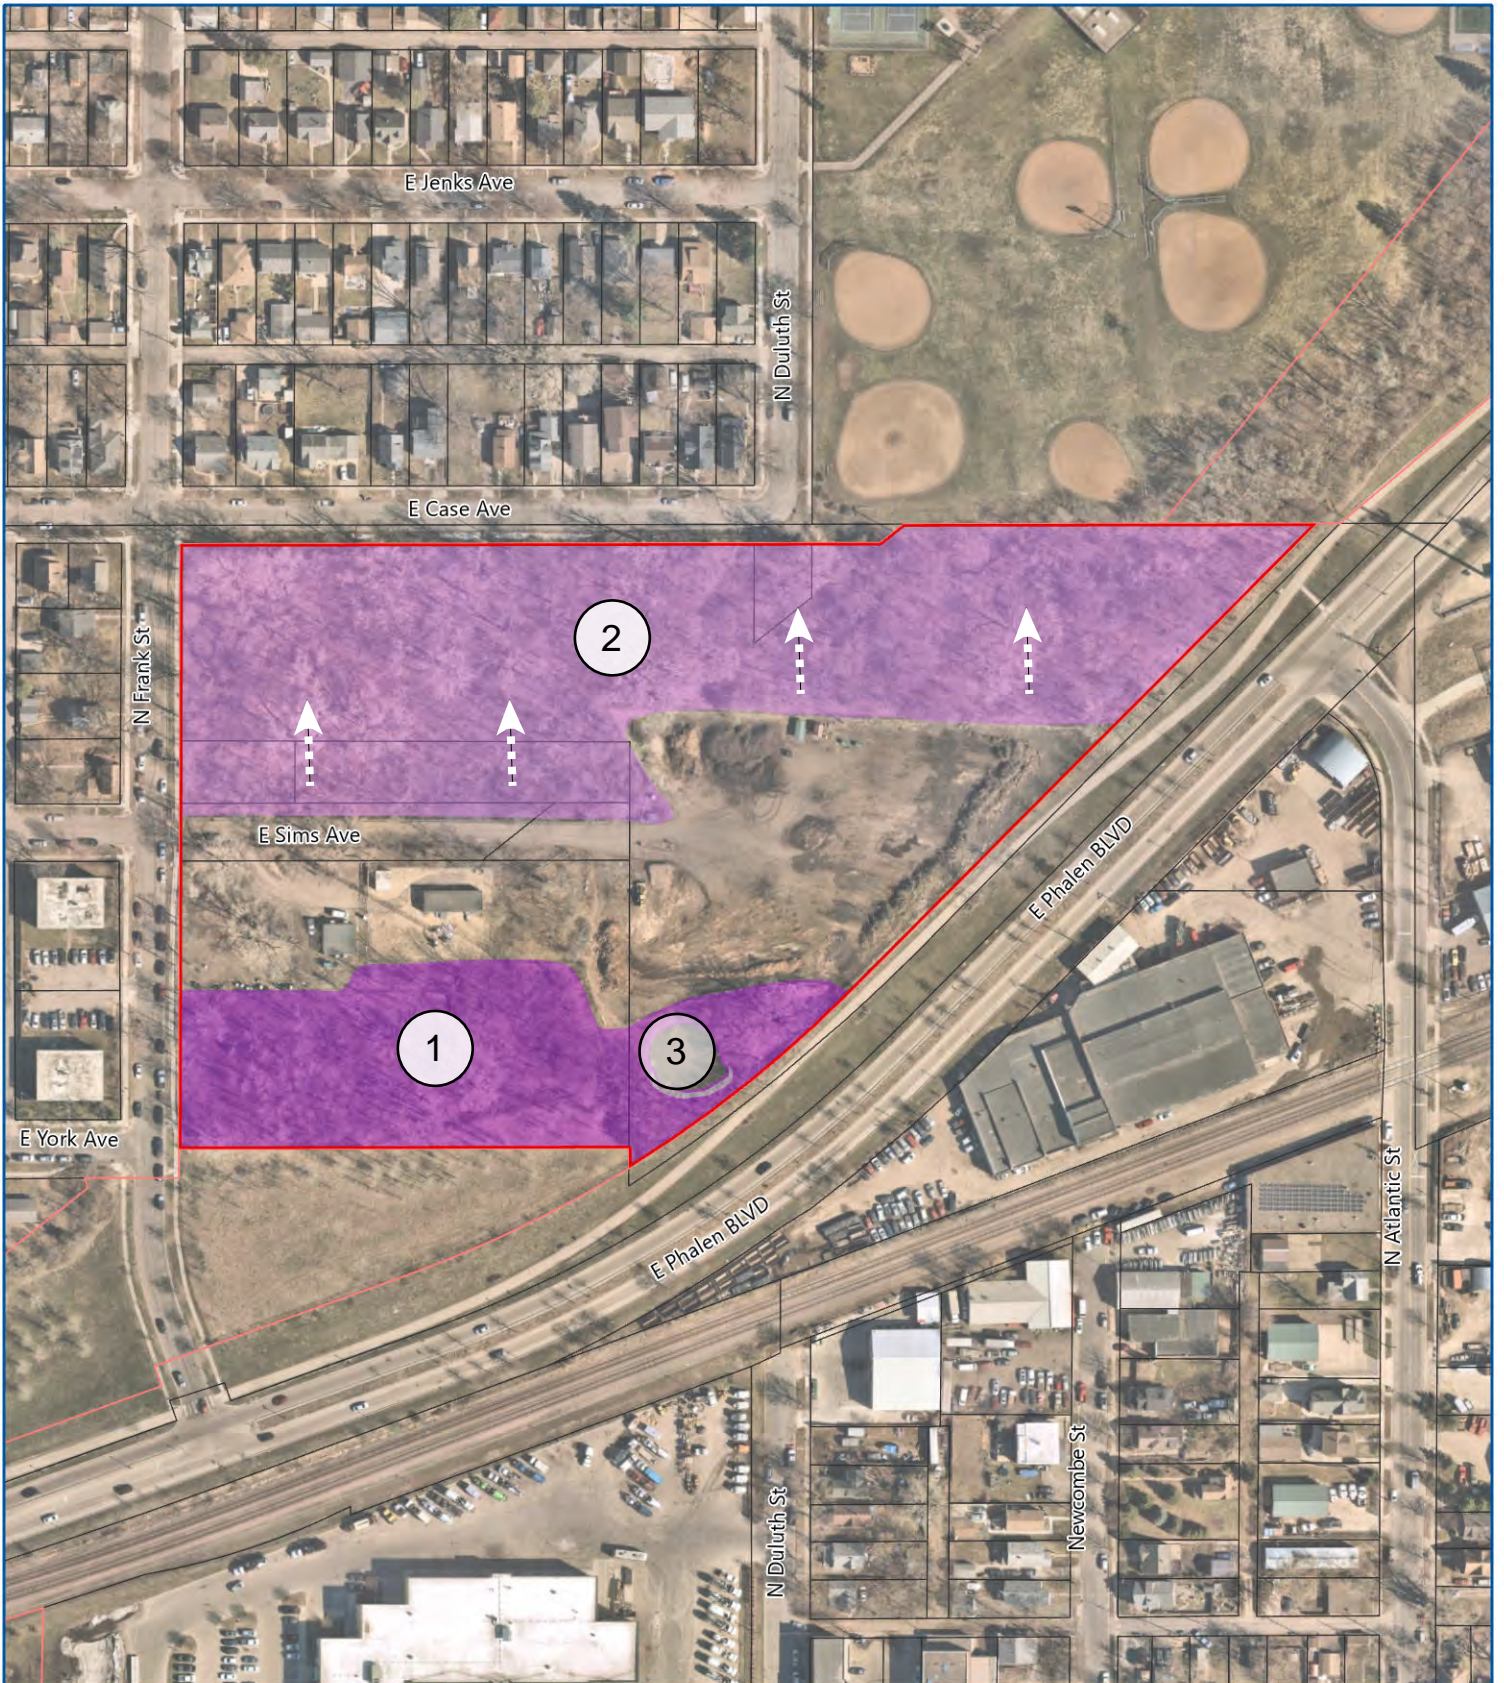
SITE - 16

Restoration Priority Note: Phasing and prioritizing restoration efforts based on existing plant community, ecological quality, habitat size, and adjacencies to areas of high ecological quality. These strategies are for planning prioritization purposes. Detailed restoration and maintenance plans should be developed for each site.

Frank and Sims Yard Waste
Collection Site
**RESTORATION PRIORITY
AND PHASING**
Natural Resources Inventory
Capitol Region
Watershed District

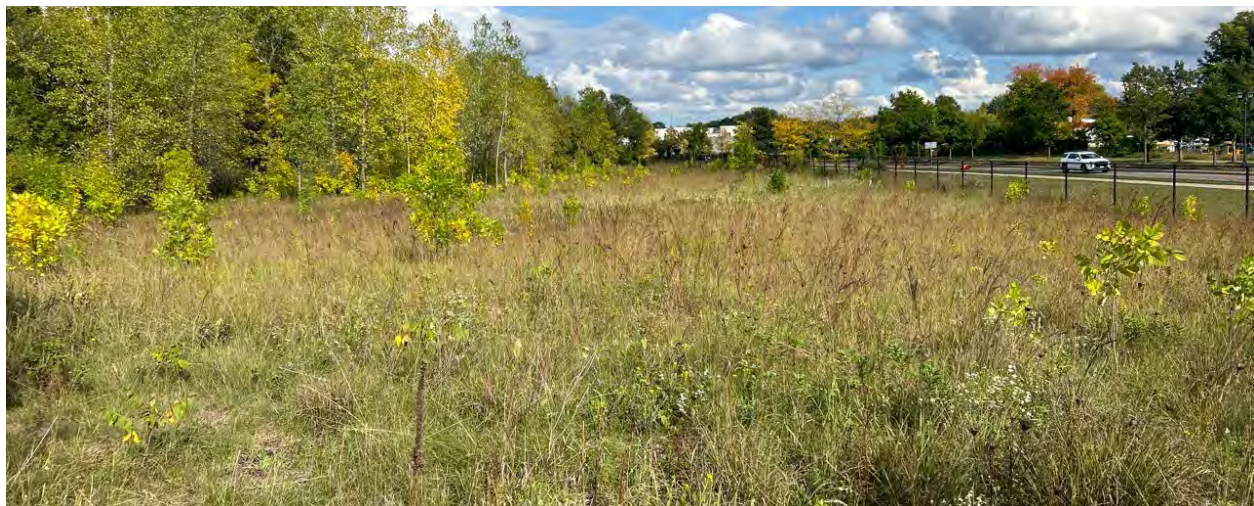
Condition Summary: Site 17 is a grassland parcel divided east-west by North Frank Street. The site is bounded by Phalen Boulevard to the south, Earl Street to the west, and by apartments and a telecom company to the north. The Bruce Vento Regional Trail, a major cycling corridor, travels through the southern edge of this site as it makes its way north toward The Gateway Trail. The western half of this parcel is a degraded, mowed turf lawn containing a dozen mature Aspen trees. The northern edge of this half is bordered by a degraded woodland of black walnut and boxelder. The eastern half of the site is a newly established prairie site and is dominated by big blue stem (*Andropogon gerardi*), heath aster (*Symphyotrichum ericoides*), and Canada goldenrod. Volunteer green ash saplings also dot the landscape. As this prairie transitions into the woodland to the north, species such as black walnut and green ash increase in size and density. The northern edge of the site is bordered by mature cottonwood and black walnut trees.

- Ecological connections to other regional parks (create habitat corridor)
- Collaborate with adjacent landowners to restore a narrow woodland that abuts the fence line
- Explore opportunity for SSGI improvements connected to the Metro Purple Line BRT project (runs adjacent to site)
- Identify opportunities to utilize large expanses of lawn areas for green infrastructure practices (stormwater quality/quantity control) and/or for oak savanna restoration
- Consider opportunities to participate in planning efforts to daylight stretches of historic Phalen Creek

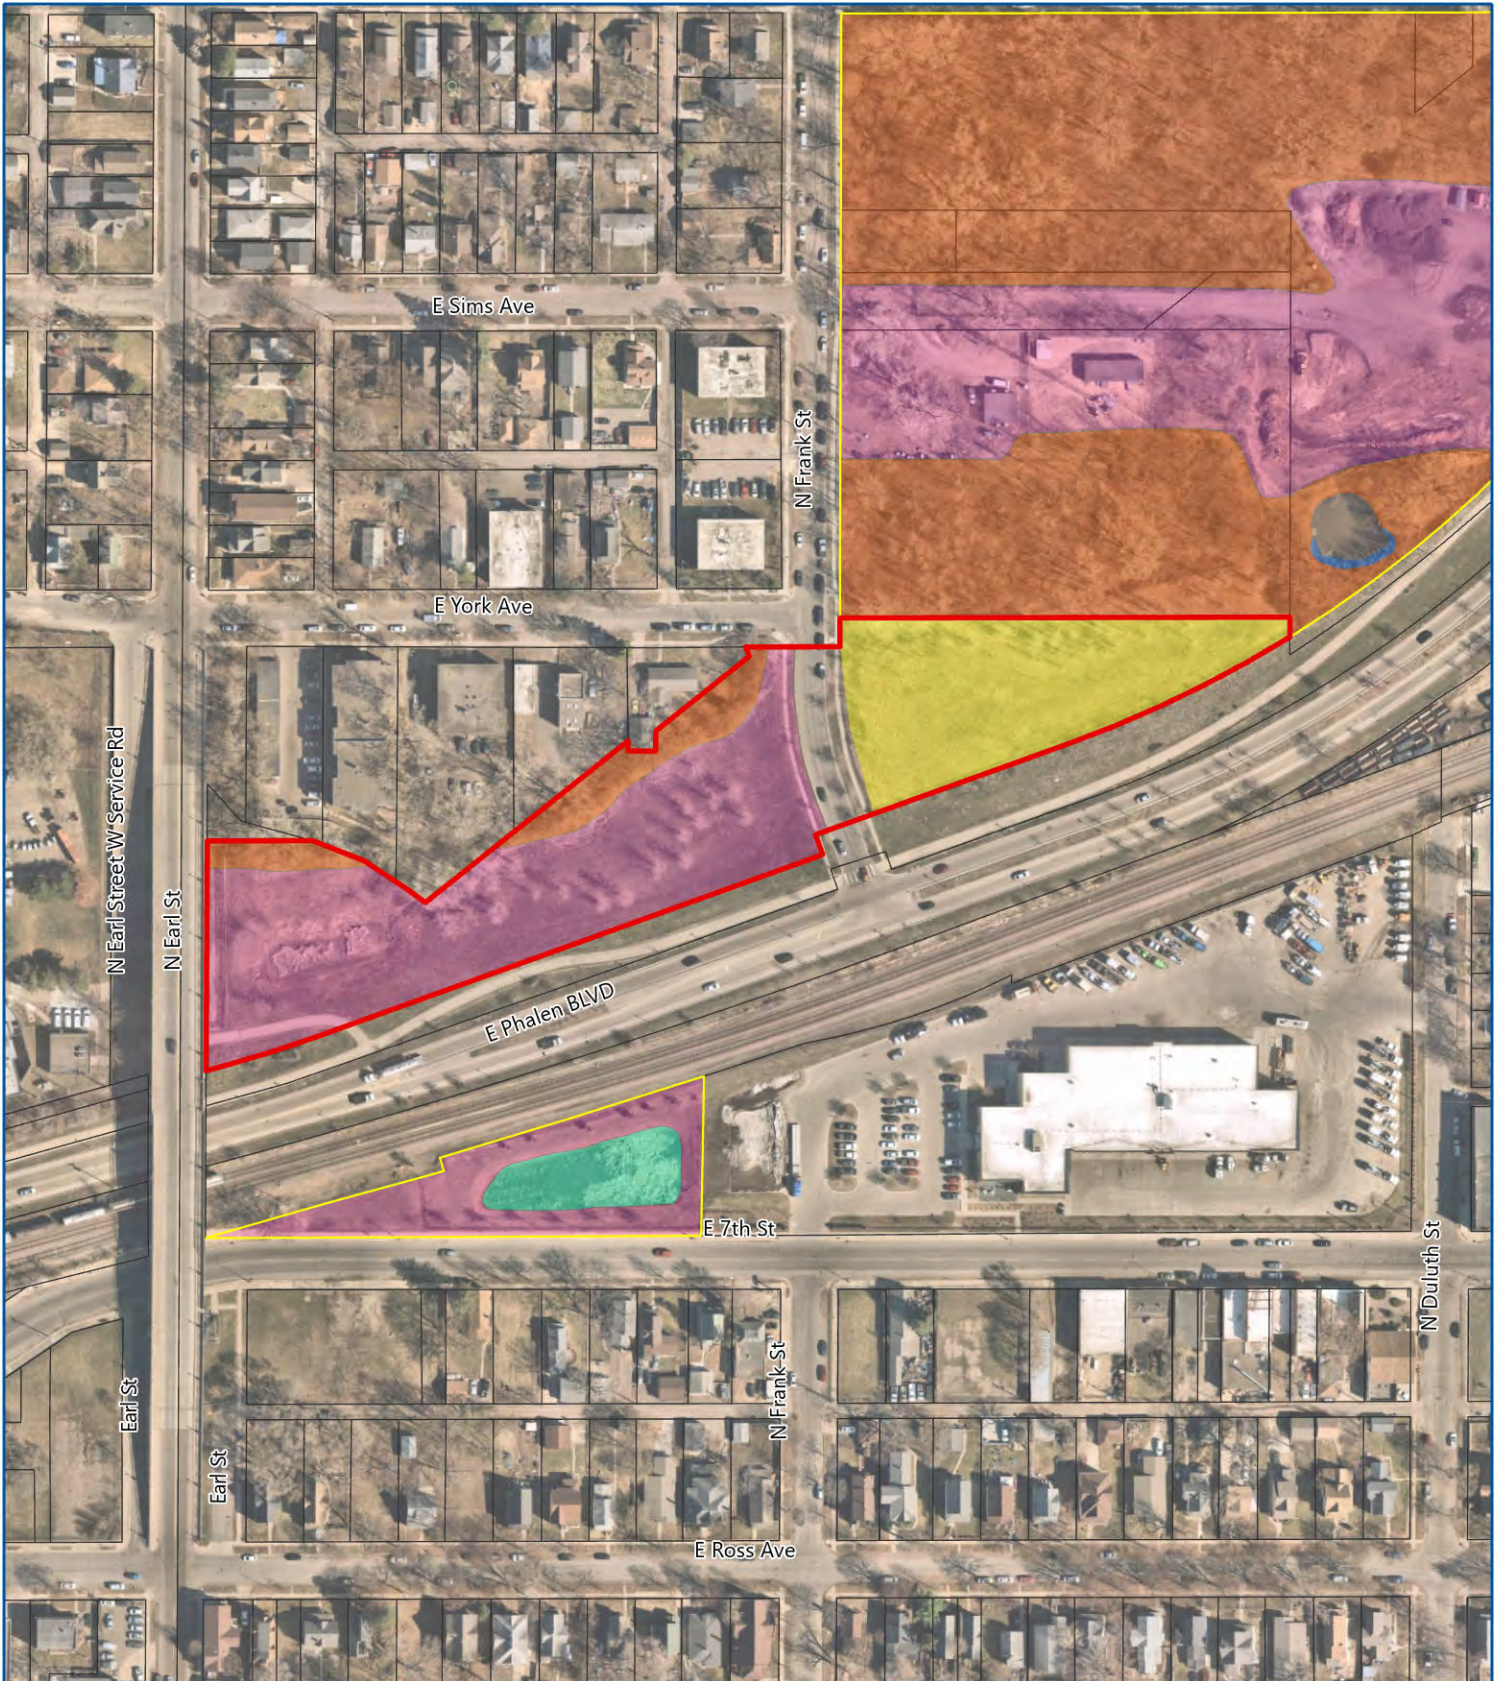
EXISTING LAND COVER
Natural Resources Inventory
Capitol Region
Watershed District

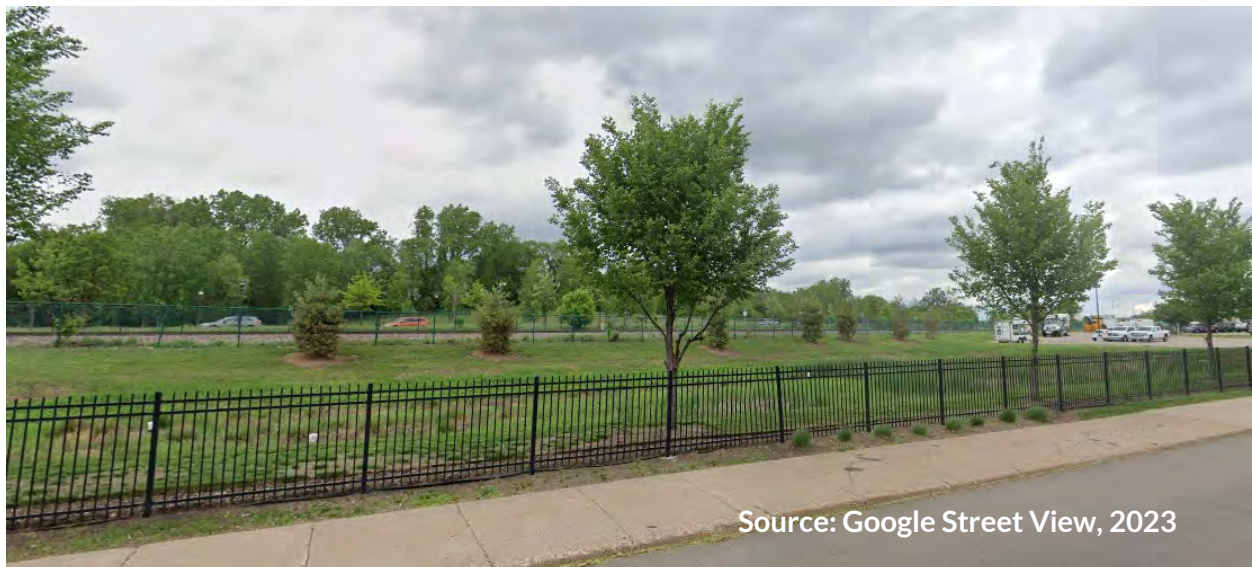
Source: Google Street View, 2023

Condition Summary: Site 18 contains a 0.3-acre stormwater pond bounded by 7th Street East to the south, a railroad to the north and west, and the MacQueen Equipment complex to the east. The site is surrounded by a fence. The stormwater basin is a dense monoculture of non-native cattails. Some evidence of an original native planting remains but the site has been almost entirely overgrown with non-native species.

- Partner with/incentivize landowner to convert unused/unnecessary mowed turf areas with native grasses, forbs, and/or tree species to combat biodiversity loss and urban heat island effect to convert turf areas with native grasses, forbs, and/or tree species
- Focus efforts to control the most aggressive invasive species as they emerge to prevent their spread to adjacent natural areas (e.g., purple loosestrife, and thistle)

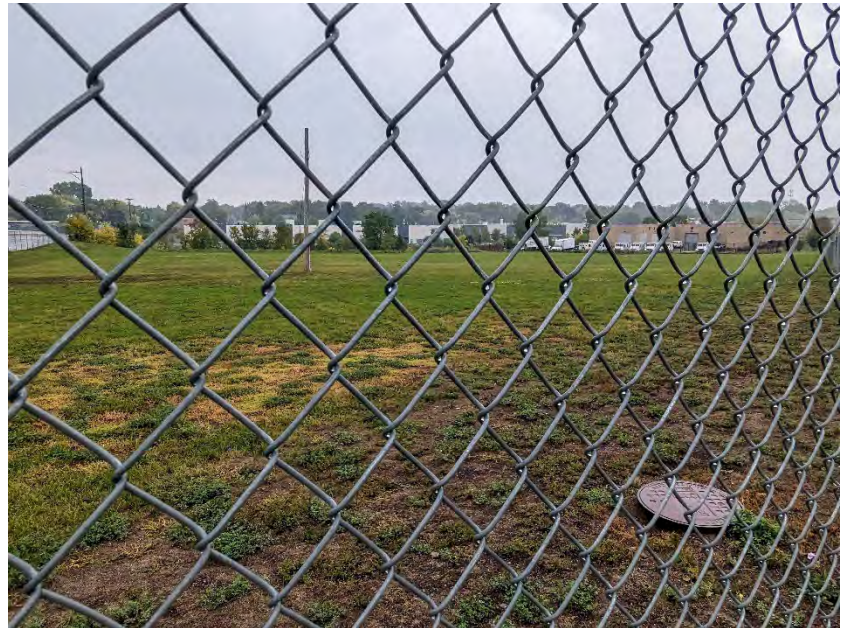
Condition Summary: Located at the intersection of 7th Street East and Forest Street North, Sites 19, 20, and 21 are all undeveloped Port Authority of Saint Paul owned properties. Site 19 contains a 2.8-acre lawn that slopes north towards a 60-foot-wide strip of tallgrass that buffers a railroad corridor. The tallgrass field is dominated by Canada goldenrod and contained common invasive species such as smooth brome grass, leafy spurge, and Canada thistle. Cottonwood saplings have established along the north edge of the site and are scattered throughout the tallgrass field.

Phalen Creek historically ran through this site before it was diverted into underground storm sewer.

- Promote native tree species diversity
- Improved habitat could serve as an ecological corridor connecting multiple nearby patches of habitat along railroad (Site 22 and potentially Sites 20 and 21)
- Partner with/incentivize landowner to convert unused/unnecessary mowed turf areas with native grasses, forbs, and/or tree species to combat biodiversity loss and urban heat island effect Identify opportunities to utilize lawn for green infrastructure practices (stormwater quality/quantity control)
- Location of historic Phalen Creek – review soils to see if portions of the historic wetland plant community could be restored

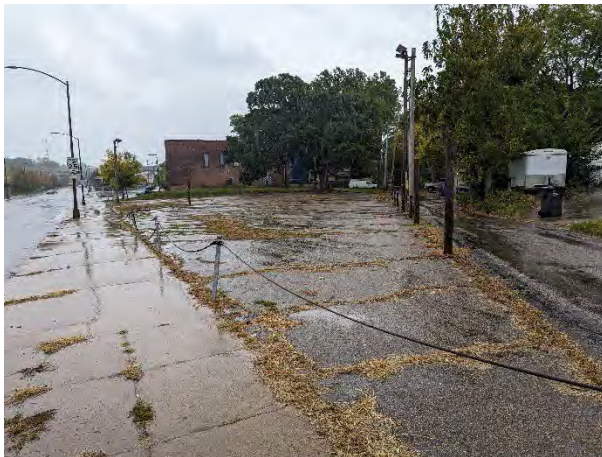
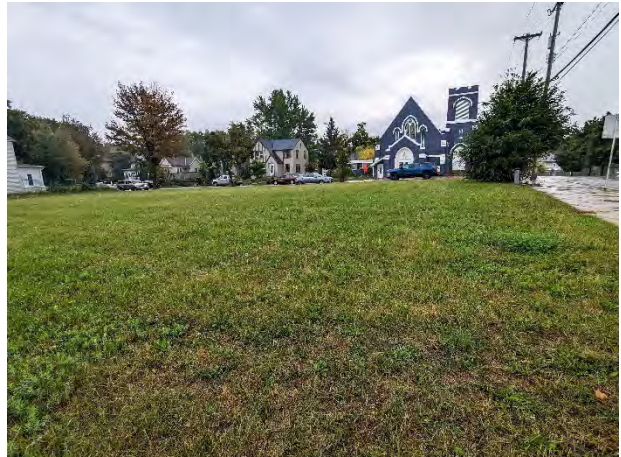
Condition Summary: Site 20 contains a 0.5-acre maintained lawn and a 0.4-acre paved parking lot that appears unused and is in poor condition. The lawn areas contain large patches of bird's-foot trefoil (*Lotus corniculatus*) and yellow toadflax (*Linaria vulgaris*); both species are considered invasive and can become problematic in natural areas.

- Improved habitat could potentially serve as an ecological corridor connecting multiple nearby patches of habitat along the railroad (Site 22 and potentially Sites 19 and 21)
- Identify opportunities to utilize lawn or the vacant parking lot for green infrastructure practices (stormwater quality/quantity control)
- Partner with/incentivize landowner to convert unused/unnecessary mowed turf areas with native grasses, forbs, and/or tree species to combat biodiversity loss and urban heat island effect Explore opportunity for partnering with neighboring church to maintain native plantings

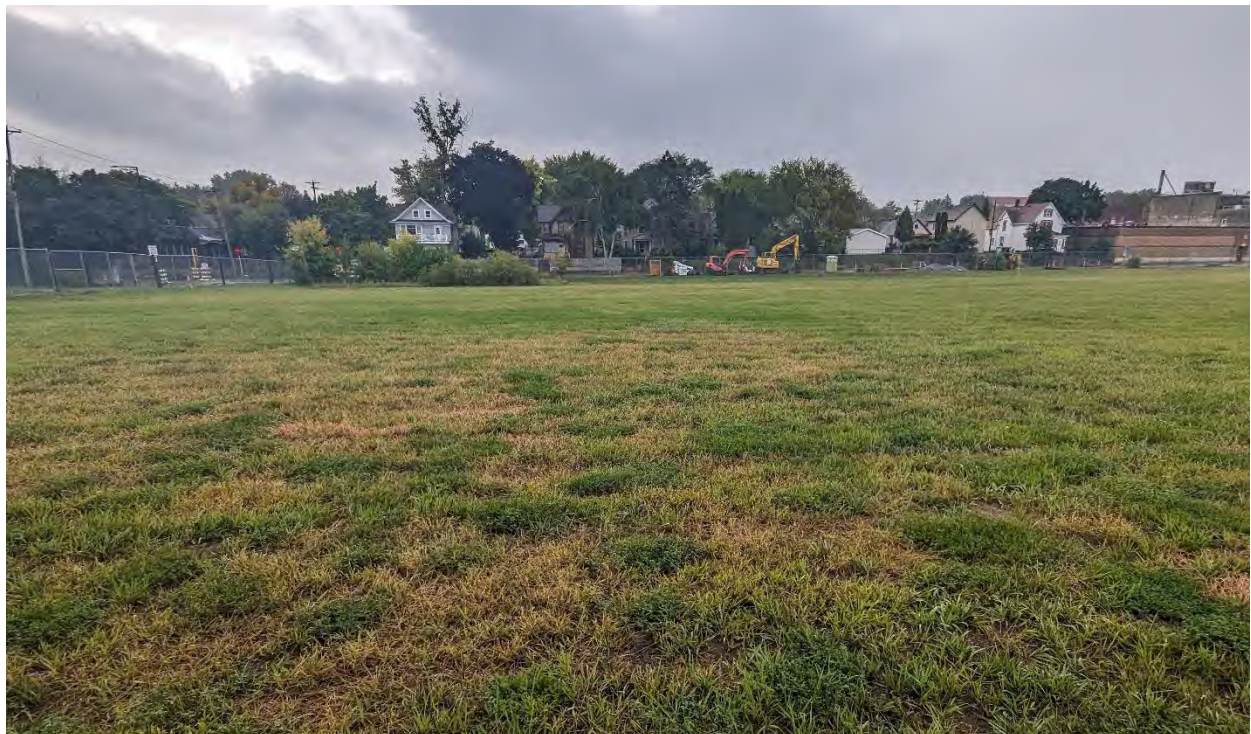
Condition Summary: Site 21 is another undeveloped Port Authority of Saint Paul parcel just west of Site 20. The 2.2-acre site is almost entirely maintained as lawn. The site is currently inaccessible due to a fence that encircles the site. The site slopes/drains towards the southeast corner where a 200-square-foot depression containing cattails is located. Boulevard trees were once mature ash but were recently removed due to the effects of the EAB.

- Improved habitat could potentially serve as an ecological corridor connecting multiple nearby patches of habitat along the railroad (Site 22 and potentially Sites 19 and 20)
- Identify opportunities to utilize lawn for green infrastructure practices (stormwater quality/quantity control)
- Partner with/incentivize landowner to convert unused/unnecessary mowed turf areas with native grasses, forbs, and/or tree species to combat biodiversity loss and urban heat island effect

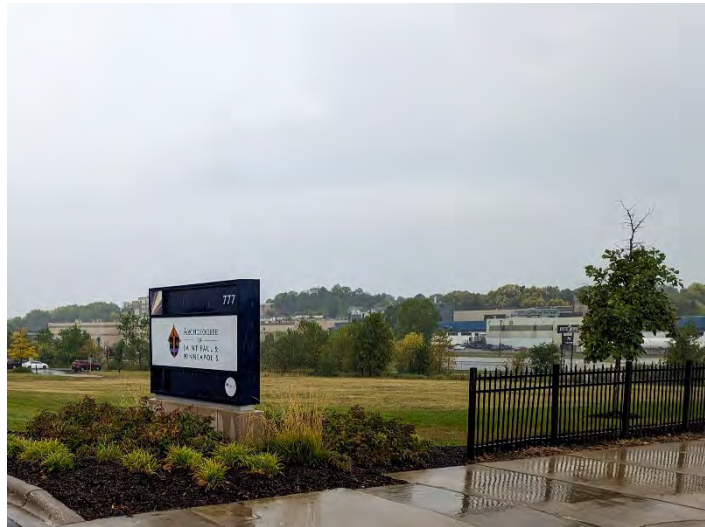
Condition Summary: Site 22 is a 5.6-acre campus owned by The Archdiocese of Saint Paul and Minneapolis. An 80-foot-wide tallgrass field extends along a rail corridor to the north. The tallgrass field is dominated by invasive species such as smooth brome grass, knapweed, sweet clover (*Melilotus officinalis*), and burdock. Common native species such as ragweed, Canada goldenrod, and riverbank grape were also present. Cottonwood, boxelder and Siberian elm trees are established throughout the field and will likely take over without future management.

A 1.2-acre lawn on the east side of the site appears to be frequently used as overflow parking for events.

- Improved habitat could potentially serve as an ecological corridor connecting multiple nearby patches of habitat along the railroad (potentially Sites 19, 20 and 21)
- Partner with/incentivize landowner to convert unused/unnecessary mowed turf areas with native grasses, forbs, and/or tree species to combat biodiversity loss and urban heat island effect Identify opportunities to utilize lawn for green infrastructure practices (stormwater quality/quantity control)
- location of historic Phalen Creek – review soils to see if portions of the historic wetland plant community could be restored

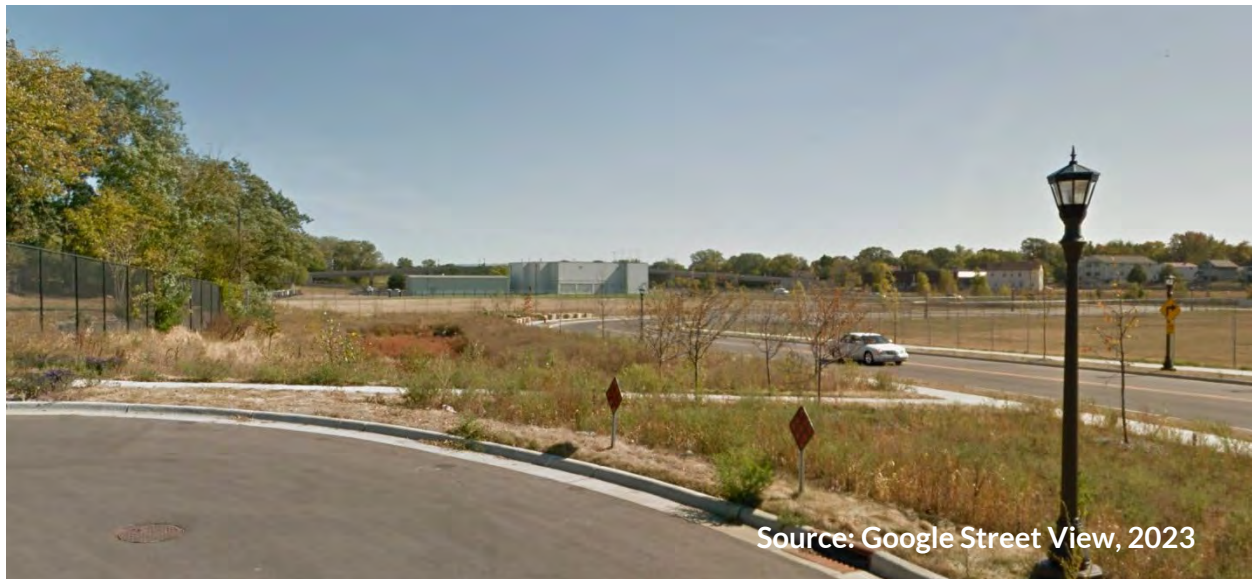
Condition Summary: Site 23 contains two stormwater infiltration basins as well as underground BMPs that treat stormwater runoff from the surrounding drainage area. The lower portion of the infiltration basins are mostly bare soil but also contain stands of narrow-leaved cattail. Small patches of bristly sedge (*Carex comosa*) were likely planted as part of the initial restoration following the creation of the BMP. Few other native wetland species are present.

- Continue to maintain and protect site's ecological quality
- High visibility and previous management efforts could be used to help leverage support for additional management efforts
- Increase vegetation diversity for pollinator and bird species (recommend basin plug plantings)
- Focus efforts to control the most aggressive invasive species as they emerge to prevent spread to adjacent natural areas (e.g., smooth brome and thistle)

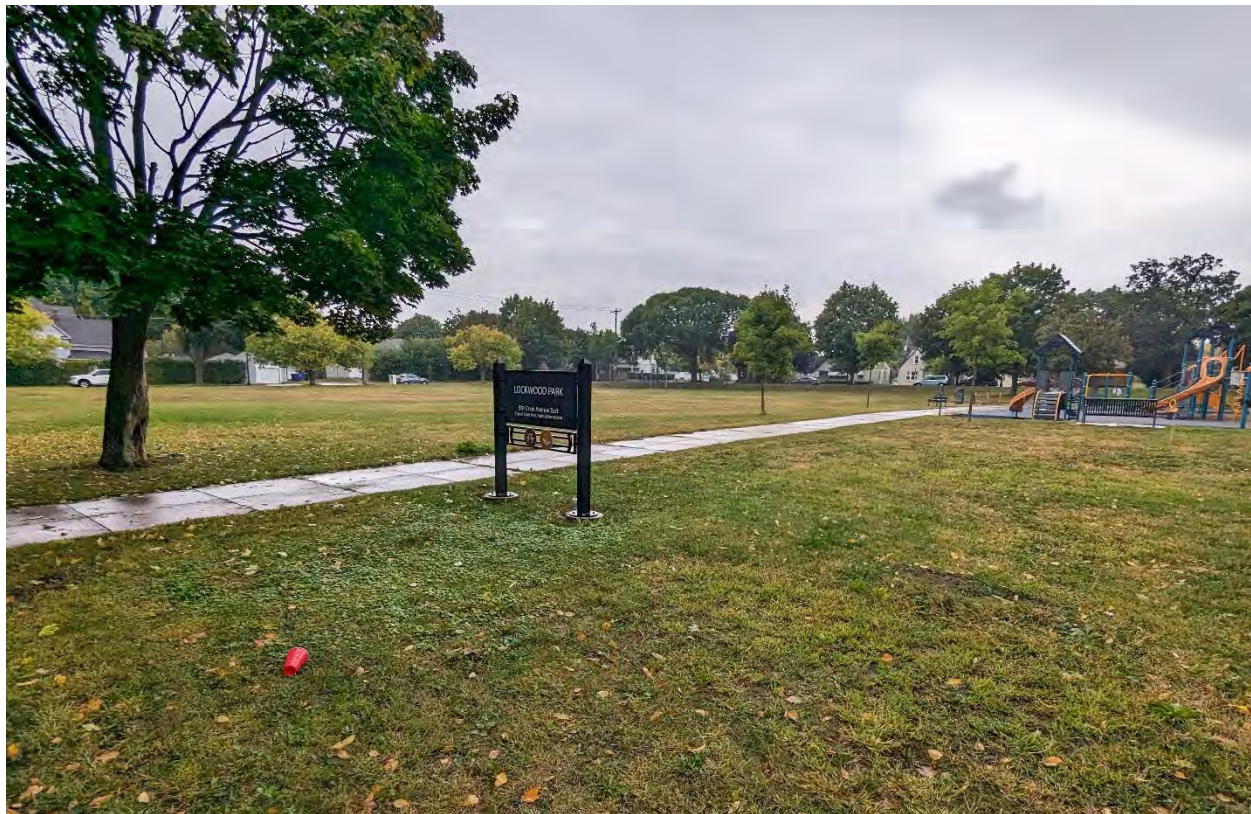
Condition Summary: Lockwood Park contains open lawn, baseball fields, picnic tables, and a playground area. A majority of the site (1.4 acres) is an unirrigated lawn consisting mostly of crab and quack grass with annual weed species mixed throughout. Mature canopy trees located along the street and adjacent to the playground appeared in good health. Tree species include red maple (*Acer rubrum*), Norway maple (*Acer platanoides*), little leaf linden (*Tilia cordata*), crabapple and American elm.

- Identify opportunities to utilize lawn for native plantings and green infrastructure practices (stormwater quality/quantity control)

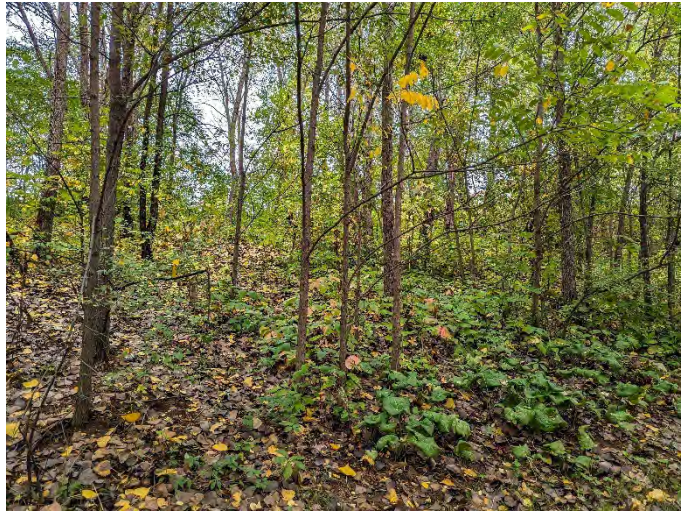
The Bruce Vento Regional Trail is a 7-mile paved multi-use trail that occupies an abandoned rail corridor. It connects Bruce Vento Nature Sanctuary, Swede Hollow Park, Eastside Heritage Park, and extends northward along the east side of Lake Phalen. Within Site 25, the regional trail is located at the bottom of a ravine along the north edge of Eastside Heritage Park. The adjacent ravine slopes are composed primarily of Siberian elm, green ash, boxelder, and cottonwood trees. The shrub layer is comprised primarily of dense thickets of buckthorn, staghorn sumac, and ash saplings. The composition of the herbaceous ground layer is characteristic of a highly disturbed plant community. It is composed of woodbine, white snakeroot, creeping Charlie, burdock, riverbank grape, catnip (*Nepeta cataria*), Canada goldenrod, and smooth brome grass. Non-native plant species dominate at all levels of the forest structure.

Eastside Heritage Park contains a 2-acre open lawn surrounded by mesic grassland plantings, a picnic shelter, a restroom facility, a small parking lot, and raingardens. The raingarden and mesic grassland areas appear to have once been planted with native prairie species but have since been invaded by non-native species. Native species within the mesic grassland areas comprise < 10% of the overall vegetative cover and include such species as cinquefoil (*Potentilla* spp.), heath aster, lead plant (*Amorpha canescens*), sideoats grama (*Bouteloua curtipendula*), upland sedges (*Carex* spp.), Canada goldenrod, wild bergamot, common ragweed, and yarrow (*Achillea millefolium*). Smooth brome grass and crown vetch are the dominant species within the grassland areas. Siberian elm, hackberry, and green ash saplings are establishing throughout the open areas and will likely take over in 5 years.

- Collaborate with YMCA to develop educational or interpretive opportunities about the importance of pollinator plantings
- Convert degraded grasslands into a more diverse savanna plant community for pollinator and bird species

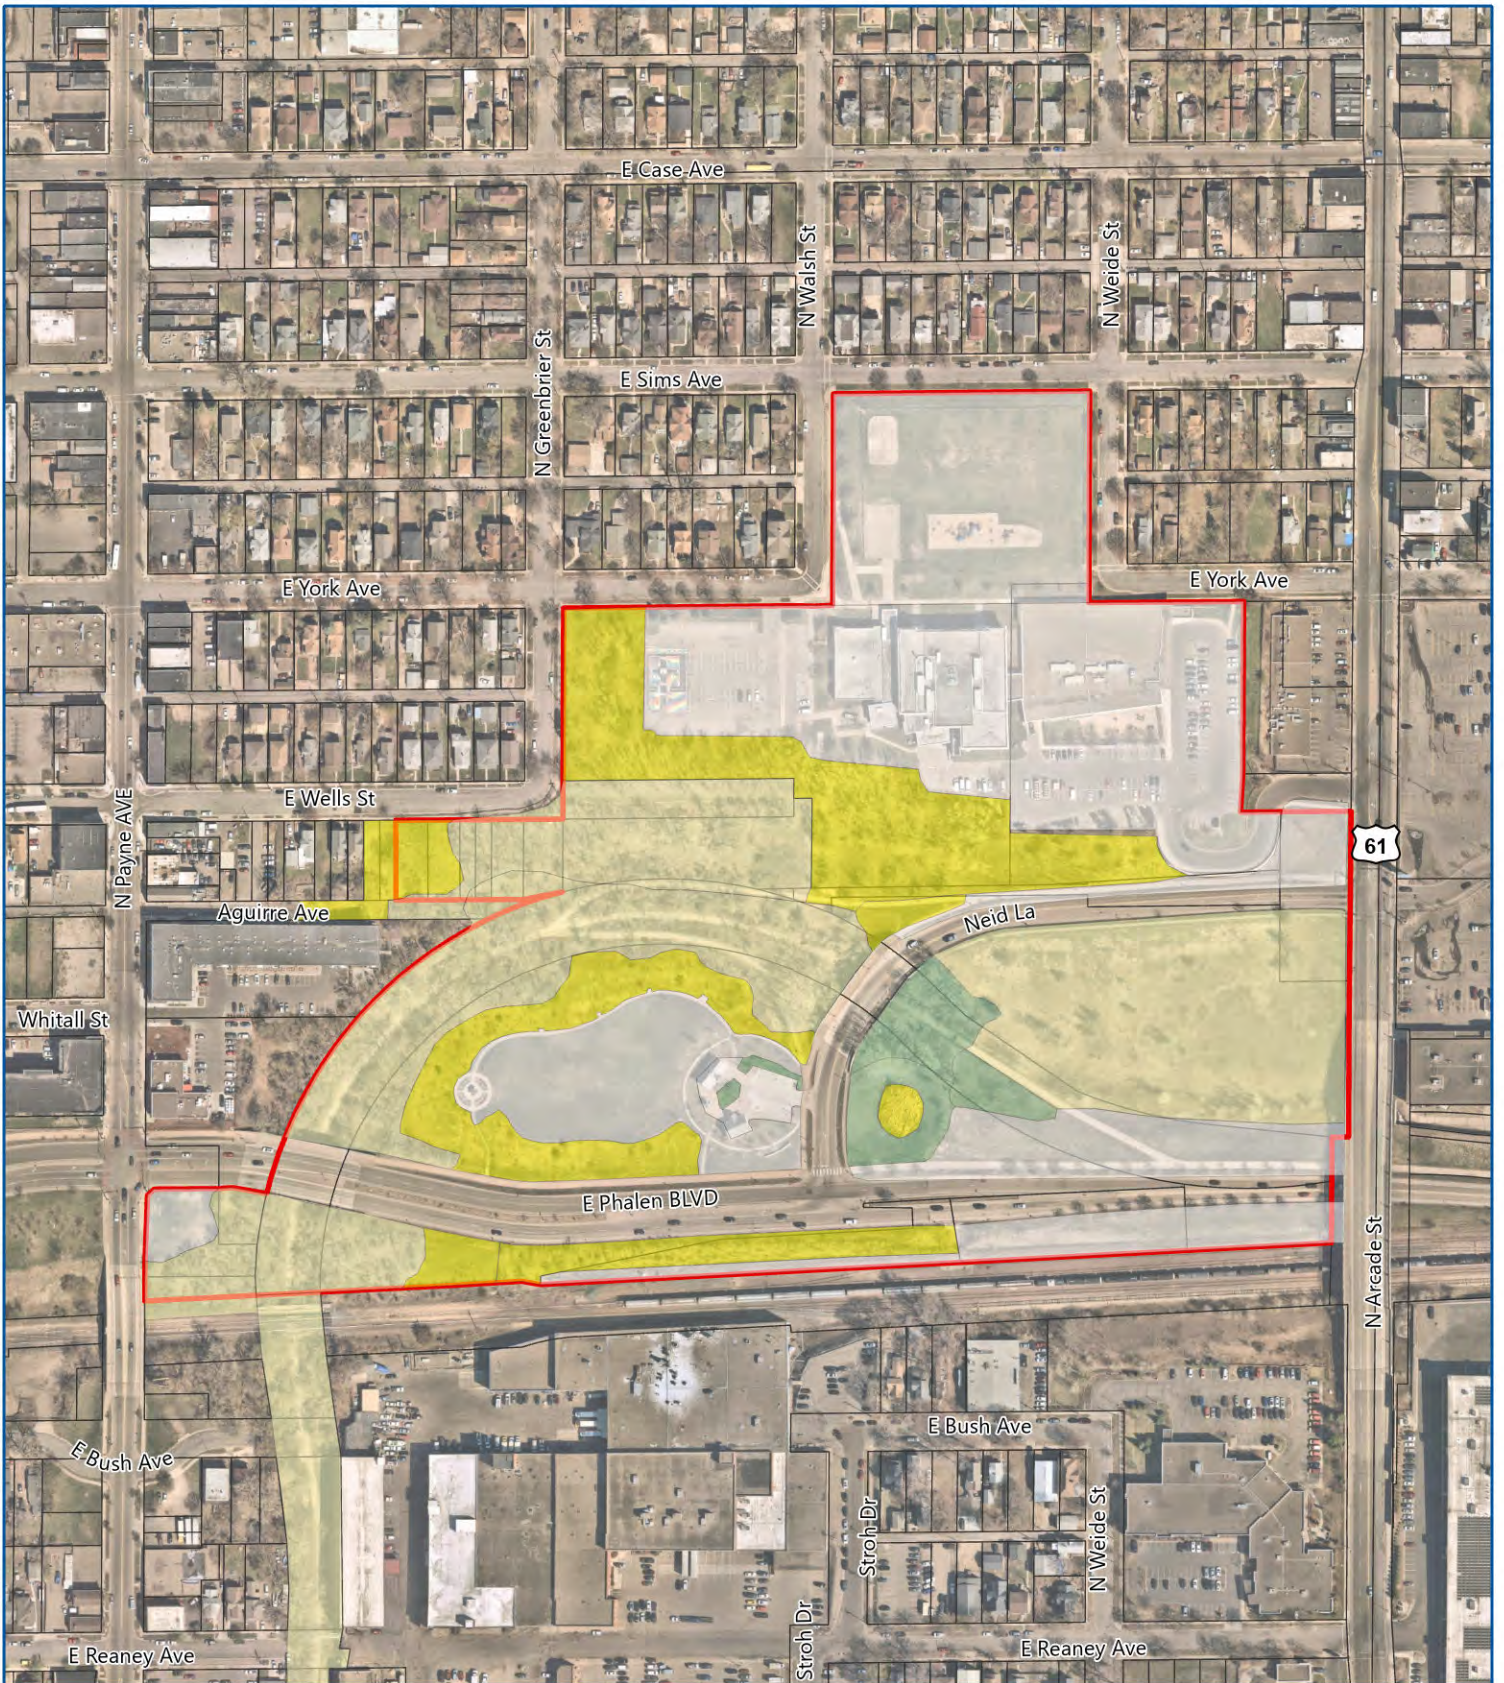
SITE - 25

Eastside Heritage Park (& adjacent
Bruce Vento Regional Trail)

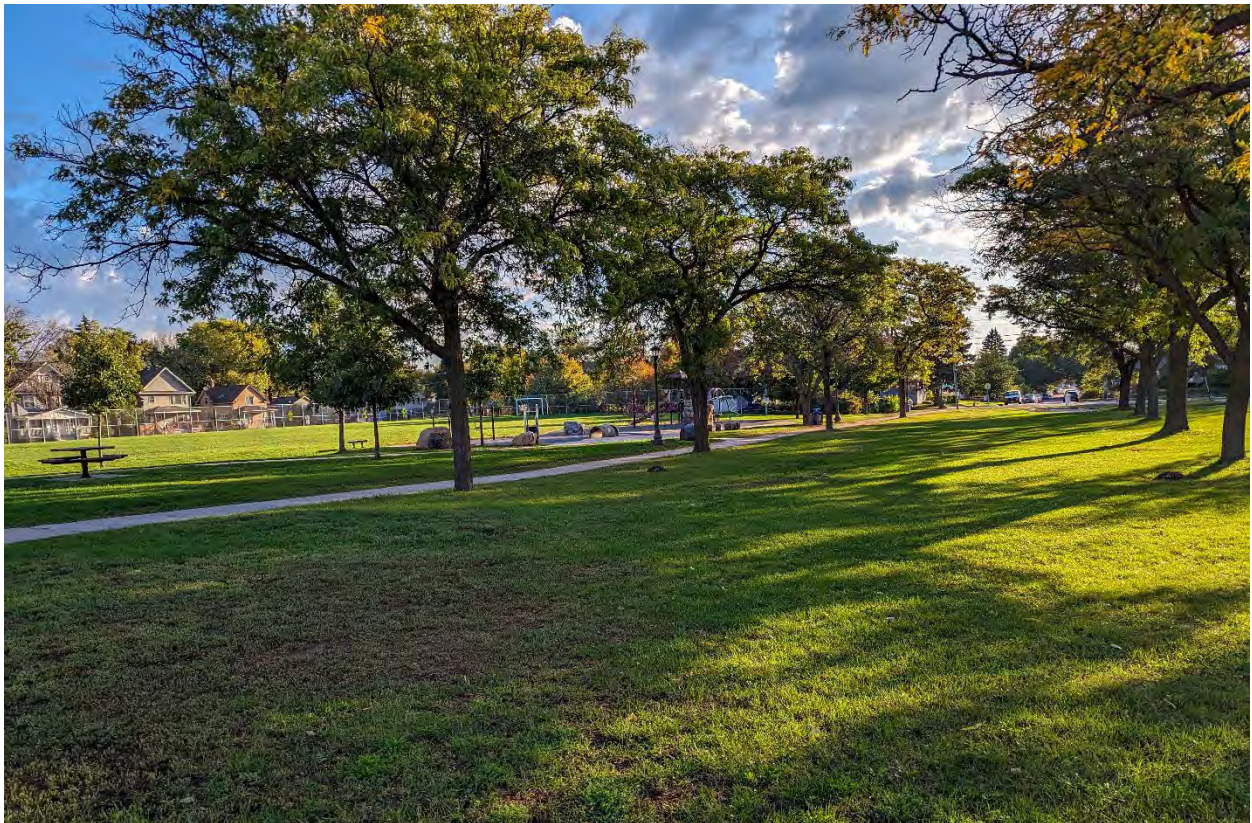
Condition Summary: The Arlington Hills Library and adjacent surface parking lot are located on the west half of Site 26. A diverse mix of well-maintained native prairie plantings surround the library foundation. Directly east of the library building is a 2-acre athletic field and playground area. A small raingarden dominated by a dense massing of red-twigged dogwoods treats stormwater runoff from the playground area.

A pedestrian walkway, open lawn, and a row of mature honey locust trees are located in what was historically Rose Avenue. Sand volleyball courts are located along the south edge of the site and are currently in poor condition (appear unused).

- Identify opportunities to utilize large expanses of lawn areas for green infrastructure practices (stormwater quality/quantity control) and/or for oak savanna restoration (unused volleyball courts and within historic roadway)
- On-site educational partnership opportunities with the Saint Paul Public Library to promote the importance of stormwater management and pollinator plantings
- Expand the existing native demonstration plantings around building

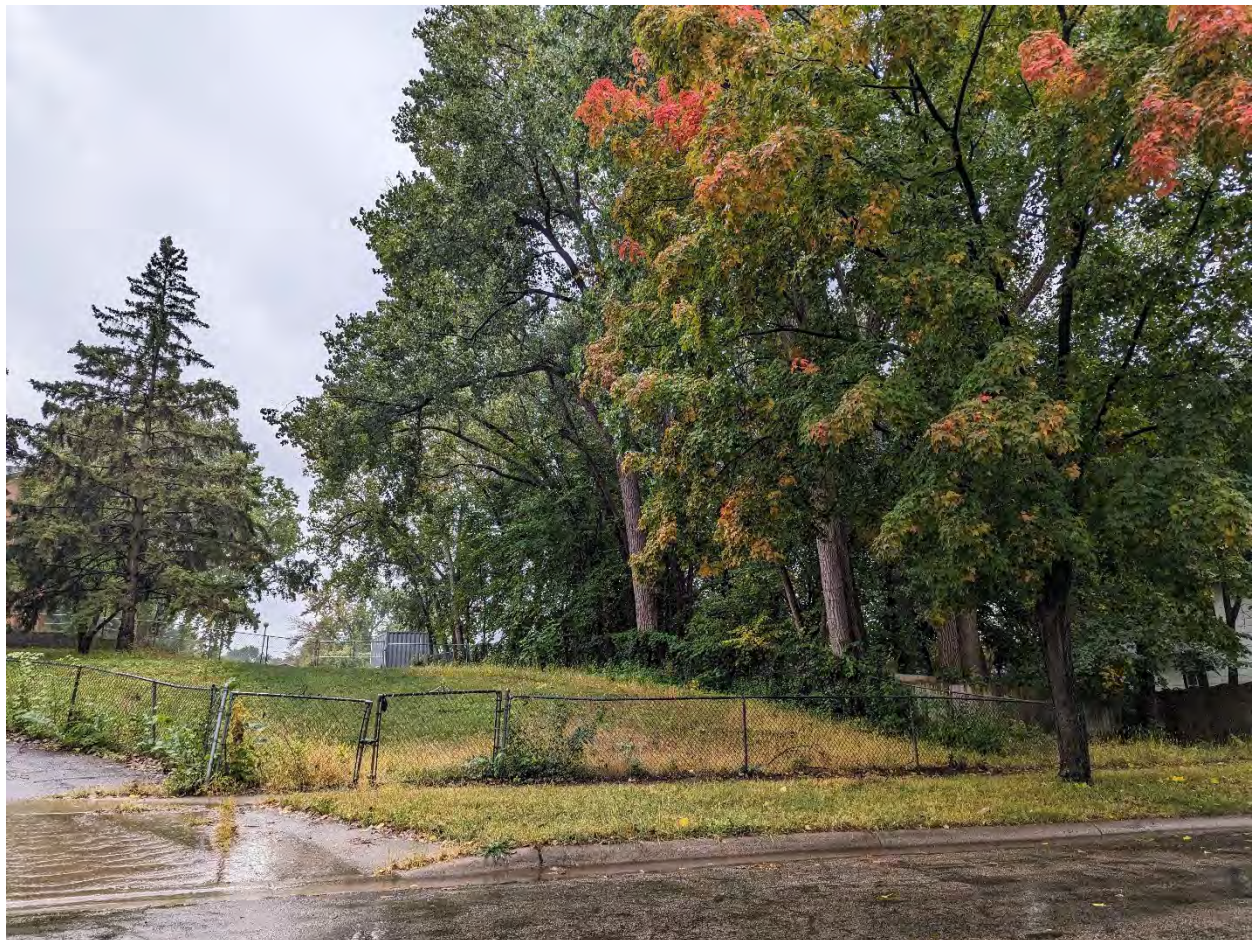
Condition Summary: St Patrick’s of Saint Paul is a tax-exempt parcel consisting of a church, church offices, surface parking lots, and a 0.25-acre forest located on the northwest edge of the property. The forest is surrounded by a fence and was inaccessible. The forest canopy is entirely made up of large mature cottonwood species that appear in good health. The shrub layer is typical of a degraded woodland and is composed of buckthorn, riverbank grape, common burdock, black raspberry, and motherwort. A patch of Japanese knotweed, an aggressive non-native Minnesota Specially Regulated Plant species, was observed on the north edge of the woodland.

- Explore opportunity for partnering with church to create and maintain native plantings
- Manage large cottonwood canopy trees - remove ash, boxelder, Siberian elm, and black walnuts and promote native understory growth.
- Control noxious weed species
