SITE - 16

Frank and Sims Yard Waste
Collection Site

Natural Resources Inventory
Capitol Region
Watershed District

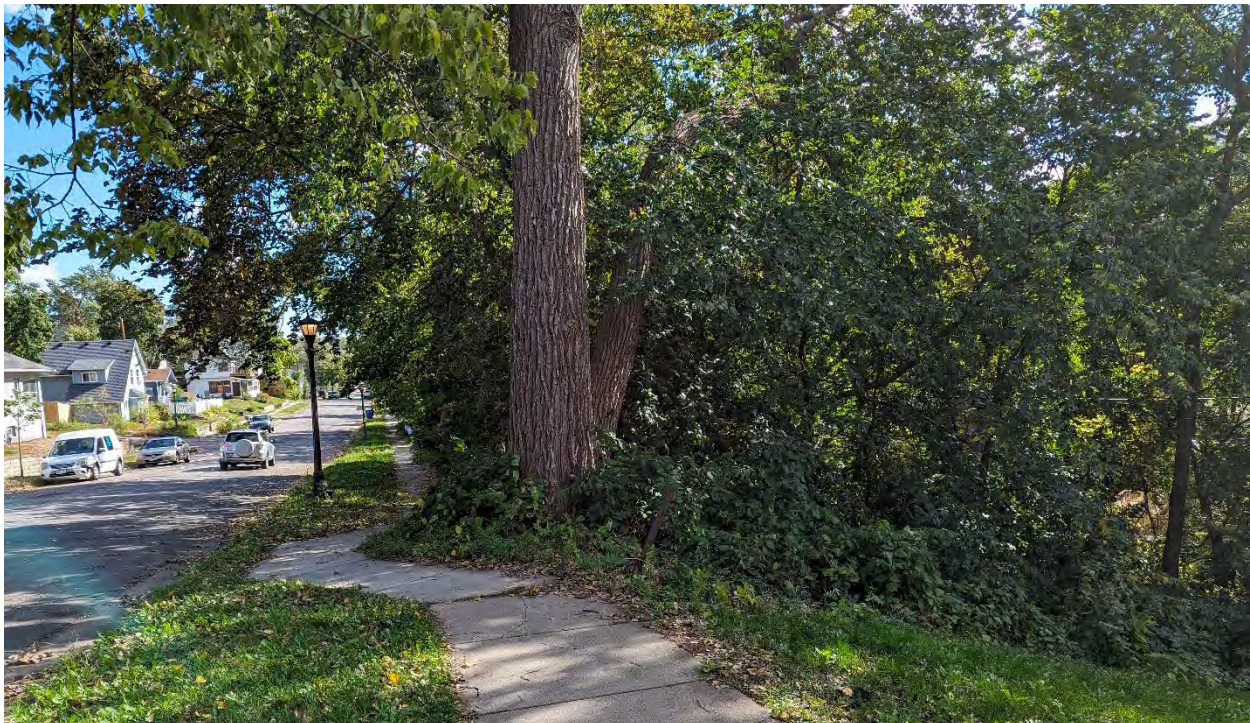
Condition Summary: Site 28 is a small forest located along a portion of Bradley Street that is too steep for the continuation of the road. A portion of the site is a privately held parcel. The woodland canopy is a mix of mature cottonwood, boxelder, and American elm tree species. The shrub layer is primarily composed of buckthorn and green ash saplings. Groundcover within the woodland is sparse (likely a result of the dense shrub land canopy cover). Burdock, sow thistle (*Sonchus oleraceus*), white snakeroot, creeping Charlie, and motherwort are present along the woodland edges.

- Control invasive tree species to open up the forest understory for the regeneration of native plants
- Collaborate with adjacent landowner to control invasive species on private property
- Manage stormwater from surrounding impervious surfaces with addition of BMPs (bottom and top of slope)
- Possible educational partnership with nearby Bruce Vento School

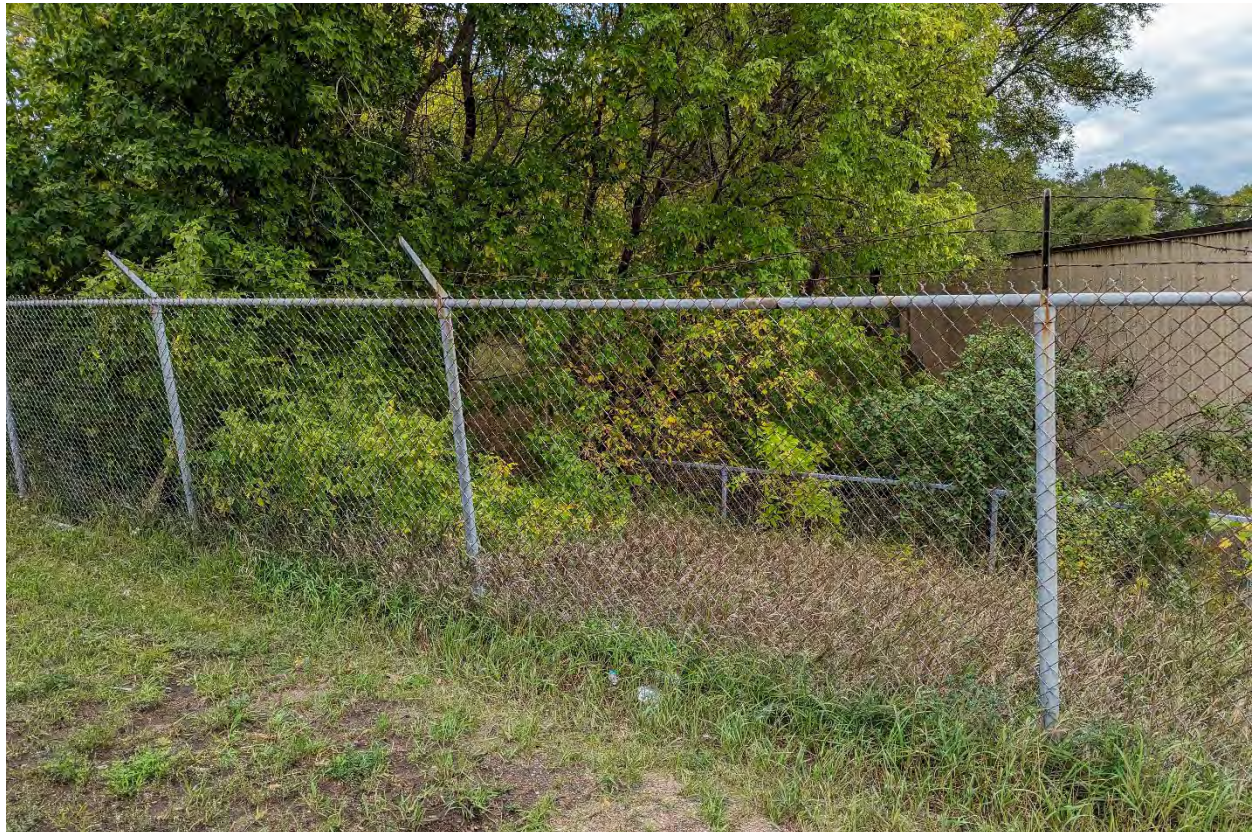
Condition Summary: Site 29 is an undeveloped degraded forest located between residential houses and a commercial warehouse on a steep west facing slope. The site is a privately-held industrially-zoned parcel that is surrounded by a fence. Cottonwood, boxelder, and green ash are the dominant canopy trees and are likely 20 to 30 years old based on historical images. Buckthorn is establishing within the shrub layer but does not dominate. The herbaceous ground layer is a dense monoculture of smooth brome grass.

- Highly degraded site with little existing plant diversity
- Inaccessible and privately held parcel

- Collaborate with landowner to control invasive species on private property
- Convert existing degraded areas into more diverse oak savanna plant community for pollinator and bird species

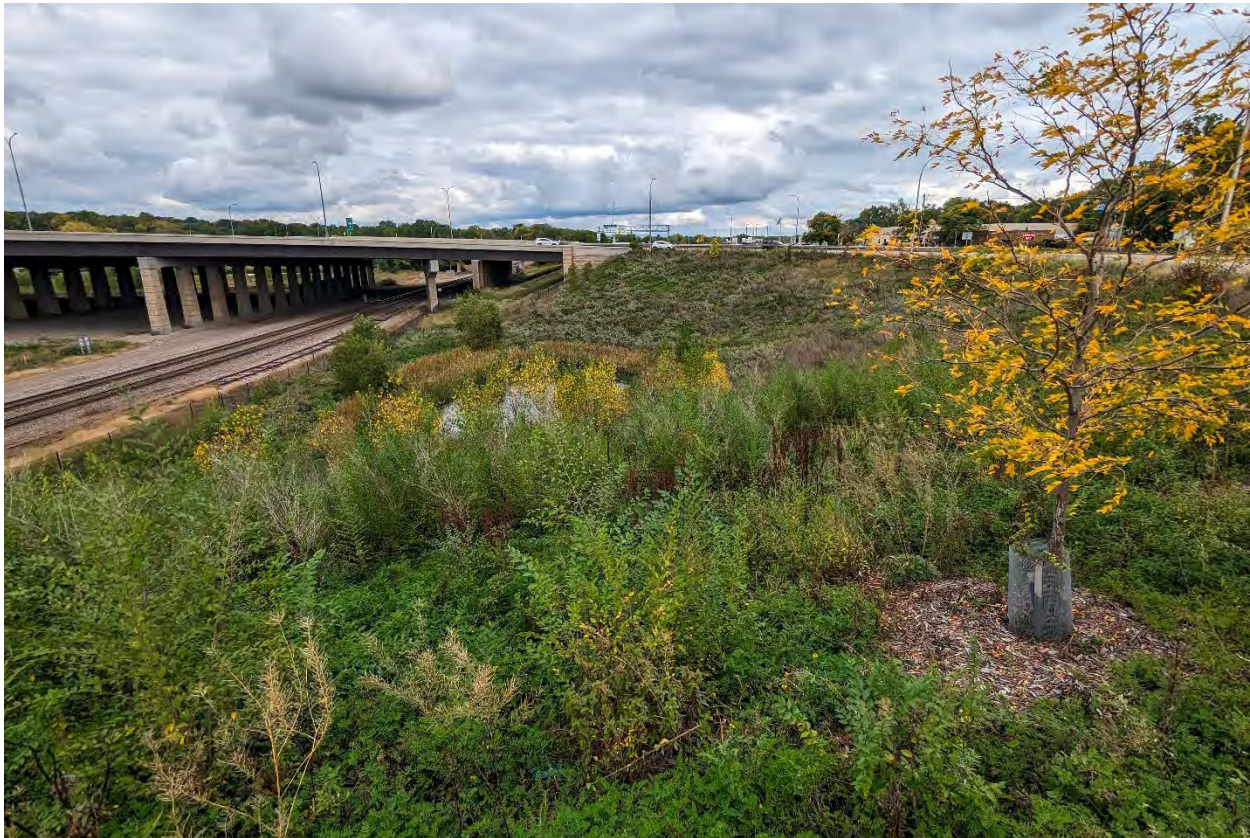
Condition Summary: Site 30 is a series of stormwater ponds and tallgrass prairie areas located within the Cayuga Street and interstate 35 East interchange. The stormwater ponds are surrounded by monotypic stands of narrow-leaf cattails. The upland areas are dominated by aggressive non-native and annual weed species such as crown vetch, wormwood (*Artemisia absinthium*), bird's foot-trefoil, smooth brome grass, yellow rocket (*Barbarea vulgaris*), lamb's quarters (*Chenopodium album*) and curly dock (*Rumex crispus*). Prairie coneflower, little bluestem, and sideoats grama are present in very limited abundance (the site was likely seeded with native MNDOT seed mixes following highway construction). Oaks, maples, pine, hackberry, and river birch saplings were recently planted throughout the site.

- Control noxious species
- Maintain BMPs for stormwater control
- Promote tree growth and survival
- TBNS adjacency-extension of habitat corridors?

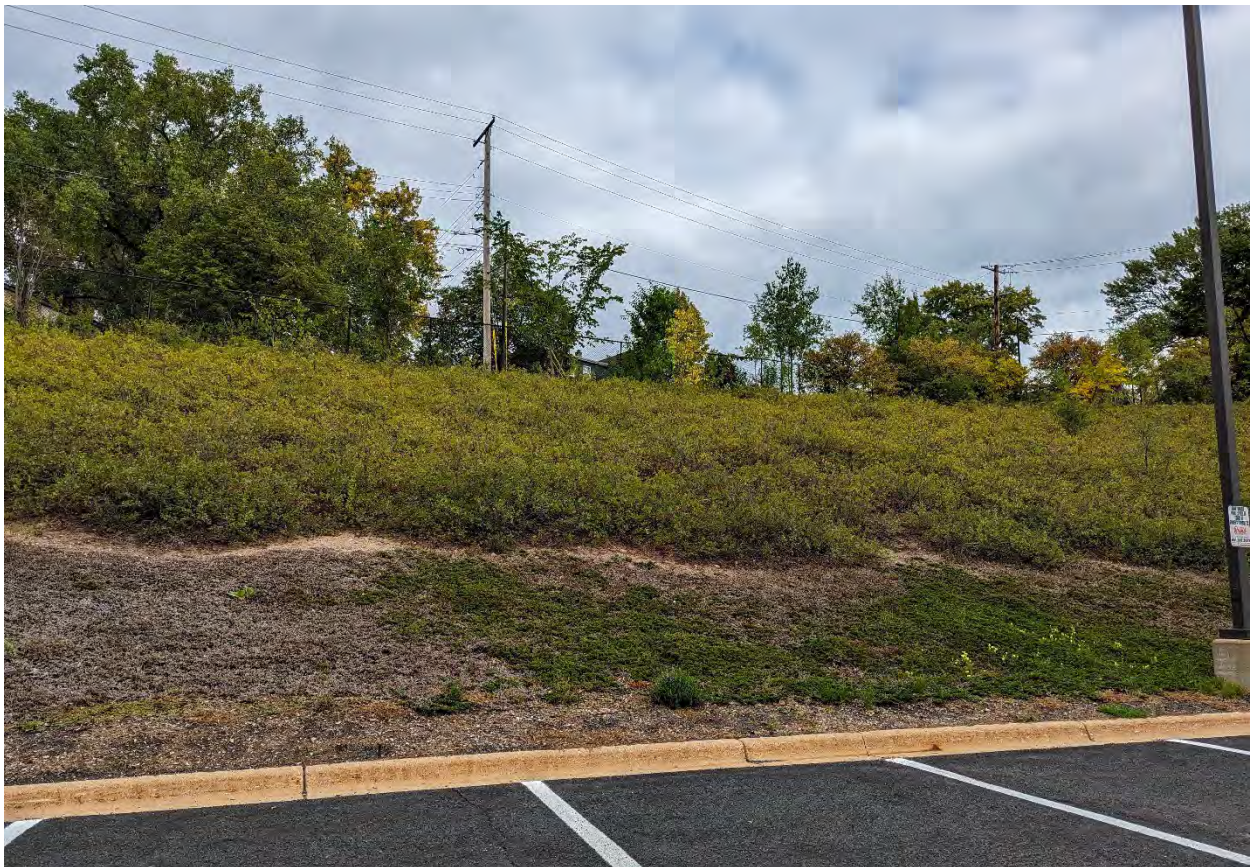
Condition Summary: Site 31 is an office campus with turf and formal foundation plantings. Steep west and south facing slopes on the edge of the property are densely planted with fragrant sumac (*Rhus aromatica*). The toes of the slopes are planted with creeping juniper shrubs that are in poor condition or have completely died off. Woodbine, green ash, Siberian elm, and willow saplings are growing up through the fragrant sumac but they appear to have recently been cut back to prevent encroachment. Ornamental paper birch (*Betula* sp.), honey locust, mugo pine (*Pinus* spp.), little leaf linden, and crabapple trees are evenly planted throughout the formal landscape areas.

- Identify opportunities to utilize lawn areas on south side of site for green infrastructure practices (stormwater quality/quantity control)
- Expand existing native plantings around building and increase diversity of native plants within large shrub plantings
- Control pioneer and invasive tree species that are quickly establishing in the shrub plantings

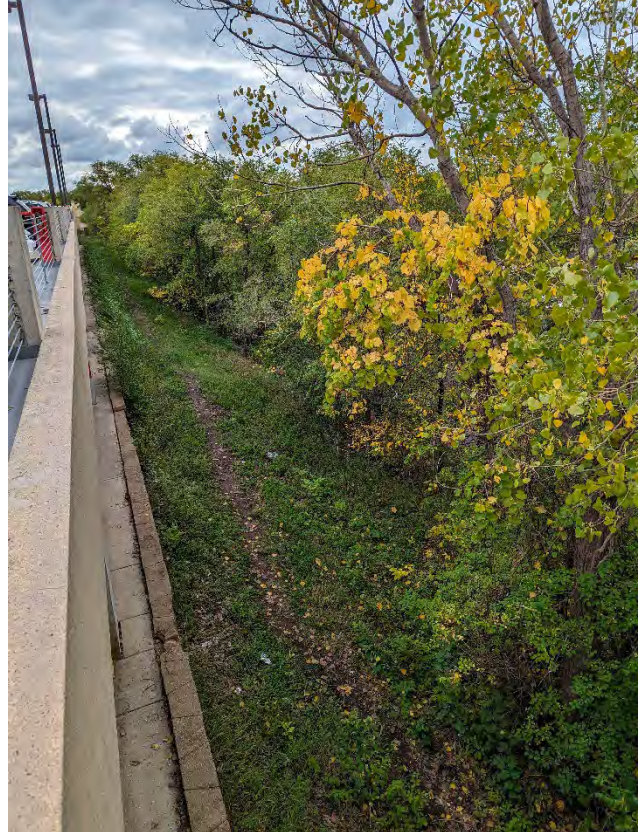
Condition Summary: Site 32 is a narrow strip of woodland and open grassland areas adjacent to the Health Partners Clinic parking ramp (west of ramp). The site is inaccessible due to steep grades and fencing. Siberian elm is the most dominant canopy tree.

Cottonwood, American elm, green ash, boxelder, and buckthorn are also present. Smooth brome, riverbank grape, Canada goldenrod, and crown vetch are the dominant ground cover. Large areas of bare soil are existing throughout. A degraded open grassland is located adjacent to a parking lot that appears to be used for storage. Plant diversity is limited and includes smooth brome, crown vetch, Canada goldenrod, and annual weed species.

- Control Siberian elm and noxious weed species
- Plant long lived native shrub and hardwood tree species to replace the ash and Siberian elm

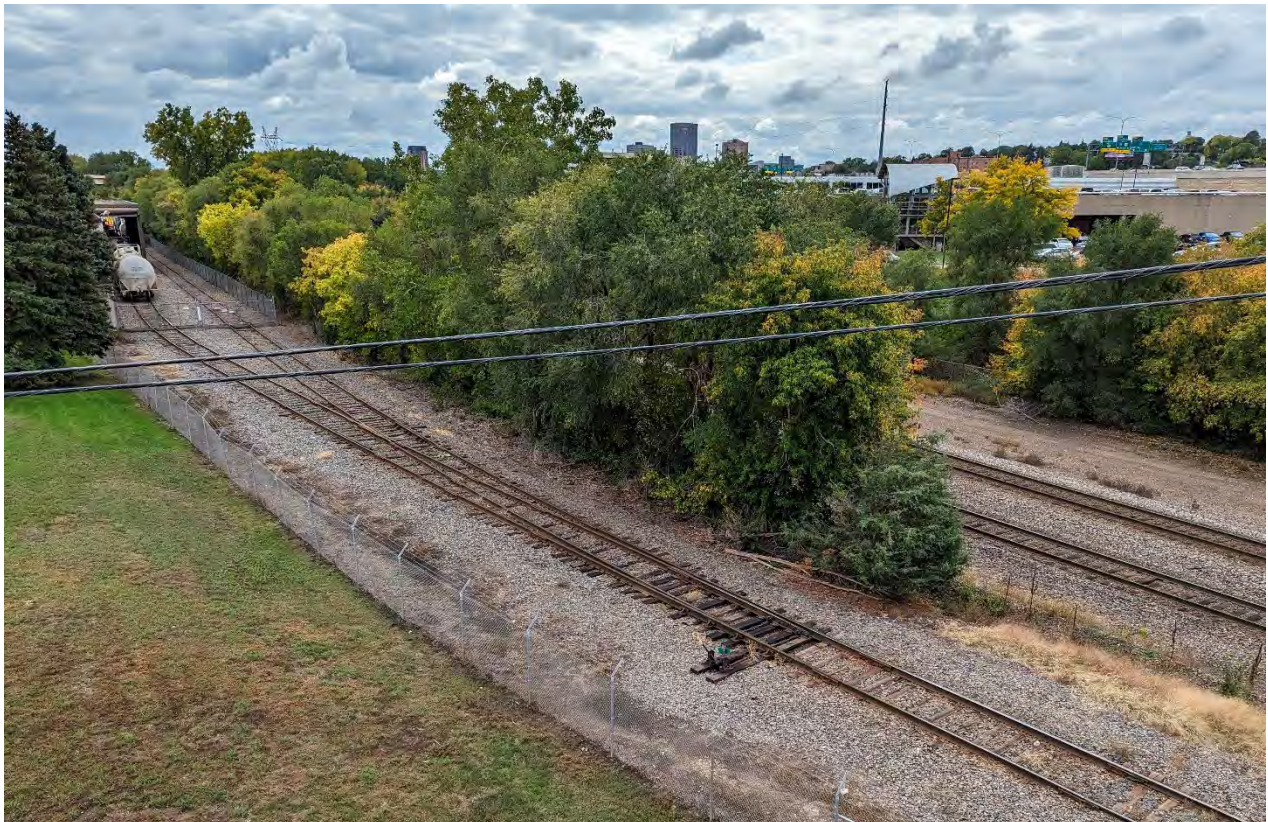
Condition Summary: Site 33 is wooded area surrounding a .4-acre stormwater pond located within the Metro Transit East Garage security fence. The site was only observed from a distance due to accessibility. Google Street view and aerial imagery shows that cottonwood, Siberian elm, and boxelder are the dominant canopy tree species. The herbaceous ground layer could not be observed; however, the site is directly adjacent to Site 32 and would likely contain similar species.

- Control Siberian elm and noxious weed species
- Plant long lived native shrub and hardwood tree species to replace ash and Siberian elm
- Collaborate with Metro Transit to control invasive species

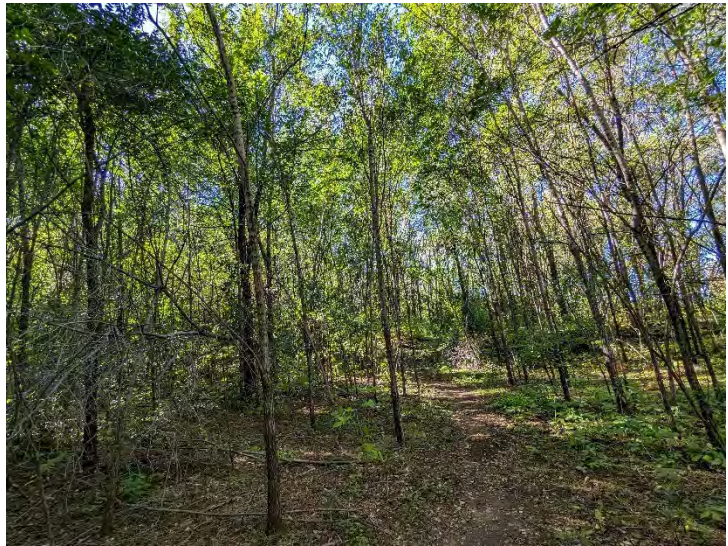
Condition Summary: Site 34 contains a 3.5 acre north facing forested slope and 1-acre stormwater treatment basin. The forest canopy is composed of densely growing boxelder, aspen, and Siberian elm trees. A vast majority of the trees are smaller than 4 inches in diameter and are likely less than 20 years old. The shrub layer is mostly made up of buckthorn and green ash saplings. The herbaceous ground cover is sparse resulting in bare soil over a majority of the area. The limited vegetation that is present includes woodbine, creeping Charlie, common plantain, and burdock.

- Continue to maintain and protect site's ecological quality
- Collaborate with adjacent landowners to restore woodland on private property
- Long term maintenance of prairie and stormwater basin plantings to promote vegetation diversity for pollinator and bird species
- Maintain stormwater basin and control structure for water quality and flood control

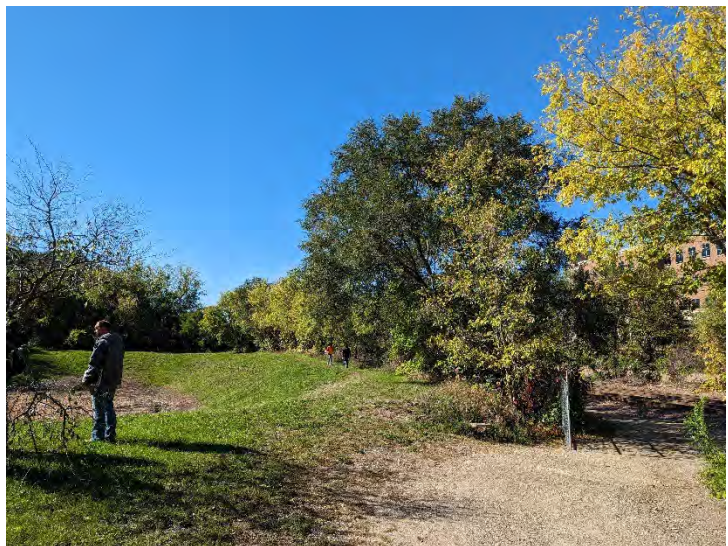
A stormwater basin and upland prairie are located at the north-east portion of the site. The stormwater basin is composed of narrow-leaved cattails and adjacent upland areas are dominated by smooth brome grass. In spring of 2024 the basin and adjacent upland sites are to be restored with a diverse native seed mix and will be maintained by Saint Paul Public Works.

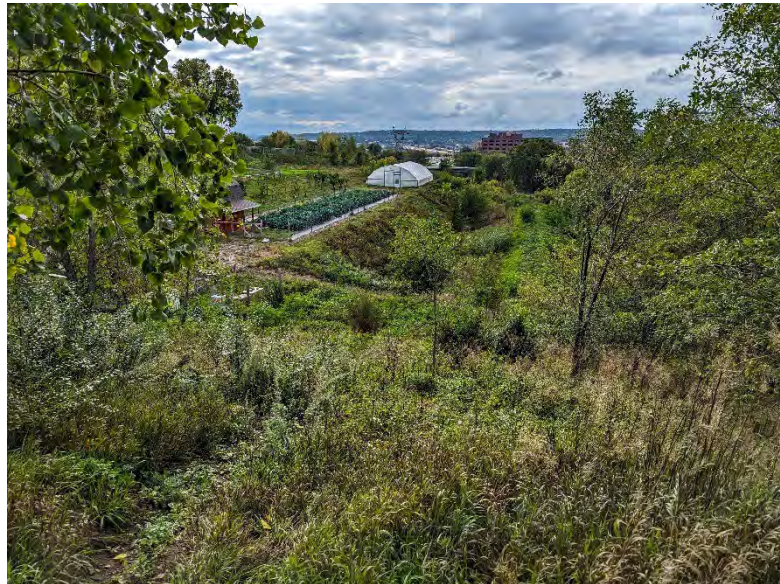
A degraded forest dominated by Siberian elm is present on the west and south facing slopes (adjacent to the railroad). Hackberry, aspen, black locust, mulberry, buckthorn, and boxelder are also present along the top edge of the slope. Buckthorn, staghorn sumac, common burdock, Canada goldenrod, wormwood, sweet clover, crown vetch, and common ragweed are present along woodland edges. An approximately 100-square-foot area of active erosion is present at the north end of the wooded slope.

- Collaborate with adjacent landowner to restore woodlands on private property
- Identify opportunities to utilize degraded areas on north and south side of site for green infrastructure practices (stormwater quality/quantity control) (may be difficult due to steep grades)
- On-site educational partnership opportunities with gardeners and the non-profit Urban Roots to promote the importance of stormwater management and pollinator plantings
- Oak savanna restoration: grasslands and woodlands are primarily composed of invasive species that should be removed and converted to a more resilient native landscape that once thrived on these types of south facing slopes

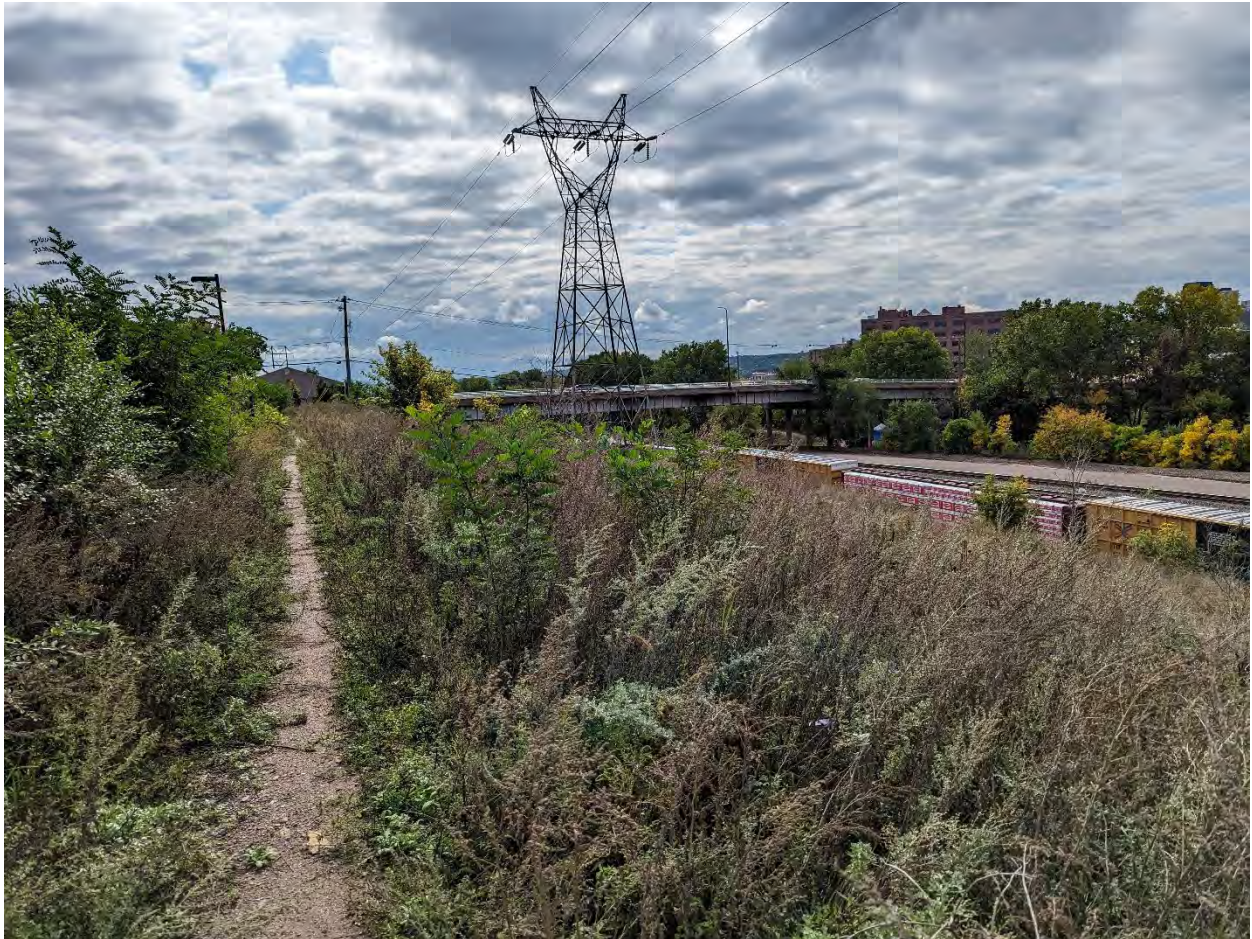
Condition Summary: Rivoli Bluffs Farm and Restoration Site is a large community garden located on undeveloped parcels owned by The Housing and Redevelopment Authority. The site is perched on a steep bluff above the active Union Pacific rail line. The central core of the site is an active community garden that contains a gravel bed tree nursery along with multiple plots used for growing vegetables and ornamental annuals (3.7 acres). Unmanaged areas dispersed between garden plots are primarily vegetated with smooth brome grass, leafy spurge, and yellow rocket.

- Highly degraded woodland with little existing native plant diversity
- Potential for erosion - steep slopes and sparse vegetation
- Portion of woodlands are privately held railroad parcels

- Improved habitat could serve as an ecological corridor along the railroad and would connect the nearby habitat patches of Swede Hollow Park (Site 39), MNDNR/MPCA Office Landscape (Site 38) and Bush-Desoto Stormwater Basin and Woodland (Site 34)
- Location of historic Trout Brook – review soils to see if portions of the historic wetland plant community could be restored

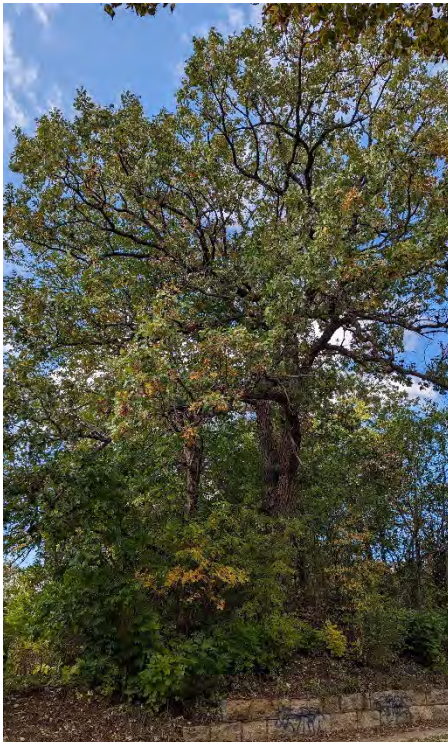
Condition Summary: Site 36 is a south facing slope located east of the Rivoli Bluffs Farm and Restoration site. The west side of the site is a smooth brome and crown vetch dominated grassland. The east edge of the site contains a grouping of large open-grown bur oak trees that are surrounded by establishing green ash and boxelders. Understory vegetation is primarily buckthorn and bur oak saplings.

- Oak savanna restoration: remove ash and buckthorn around existing oak trees and convert the site into a more resilient native landscape that once thrived on these types of south facing slopes
- Evaluate opportunity to coordinate grants while work is ongoing for Dayton's Bluff Neighborhood Housing Services
- Coordinate restoration efforts with the adjacent Rivoli Bluff Farm site to create a larger more manageable habitat patch (larger quality habitat cores can reduce weed pressures and maximizes restoration efforts and efficiency)

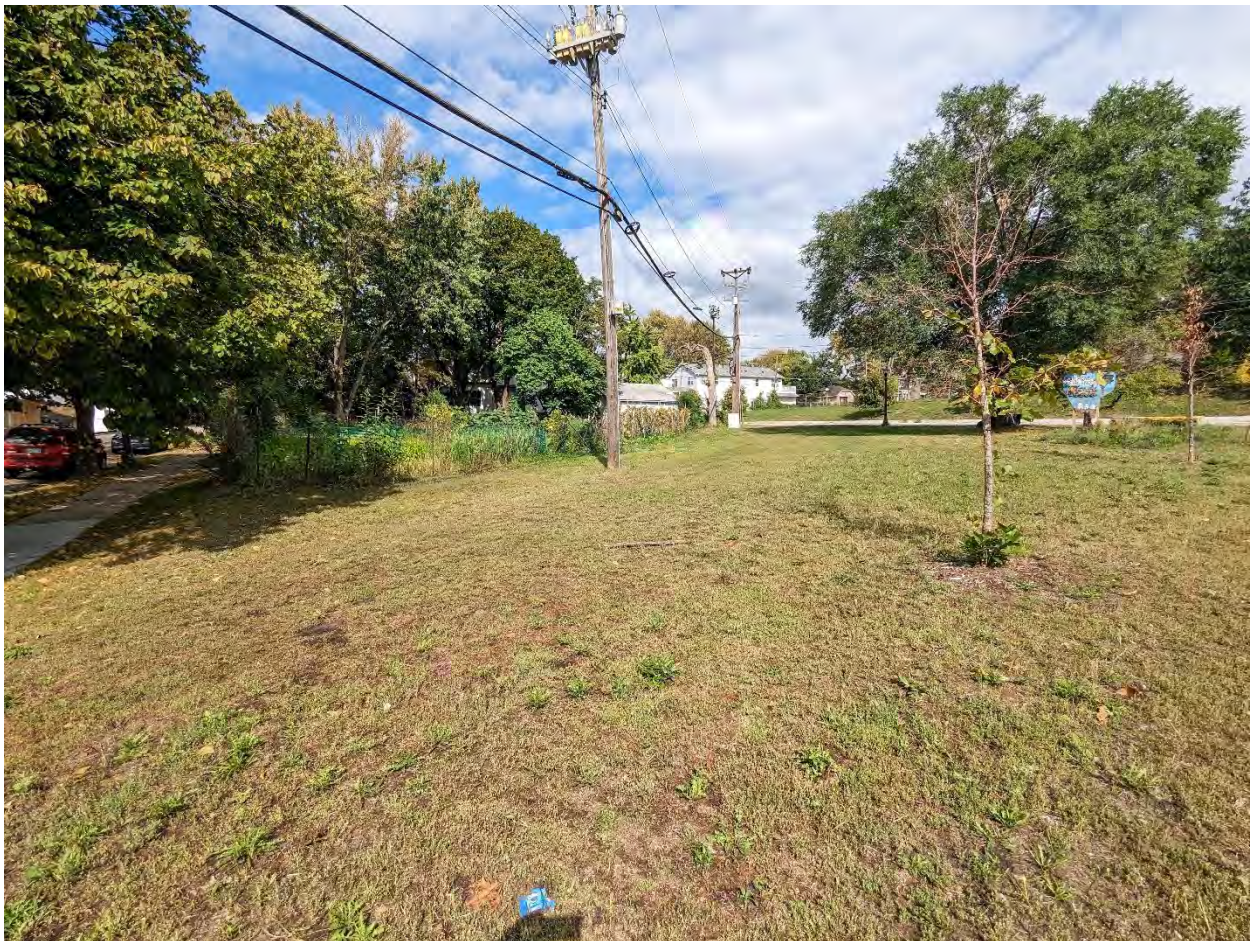
Condition Summary: Located at the intersection of Desoto Street and Lafayette Road, Railroad Island Greenspace is a neighborhood community garden and open space. The north half of the site is maintained as a cultivated garden for vegetables and annual flowers. The south half of the site is an open lawn area that contains an Amur maple and large Siberian elm. Two recently-planted oak trees are in poor condition and have lost half of their foliage (likely due to drought). The lawn is primarily composed of crab grass, dandelion, and prostrate knotweed (*Polygonum aviculare* L.).

- Identify opportunities to utilize lawn for native plantings and green infrastructure practices (stormwater quality/quantity control)
- On-site educational partnership opportunities with gardeners to promote importance of stormwater management and pollinator plantings

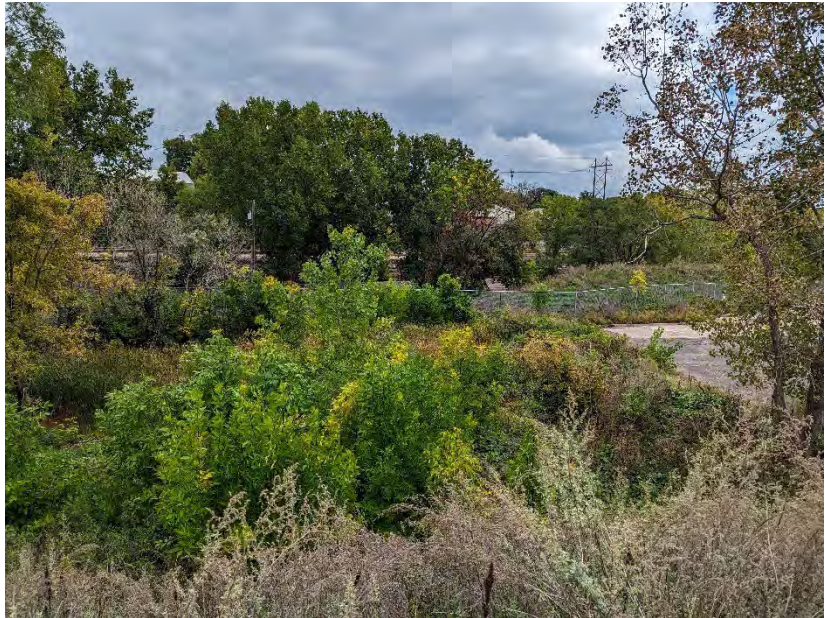
Forested areas are similarly dominated by non-native plant species. Large cottonwood trees are the most abundant canopy tree. Mature boxelder, Siberian elm, and green ash trees are also present. Buckthorn, woodbine, white snakeroot, and common burdock are the most common understory species. A small cattail dominated wetland is located within an opening of the north forested area.

- Oak savanna restoration – woodlands are primarily composed of non-native Siberian elm that should be removed and converted to a more resilient native plant community for pollinator and bird species
- Collaborate with site owner to control invasive species
- Explore opportunity for SSGI or habitat improvements around surface parking lots (SSGI concepts were developed for the Treatment Master Plan for Lafayette Campus 2015, Barr Engineering)
- Partner with/incentivize landowner to convert unused/unnecessary mowed turf areas with native grasses, forbs, and/or tree species to combat biodiversity loss and urban heat island effect

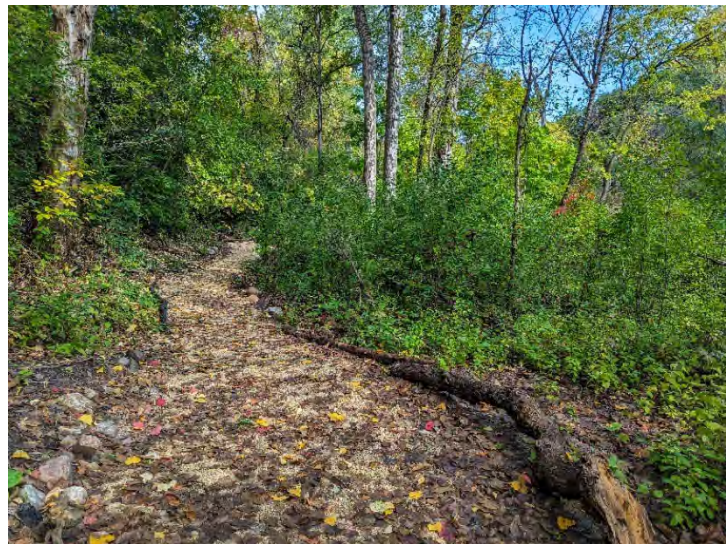
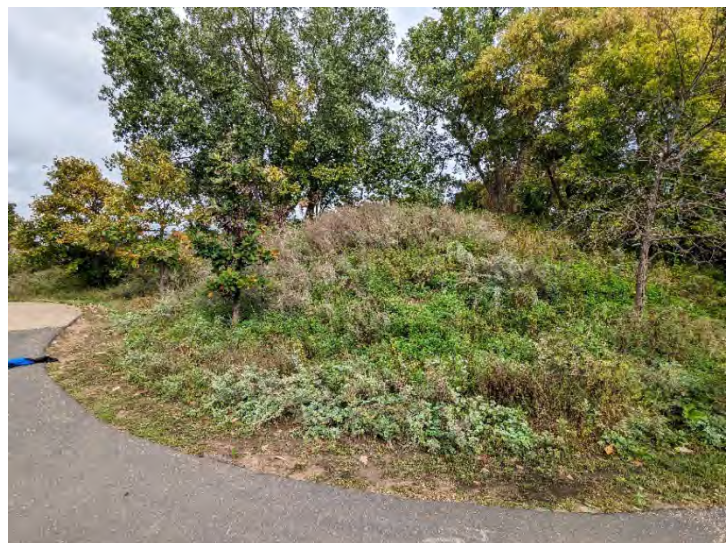
A park Master Plan that details natural resource management goals was approved in 2019. The plan depicts target plant communities for natural areas within the park and includes a detailed list of native plant species for each community to be restored. With the newly adopted plan and funding, the plant diversity and presence of invasive species will likely transition over the next 10 years.

- Managing cattails and reed canary grass within the wetland would be difficult and will remain an ongoing issue
- Potential for erosion - steep slopes with sparse vegetation
- Pioneer and invasive tree species are quickly establishing in open grassland areas
- Highly degraded woodlands with little existing native plant diversity

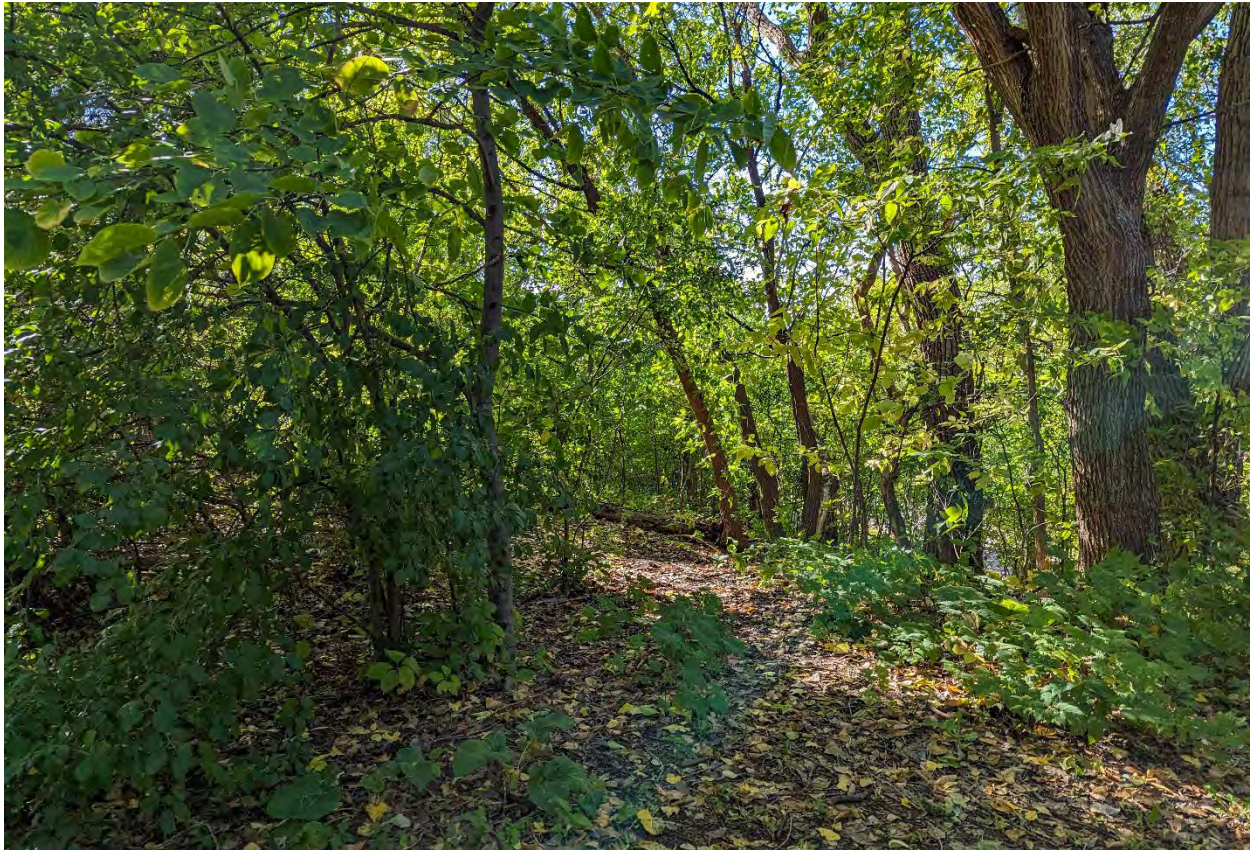
Condition Summary: Site 39 includes the 36-acre Swede Hollow Park and a 2.6-acre wooded ravine that extends to the north from the park. The linear park is situated within a steep wooded valley between East 7th Street (on the south) and Beaumont Street (on the north). A small portion of Site 39 extends north along an oak forested ravine (natural plant community extends beyond the formal park boundary).

- Long term maintenance of prairie and woodland plantings to promote vegetation diversity for pollinator and bird species
- Continue oak woodland restoration through steep northern ravine (woodland extends east through a city ROW and the north corner of St. John Lutheran Church property)

- Collaborate with the City and local partners to support the existing park master plan and to restore habitat (Swede Hollow Park Master Plan)

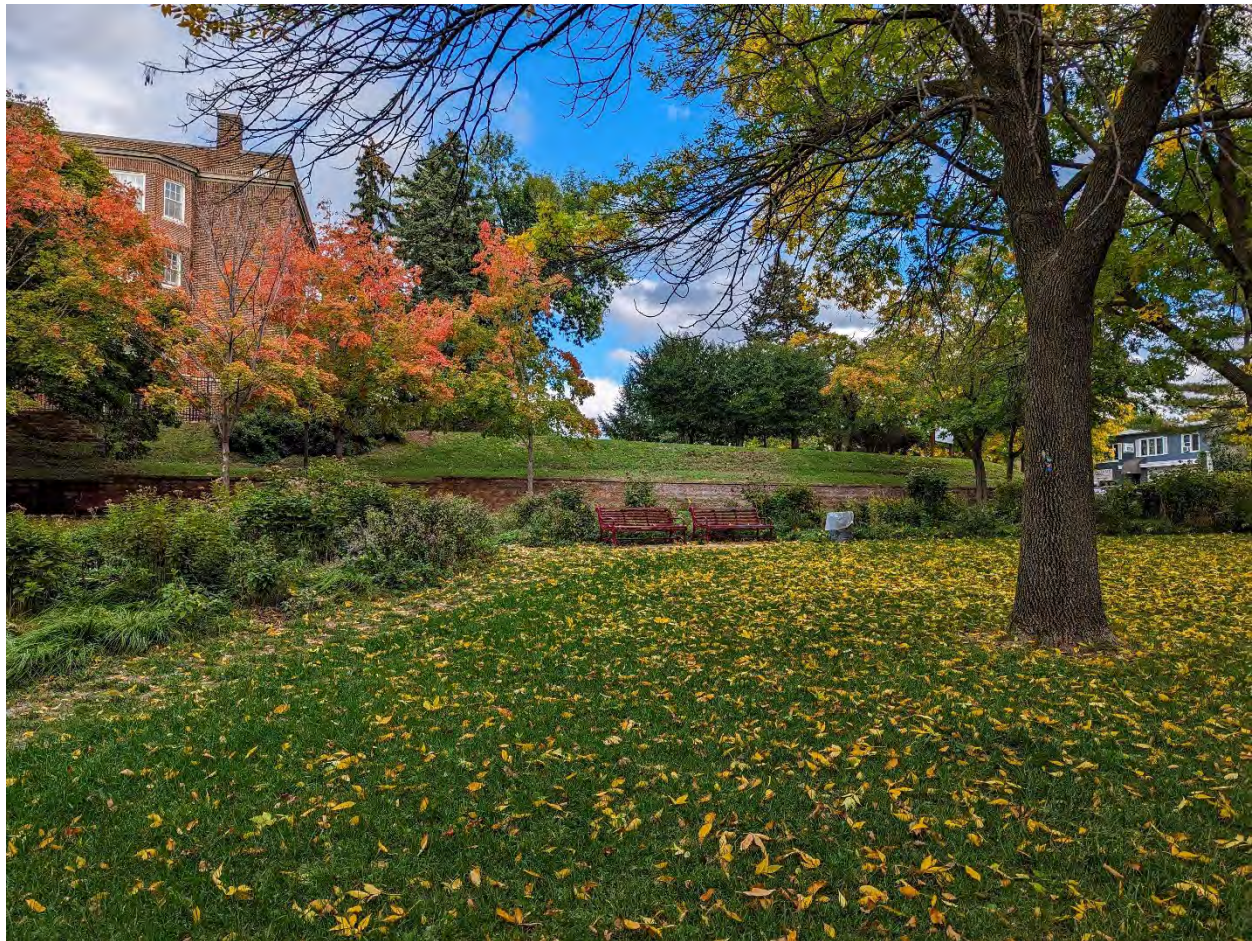
Condition Summary: Sitting diagonally from Swede Hollow Park, Hamm’s Park is primarily composed of well-groomed lawn areas that contain narrow gardens of native and ornamental perennial plantings. The gardens are well maintained and display a diversity of native flowers, sedges, and grasses. Native plant species include fragrant hyssop (*Agastache foeniculum*), Pennsylvania sedge (*Carex pensylvanica*), wild bergamot, Joe-Pye weed (*Eutrochium purpureum*), common milkweed, showy goldenrod (*Solidago speciosa*), zig-zag goldenrod (*Solidago flexicaulis*), heart-leaved aster (*Symphyotrichum cordifolium*), and fox sedge (*Carex vulpinoidea*).

Large red maple, Austrian pine (*Pinus nigra*), and green ash trees are present throughout the lawn areas. Green ash trees show signs of EAB damage and will likely die as a result of the infestation.

- A great example of a well-maintained pocket prairie with native plant diversity
- Continue to maintain and protect site quality

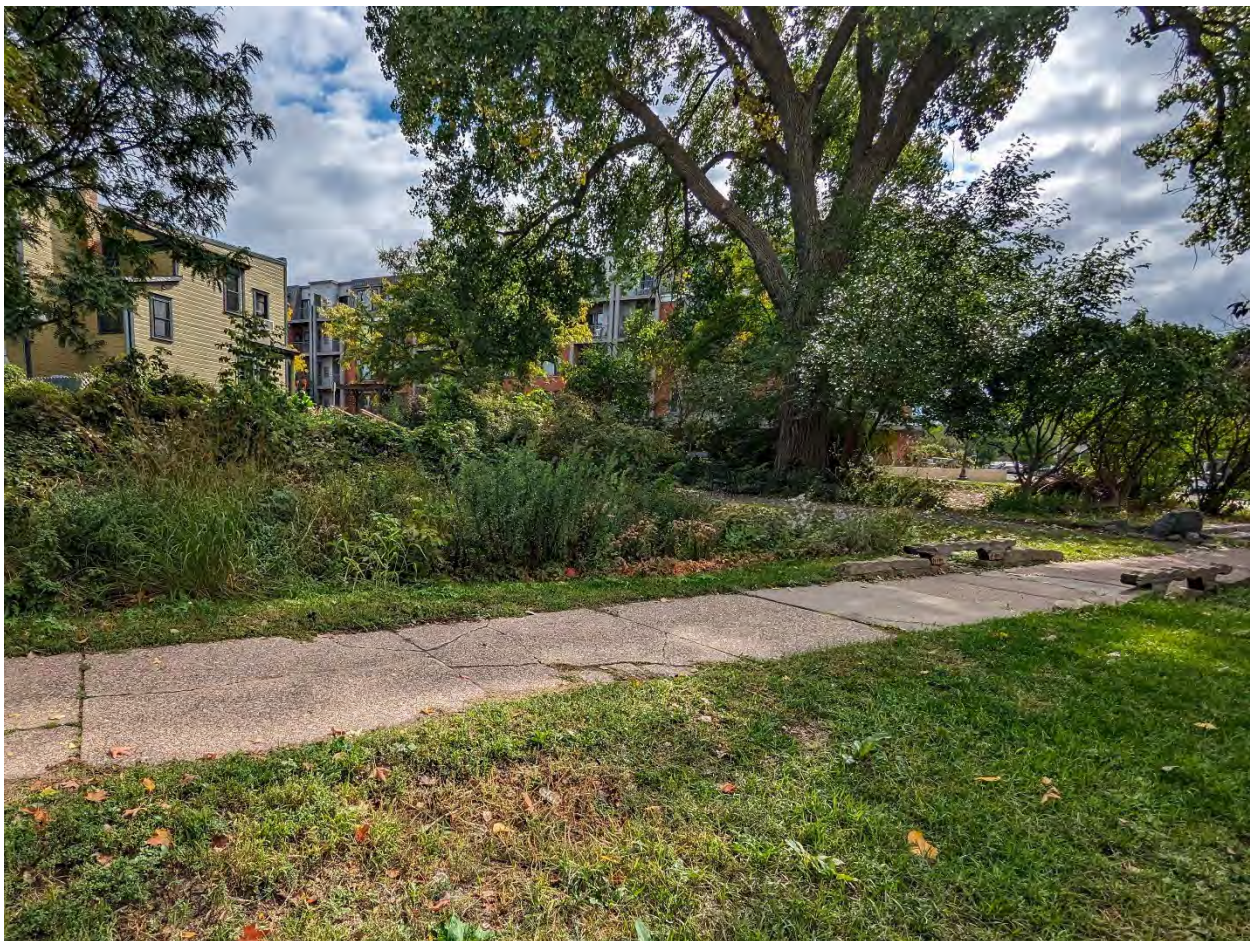
Condition Summary: Site 41 is a privately held parcel that contains two well maintained rain gardens. One of the rain gardens treats water from the city's storm sewer, the other rain garden treats runoff from the adjacent commercial building. The rain gardens contain a mix of native and non-native ornamental perennial plant species. Native plant species include little bluestem, big bluestem, New England aster (*Symphotrichum novae-angliae*), prairie cord grass (*Spartina pectinata*), and obedient plant (*Physostegia virginiana*). The adjacent lawn areas contain cherry, crabapple, cottonwood, and red maple shade trees that appear to be in good health.

- A great example of a well-maintained stormwater basin planting with a mix of plant diversity
- Continue to maintain and protect site quality
- Continue to collaborate and promote importance of stormwater management and pollinator plantings with Urban Roots (non-profit currently maintaining plantings)

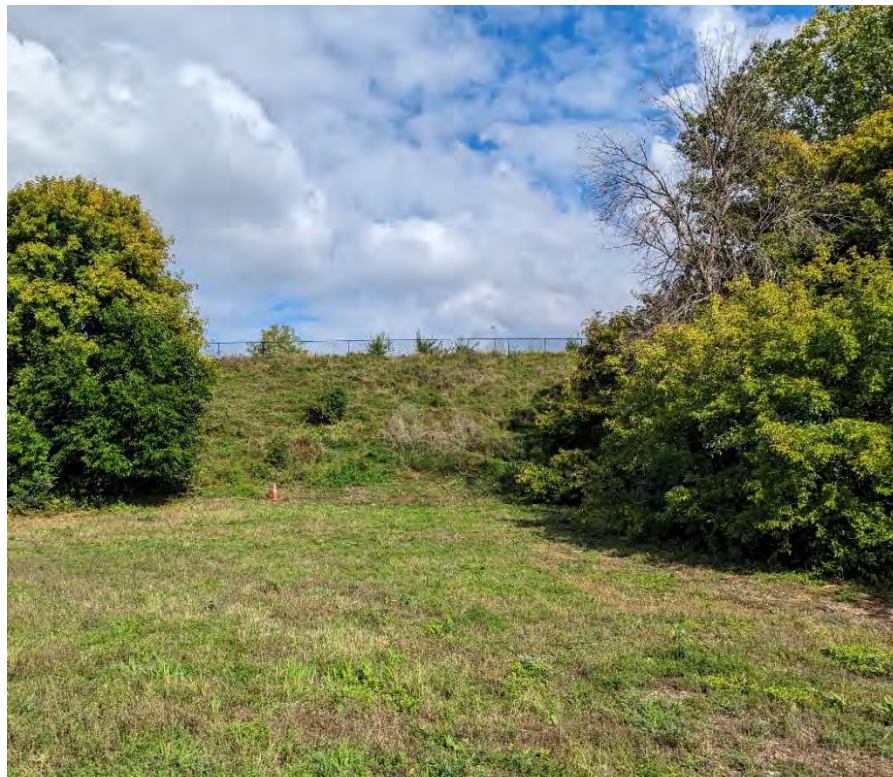
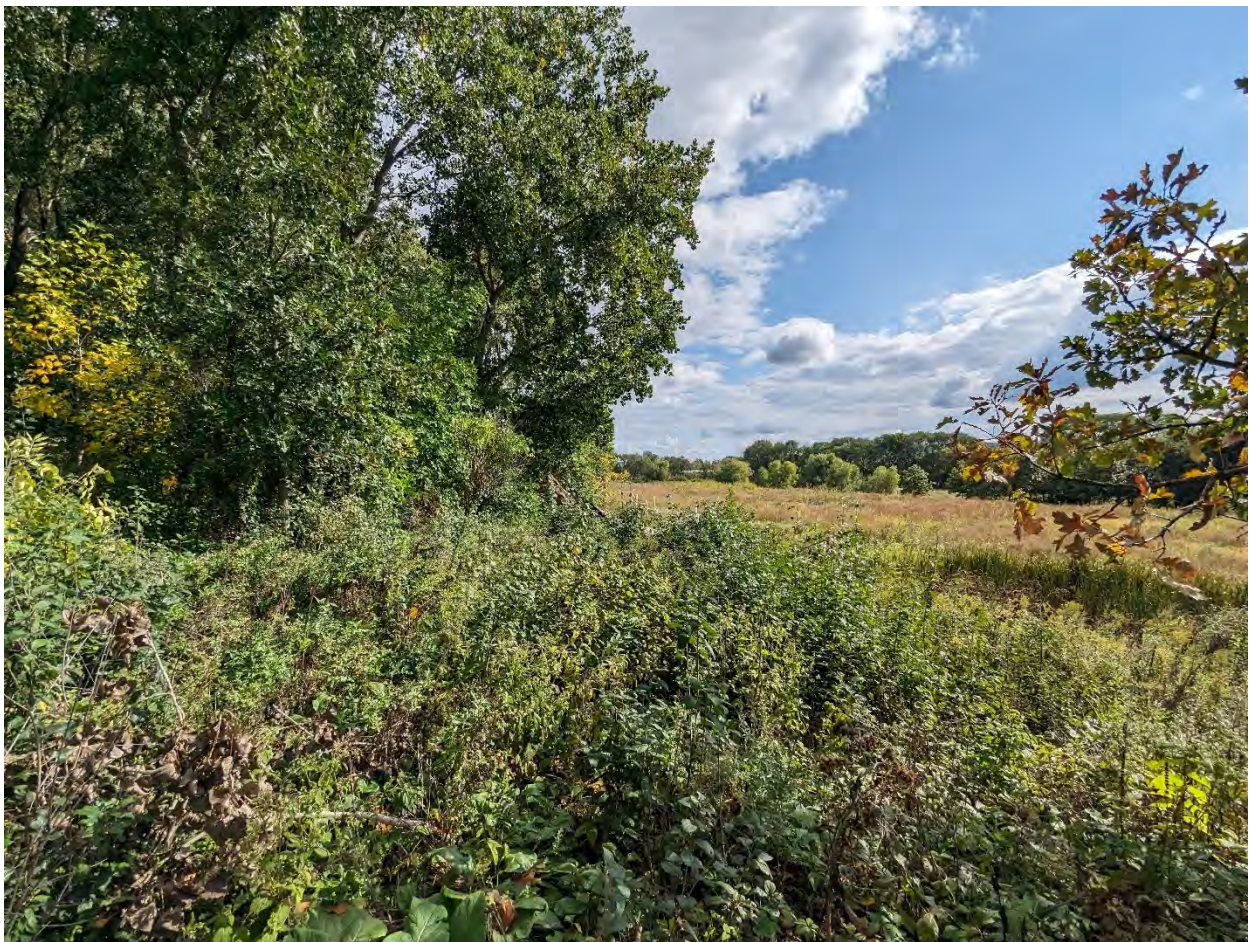
Site 40 covers the northeast portions of the Bruce Vento Nature Sanctuary from the parking lot leading up to Commercial Street (Site 42 does not include all of the 27-acre park). The area of Bruce Vento Nature Sanctuary is located below a sandstone bluff and has been a sacred place for Dakota People for thousands of years until they were forcibly removed more than 150 years ago. The site was then used for industrial purposes until the area was largely abandoned in the 1970s. As a result of past disturbances, the herbaceous ground plane is dominated by non-native invasive species. Open grasslands are primarily composed of smooth brome, crown vetch, Canada thistle, common burdock, and wormwood. Woodland areas are similarly disturbed and contain dense stands of buckthorn throughout. The woodland canopy is primarily composed of cottonwood and boxelder tree species. Woodland restoration efforts have been ongoing since 2005 and signs of past buckthorn management and oak restoration plantings are present in lowland areas near the south side of the site.

Phalen Creek historically ran through this site before it was diverted into underground storm sewer.

- Potential for erosion - steep slopes south of commercial street
- Pioneer and invasive tree species quickly establishing in open grassland areas
- Highly degraded woodlands with little existing native plant diversity

- Collaborate with City of Saint Paul's Department of Parks and Recreation, Friends of the Mississippi River, Mississippi Park Connection, Wakan Tipi Awanyankapi (WTA) and Urban Roots in the development and implementation of the 2020-2024 Ecological Management Recommendations plan.

- Coordinate with the City and local partners to support the ongoing restoration efforts to create a larger more manageable habitat patch (project area encompasses only a portion of the park)
- Expand oak woodland restoration – Siberian elm, buckthorn, honeysuckle, and black locust should be removed and restored with native understory species
- Convert low diversity grasslands into a more diverse savanna plant community for pollinator and bird species
- Improved habitat could serve as a high-quality ecological corridor connecting the multiple nearby patches of habitat located at Swede Hollow Park (Site 39) and Indian Mounds Regional Park (Site 43)
- Consider opportunities to participate in planning efforts to daylight stretches of historic Phalen Creek.
