SITE - 16

Frank and Sims Yard Waste
Collection Site

Natural Resources Inventory
Capitol Region
Watershed District

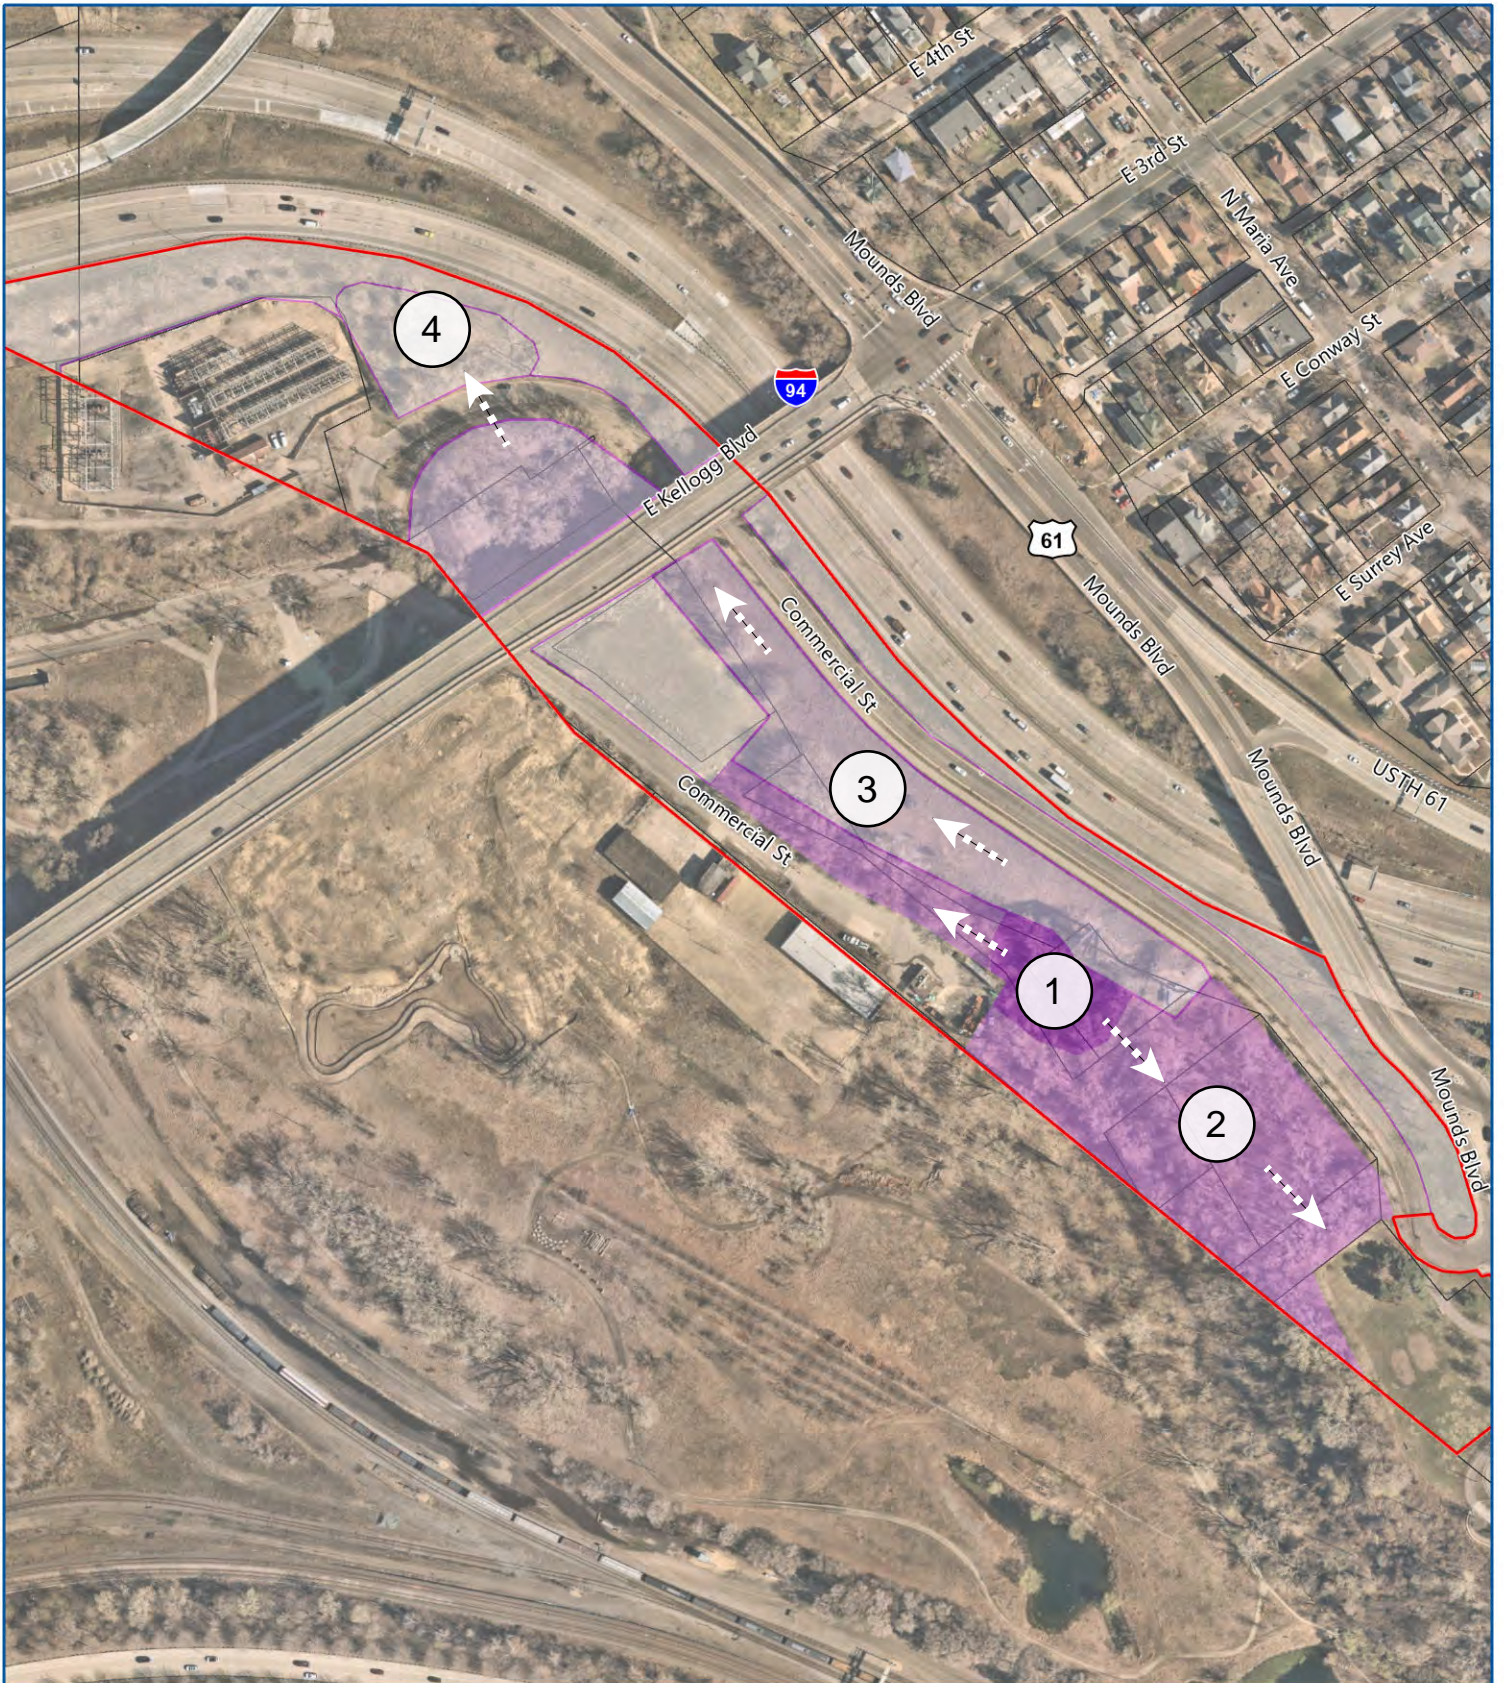
Natural Resources Inventory
Capitol Region
Watershed District

TARGET PLANT COMMUNITY

- 1 - Restoration efforts begin in these areas.
- 2 - Second priority for restoration. Move restoration efforts to these areas once phase 1 restoration efforts are complete. Continue maintaining phase 1 to retain restoration success.
- 3 - Expand restoration to these areas as resources allow. It is critical to maintain previously restored areas.
- 4 - Last priority for restoration due to the extent of degradation.

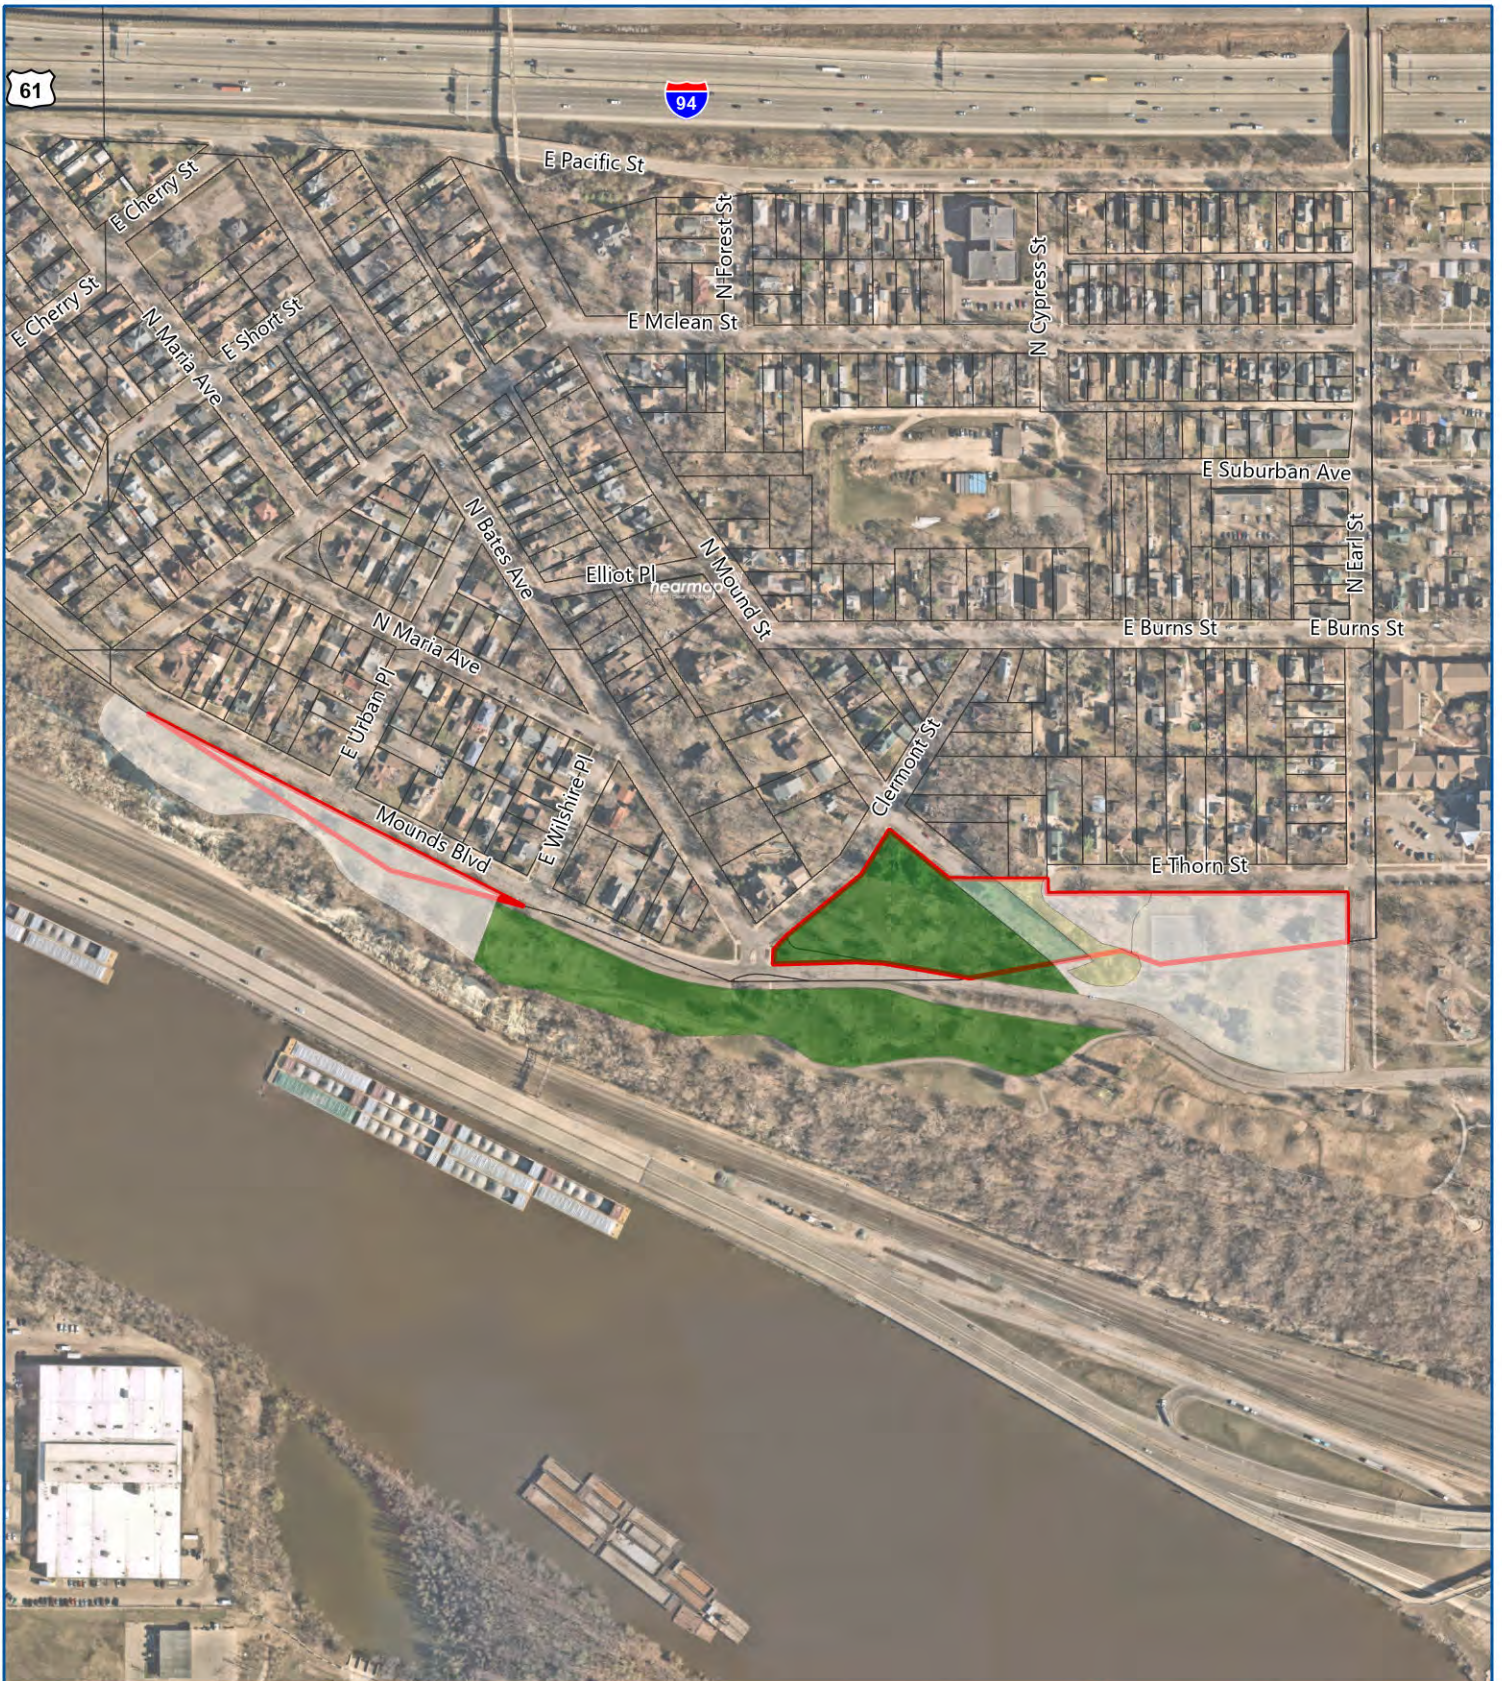
EXISTING LAND COVER
Natural Resources Inventory
Capitol Region
Watershed District

Condition Summary: Located on the top of a high bluff along the Mississippi River Valley at the southern edge of the project area, Site 43 encompasses portions of the Indian Mounds Regional Park (Site 43 does not include all of the 111-acre park). This site is considered a significant and sacred place to the Upper Sioux Community, Lower Sioux Community, Shakopee Mdewakanton Sioux Community, Prairie Island Indian Community, Ho-Chunk Nation of Wisconsin, Iowa Tribe of Kansas and Nebraska, Sisseton-Wahpeton Oyate, and other descendants of those who are buried here.

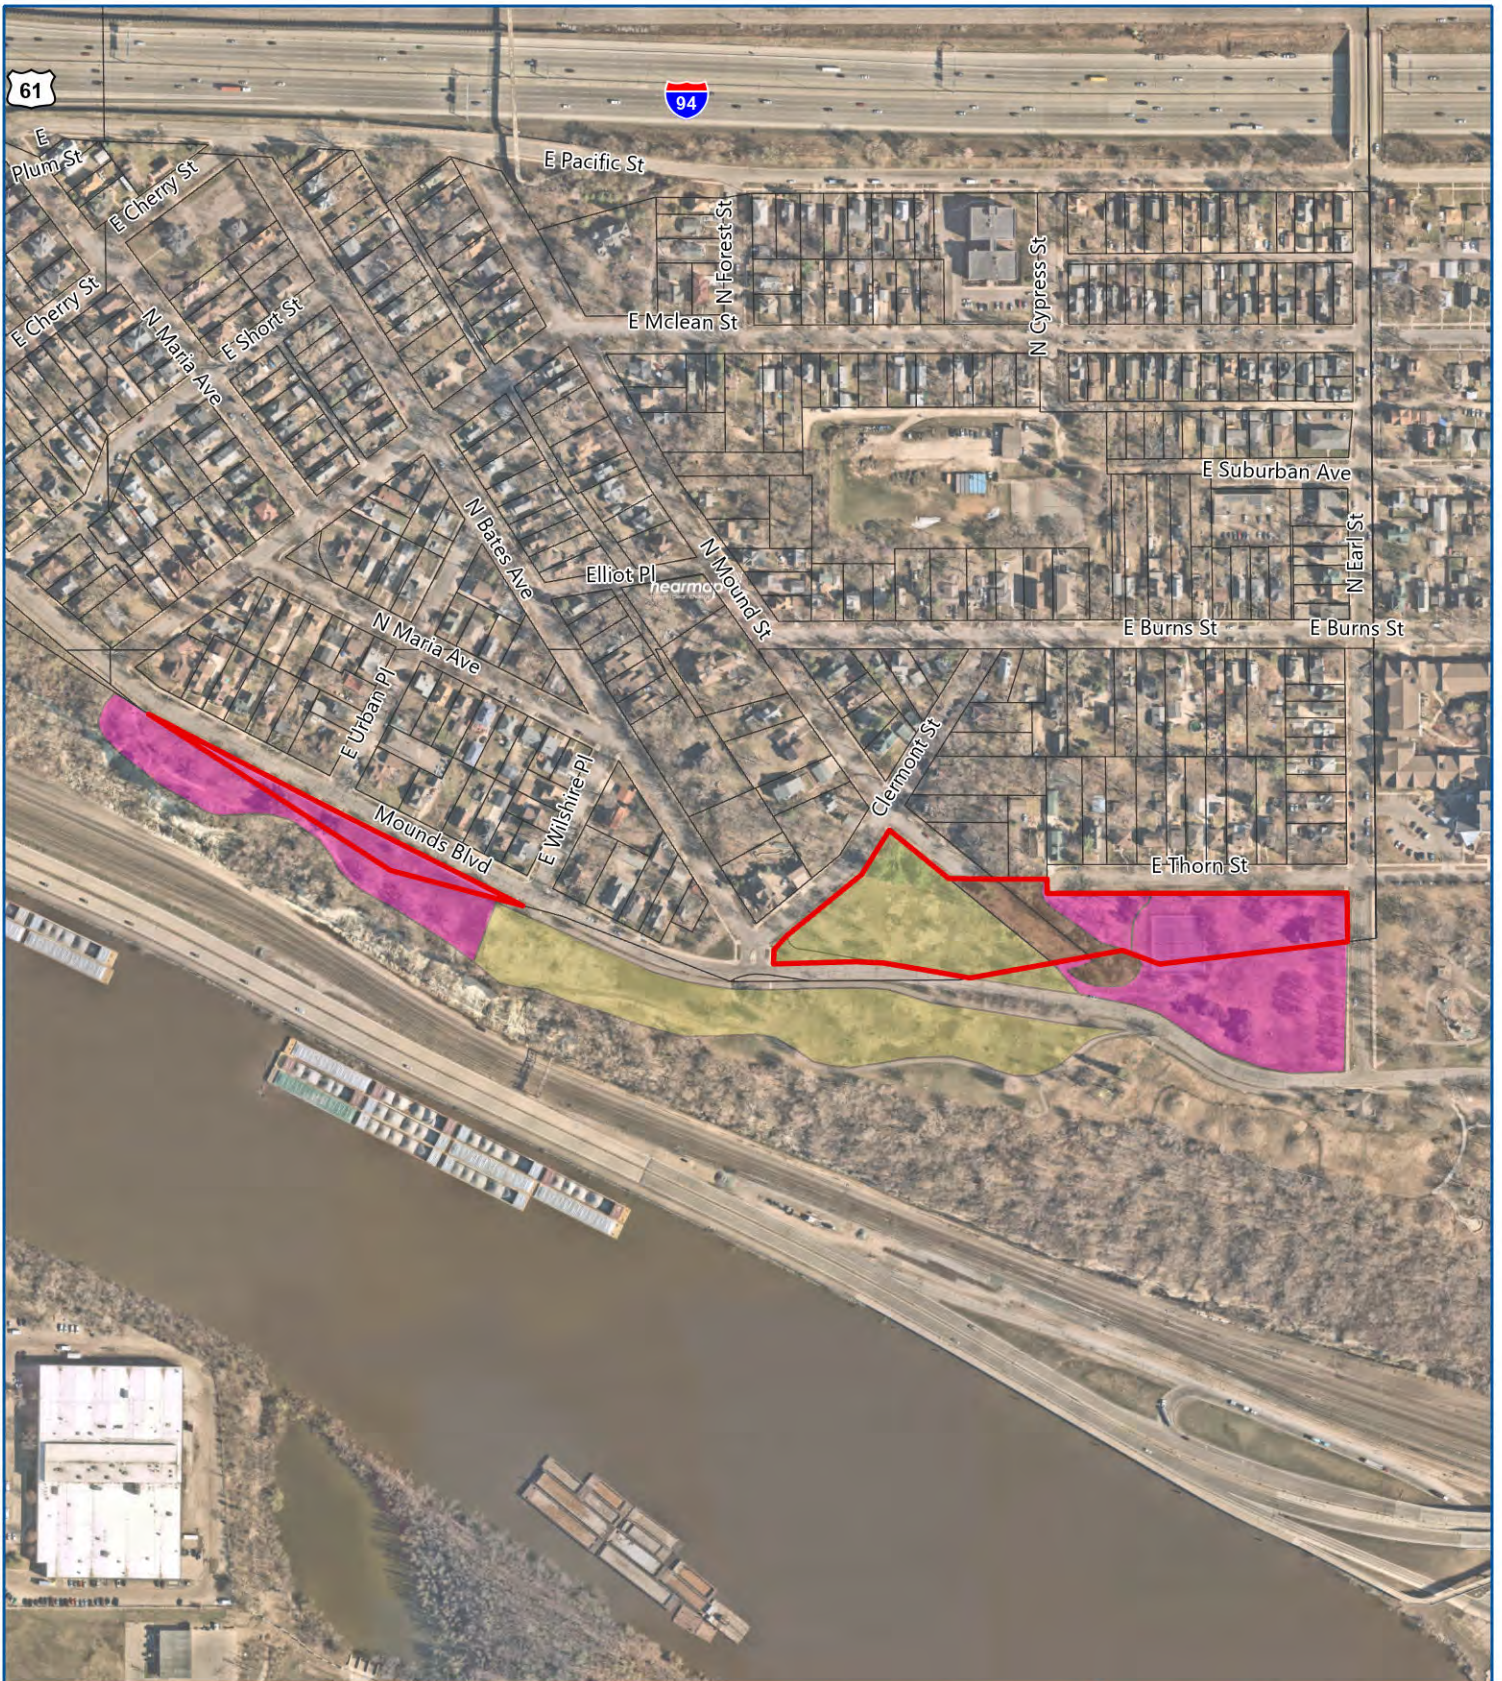
ECOLOGICAL QUALITY

Ecological Quality Ranking

- A
- B
- C
- D
- CL (Cultural Landscape)
