Injecting Biology along Riprap Shorelines

by Bill Bartodziej and Simba Blood

This article describes a project that used an ecological restoration approach to improve a long stretch of degraded riprap shoreline along an urban lake in Minnesota. The long-standing riprap tradition was broken and now lake users, fish, and wildlife are reaping the benefits.

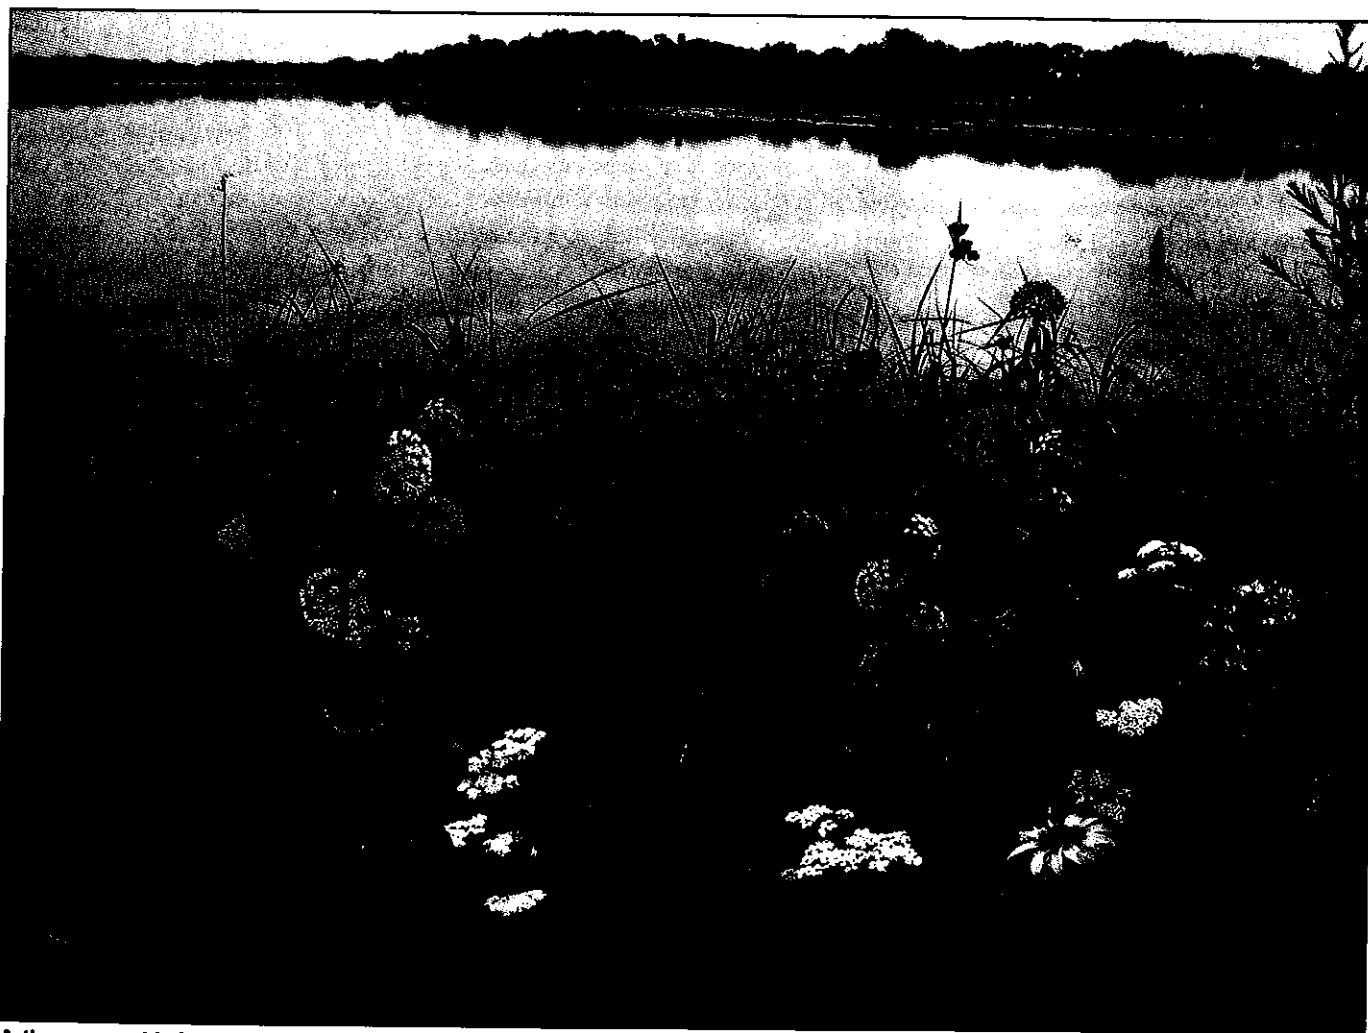
A three-year-old shore restoration segment on Lake Phalen, St. Paul, Minnesota.
