Maplewood Mall Stormwater Retrofit Project

Five Year Project Anniversary Inspection and Inventory

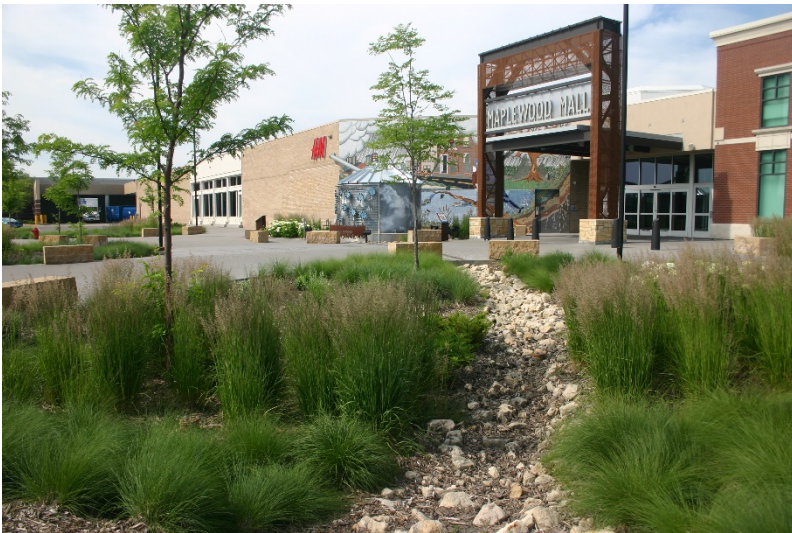
Overall Project Condition Notes

- The project is functioning well and weathering the storm of heavy mall traffic.
- Rain gardens and entry plantings are very healthy growing environments; water quality improvement as planned. Existing maintenance program very valuable.
- Tree trench design supporting good tree growth for some species, some species struggling. Overall design still very promising.
- Stormwater infrastructure in solid shape but some areas worth watching, potentially repairing.

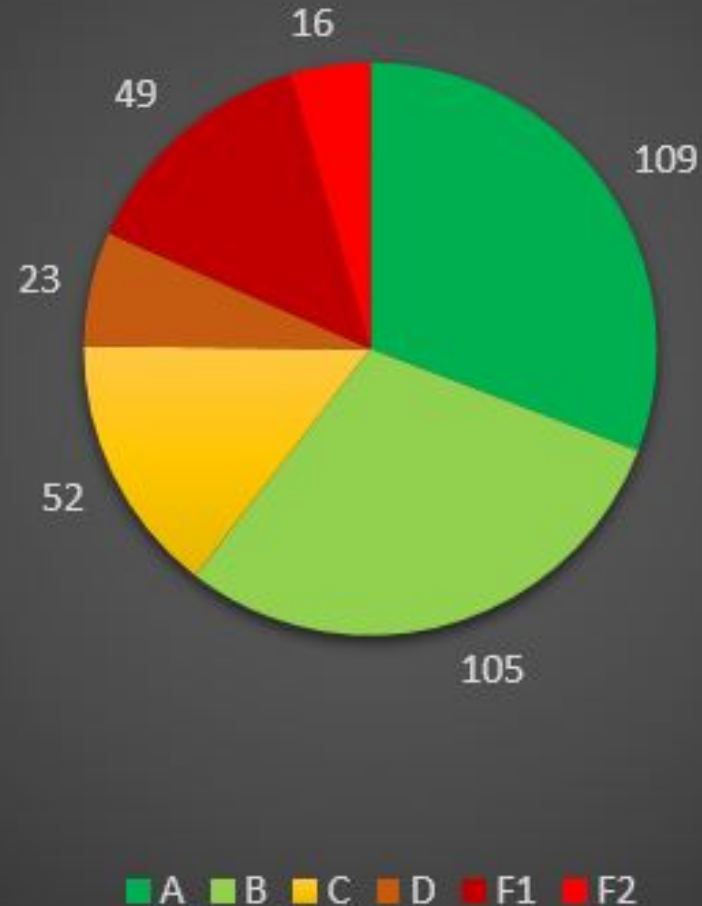
Total Trees by Condition

- Tree trench creates a unique growing environment well suited to some species
- Species chosen for dry conditions have struggled
- Shallower trenches have higher tree mortality

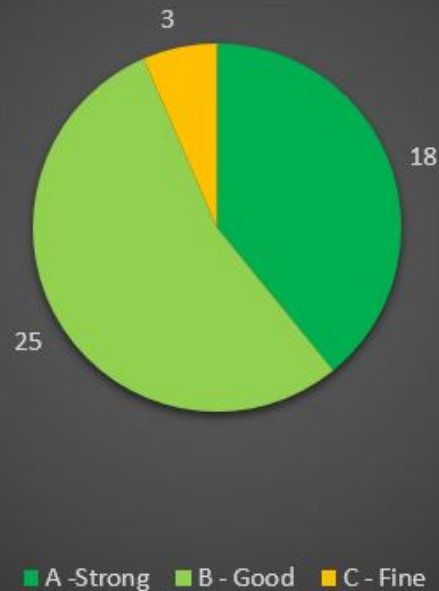
Discovery Elm

- Elm cultivars and swamp white oak showing outstanding growth
- Tree trenches creating a floodplain-like environment

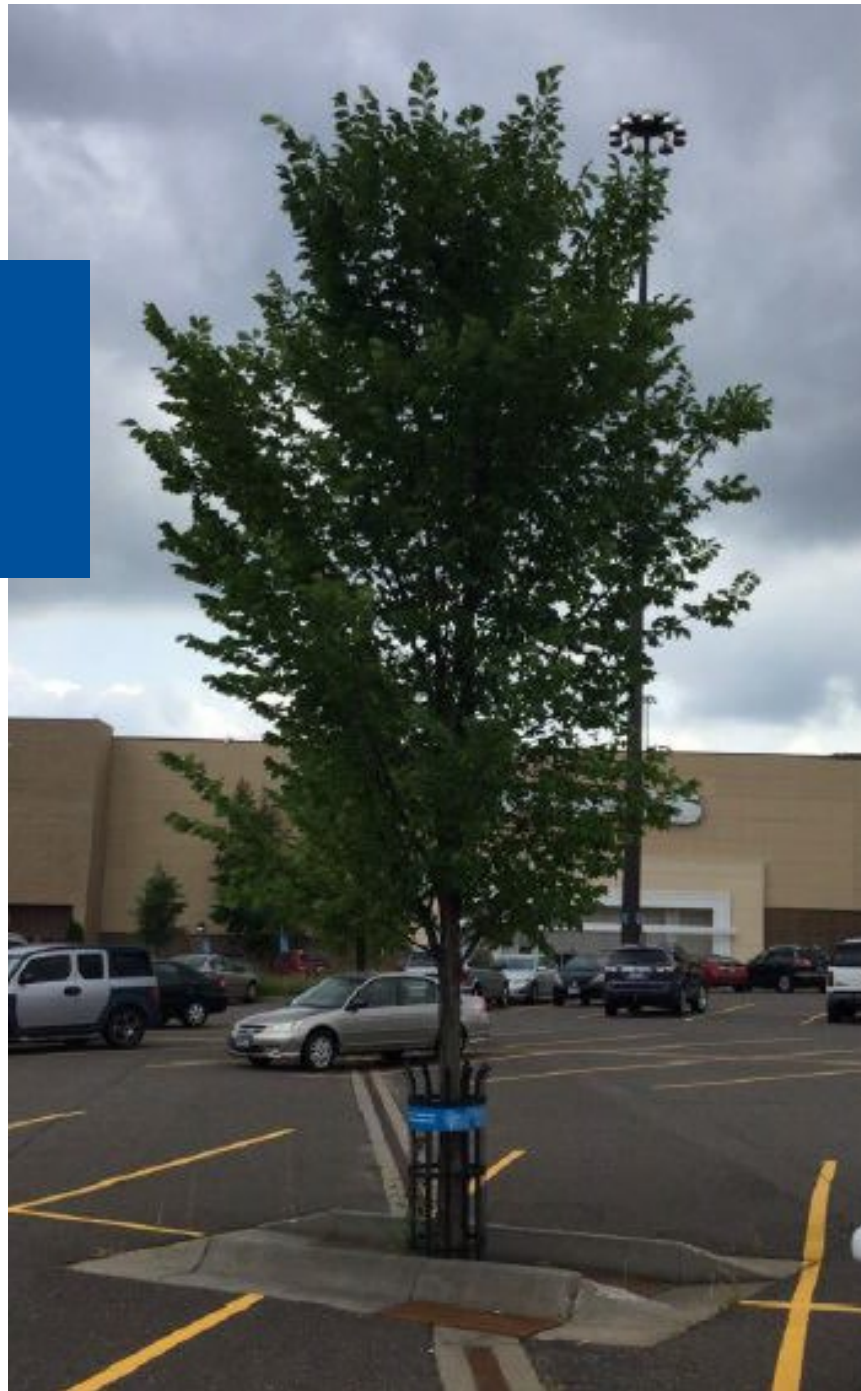
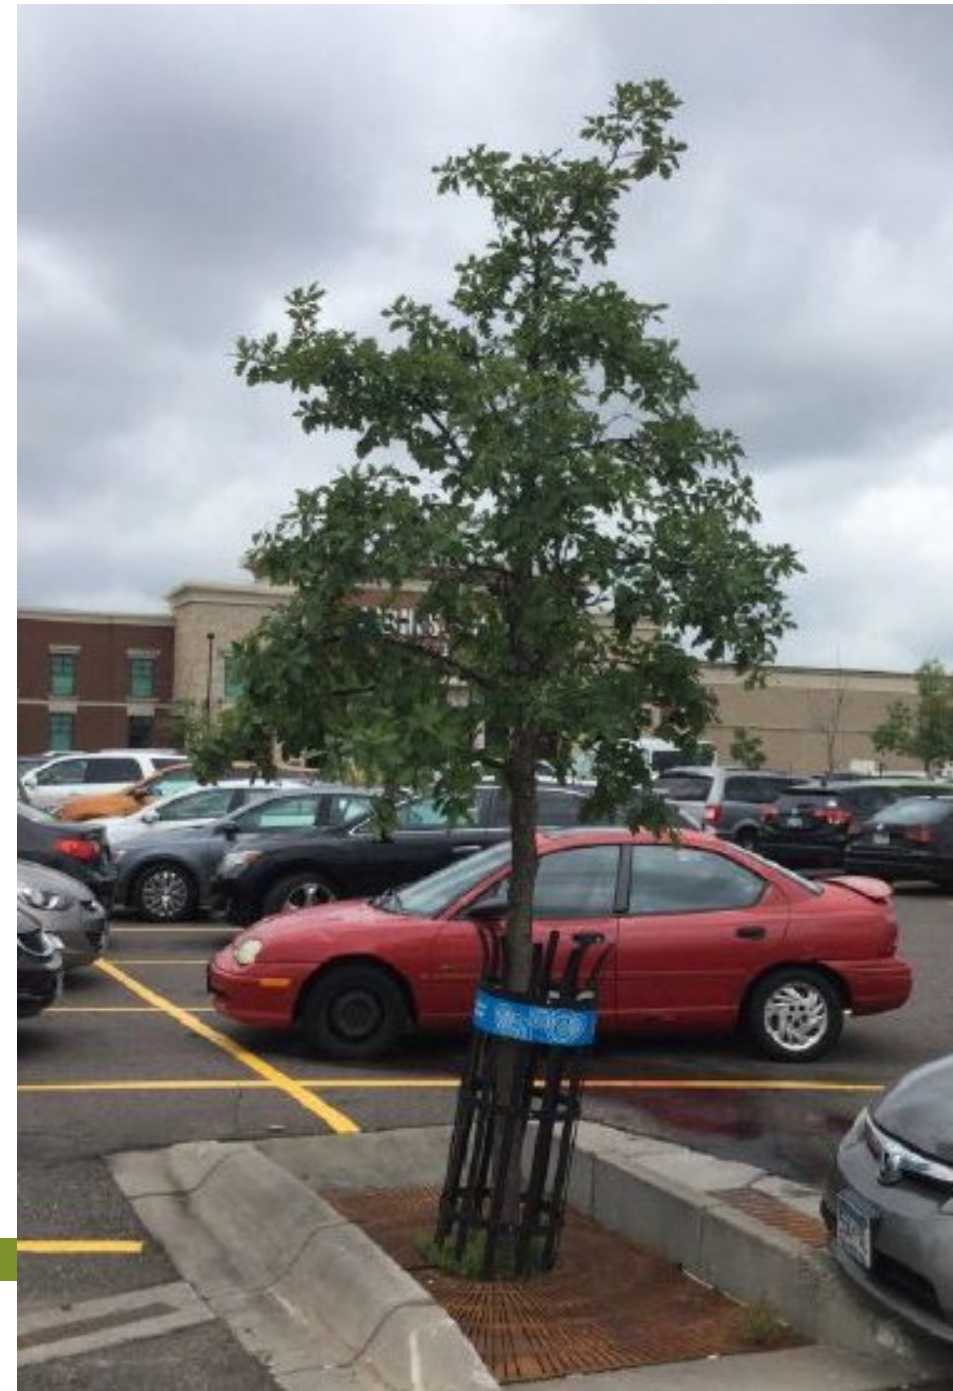
- Elm in West Grove
- Swamp white oak in East Grove
- Some trees installed at 2" DBH currently up to 5.5"+ DBH
